ARTICLES CONTAINED IN THIS ISSUE

07 2019MY FORESTER, DRIVER MONITORING SYSTEM (DMS) INOPERATIVE B2632 B2642

11 SECONDARY AIR INJECTION DIAGNOSTIC TROUBLE CODES P2441 AND P2442

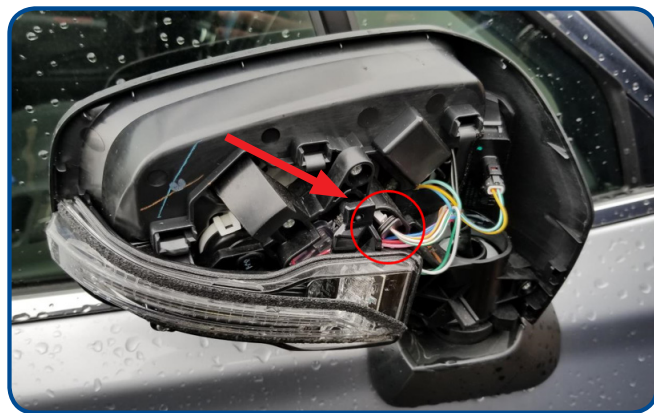
- Driver Focus will not register a name.
- When registering a new user, the system will fail registration, yet create a new profile with a default name that cannot be customized.
- Memory seat switches are inoperative.
- Right door mirror does not dip in reverse, check for poor contact at the door harness connection as shown in the photo.

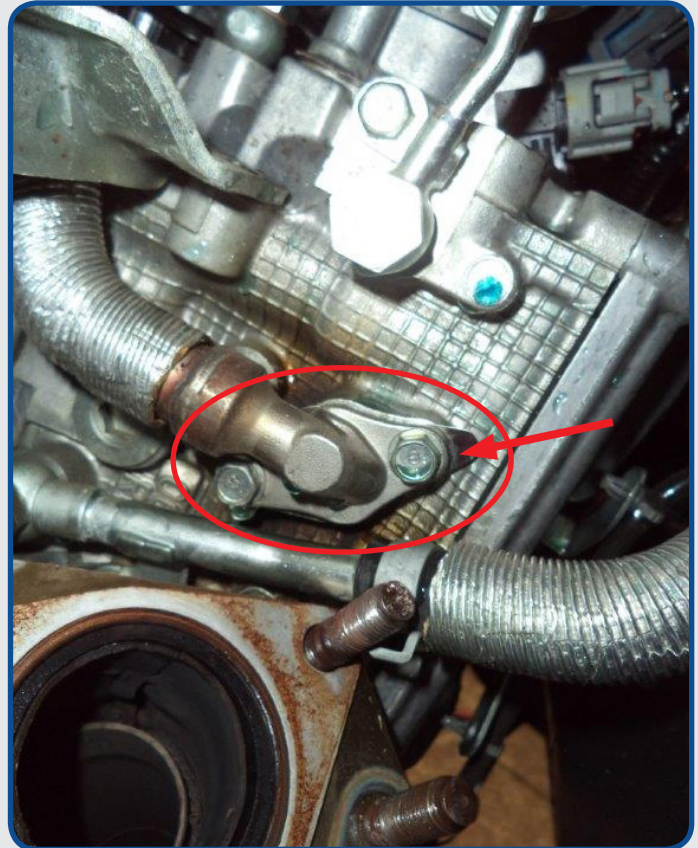
If so, check to see if there appear to be traces of carbon on the back of the right hand cylinder head. Turbo Charger removal may be necessary to get a good view of the pipe which bolts to the back of the cylinder head. If carbon traces are seen as shown in the photos below, there is a good chance the gasket that seals the secondary air pipe to the back of the cylinder head is installed in the wrong direction (from prior repair) causing secondary air flow to be partially blocked.

As seen in the attached photos, this gasket is pointed on one end. The correct way to install this gasket is with the pointed end facing towards the transmission.

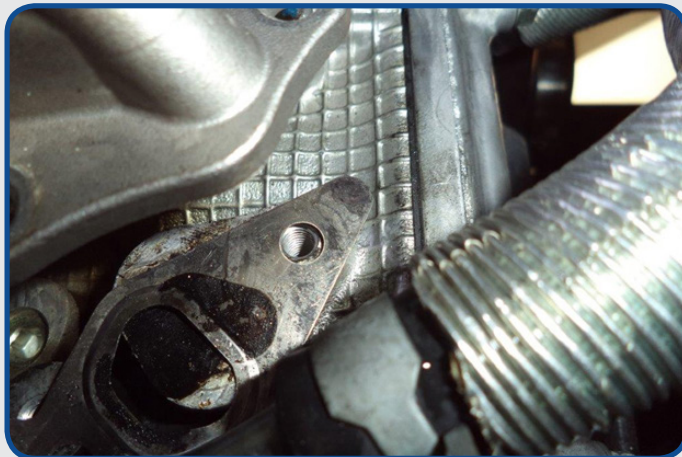
Wrong Way (Point Towards the Valve Cover)

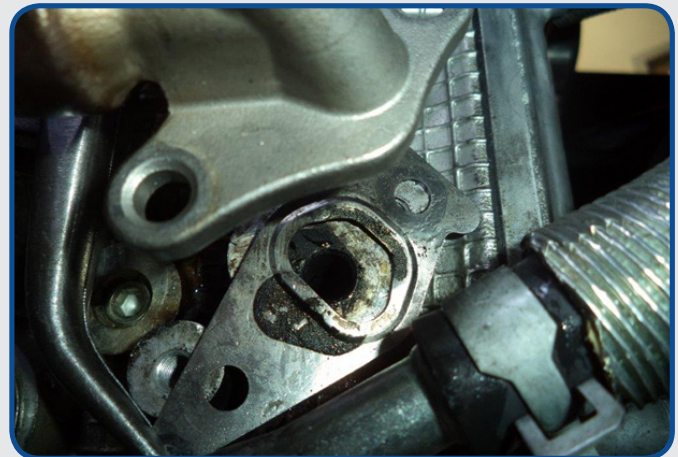
Correct Way (Point Towards the Short Block)
