SERVICE BULLETIN

APPLICABILITY: 2019MY Forester **NUMBER:** 07-151-19

SUBJECT: DTC B112C or B112E -Driver Monitoring / **DATE:** 04/25/19

DriverFocus™ System (DMS)

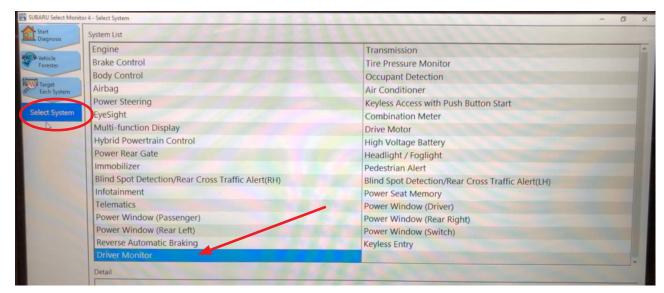
Go to: Diagnosis > Each System > Select Driver Monitor from the System List.

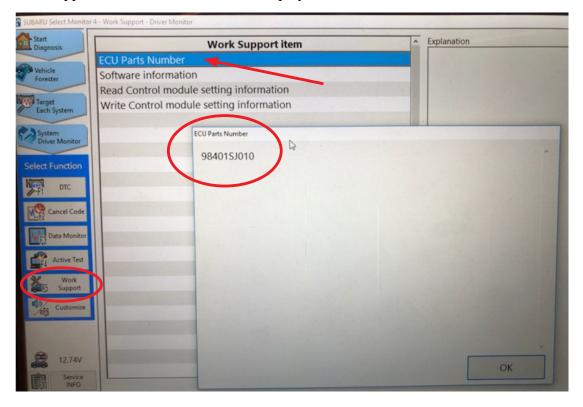
Select Work Support > ECU Parts Number to display the current version.

- 2) If the part number is 98401SJ010, proceed with reprogramming the DMS control module following the normal FlashWrite procedure below. If the DMS control module already has the latest part number, 98401SJ011, the procedure is complete. Proceed to the Warranty / Claim Information section and process a claim for inspection only. If the part number is different, diagnose the DTC per the applicable Service Manual. When reprogramming, select DMS from the CPU drop-down list.
- 3) After the reprogramming procedure is complete, turn the Ignition OFF, close all doors and the rear gate then wait for a few minutes until the indicator lamp for the DMS goes out. When the indicator goes off, the CAN bus is "asleep". **NOTE:** On push-button start models, the access fob must be away from the vehicle (out of range) or the system will not go to sleep.
