## SERVICE BULLETIN

**NUMBER:** 15-229-18R

**SUBJECT:** Harman Audio / Infotainment: Troubleshooting  
 Clock-Related Concerns

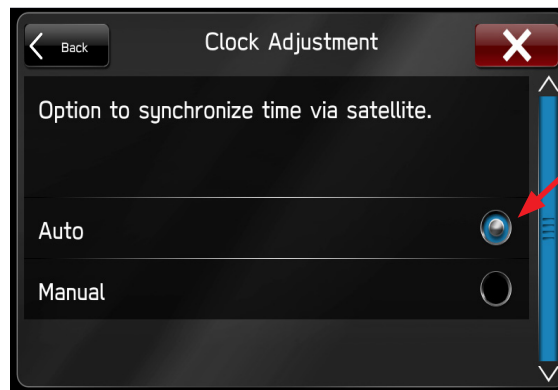
- a. What is the clock adjustment setting, Manual or Auto? (Clock setting information can be found under Settings > Vehicle > Clock Adjustment as shown below.)

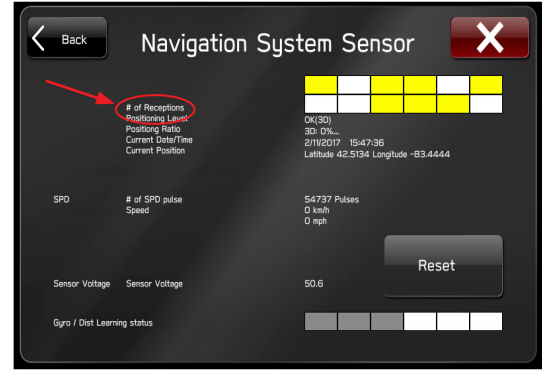
i. Open the Navigation System Sensor screen. Press and hold the Home hard key and press the Tune knob 6 times, then release the Home button. In the Dealer menu, select “Function check” > “Navi System Sensor” (See screenshot to the right.)

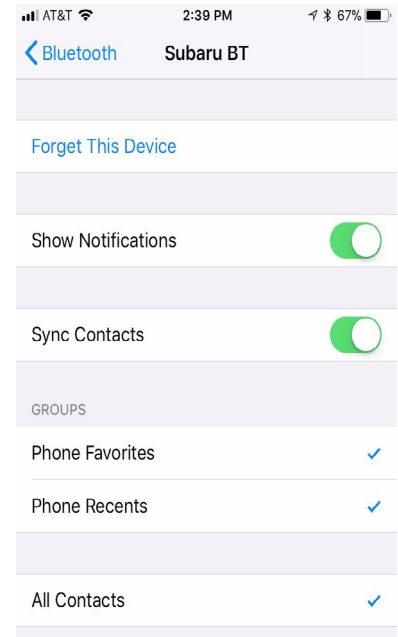
After pairing, access must be enabled on the phone. To do this, go to Settings > Bluetooth > Select the paired head unit labeled “Subaru BT” and make sure both Sync Contacts and Show Notifications are enabled. (See screenshot to the right.)

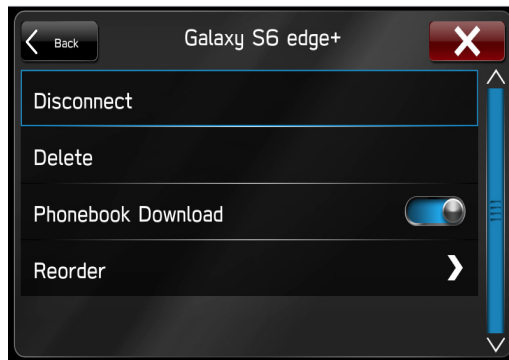
iii. After these items are enabled, disconnect the device from the head unit then reconnect. (See example screenshot of head unit display below.)

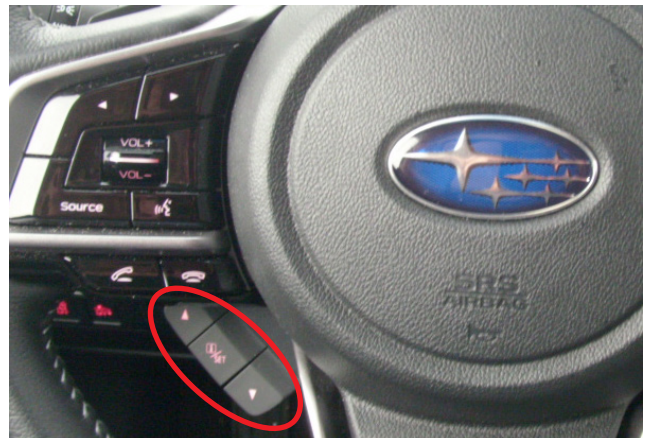
i. If vehicle is equipped with a color MFD, press the i/Set button until the MFD displays the “Hold SET button” screen. Hold the i/Set steering wheel button to enter the settings menu. The date and time settings are accessible from this menu.
