SERVICE BULLETIN

APPLICABILITY: 2015-18MY Legacy and Outback

NUMBER: 06-70-19

SUBJECT: VDC Control Module- Software Change
Hill Holder Indicator Lamp / Tone Operation

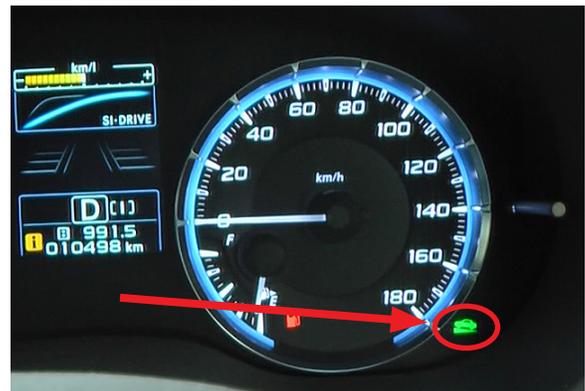
This bulletin announces a change to the operating software included in the Vehicle Dynamic Control (VDC) Control Module and Hydraulic Unit (VDCCM&H/U) on the models listed above. This change is in response to a very small number of customer inquiries regarding the Hill Holder system's indicator lamp blinking once along with a single tone (chirp) being heard when starting the engine using the key, push-button or with use of a remote engine start.

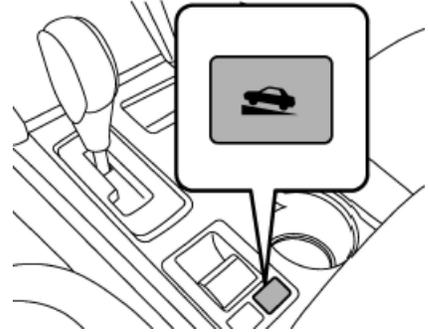
Currently, if the Hill Holder feature is turned on (green indicator lamp illuminated) and a low battery voltage / drop condition is detected (e.g. when starting the engine or when the engine cranks during a Remote Engine Start), the Hill Holder indicator lamp will blink once and a warning tone (chirp) will sound once. Function of the Hill Holder is not affected by these events.

The new software changes how the Hill Holder indicator lamp and corresponding single flash / chirp operate. After installation of the new VDCCM&H/U, if a low battery voltage condition is detected when cranking and the battery voltage drops low enough, the indicator lamp will no longer flash once and the tone will no longer sound. The Hill Holder feature operation is otherwise unchanged.
