PRODUCT CAMPAIGN BULLETIN

<p>APPLICABILITY: 2010-2014 model year Legacy 2010-2014 model year Outback 2010-2013 model year Forester 2010-2014 model year Tribeca 2010-2011 model year Impreza 2010-2014 model year WRX and STI</p> <p>SUBJECT: Takata Front Passenger Airbag Inflator Replacement (2019 Calendar year expansion)</p>	<p>NUMBERS: TKA-19 TKB-19 TKC-19</p> <p>DATE: 01/14/19</p> <p>REVISED: 03/19/19</p> <p>NHTSA ID: 19V-007 19V-008 19V-009</p>
-------------------------------------------------------------------------------------------------------------------------------------------------------------------------------------------------------------------------------------------------------------------------------------------------------------------------------------------------------------------------------------------------------	--------------------------------------------------------------------------------------------------------------------------------------------------------------------------------------------------------------

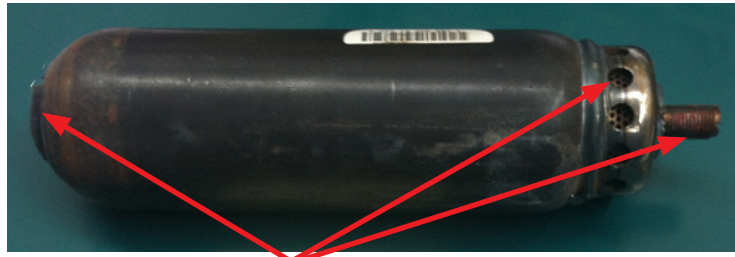
The shape, holes, and copper-colored stud indicate this not a Genuine Subaru inflator.

- **Do not proceed with this repair if your inspection reveals a non-Genuine Subaru airbag module has been installed in the vehicle.** Follow the instructions described in the “Counterfeit Airbag Information” Dealer Advisory Bulletin.

- Document the presence of the aftermarket or counterfeit device on the repair order and with photos. Report this information immediately on a Quality Monitoring Report (QMR). **IMPORTANT:** When entering a related QMR, use failure code **ULF** and **NOT** the campaign fail code.
