ARTICLES CONTAINED IN THIS ISSUE

07 ELECTRICAL DIAGNOSIS AND AFTERMARKET EQUIPMENT

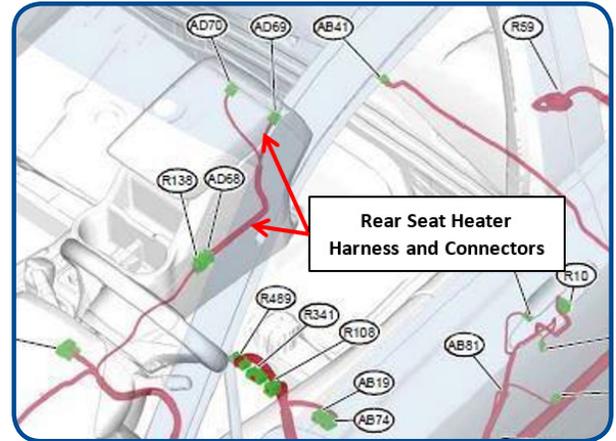
Should a customer present their vehicle with a concern of inoperative rear seat heaters, review the service history to check for any repairs which may have required removal of the center console box. The wiring harness for the rear seat heaters is secured with tape to the inside of the console box. If the tape were to come loose, the harness could droop down and become exposed. Rear seat passengers may inadvertently move or pull the exposed harness with their feet and disconnect rear seat heater connector(s). If the harness is found to be loose, remove the remains of the original tape and adhesive, clean and dry the affected area and properly re-secure the harness with a quality adhesive tape (e.g. duct tape). Make sure the new tape does not extend past the edge of the console box trim and become visible from the outside.

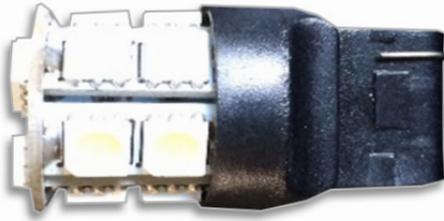
This replacement LED bulb which came from a 2010 Outback, had no resistor and was determined to be causing the shift lock solenoid to turn on/off randomly. In addition, the solenoid would occasionally stick “on” enabling the transmission to be taken out of Park without stepping on the brake pedal. Voltage at the BIU, ECM, TCM, and VDC control modules from the brake light circuit measured 2.83V with the brake pedal not depressed (specification is less than 1.5V). The result was a damaged BIU which caused the 2.83V output voltage to the shift lock solenoid.
