Preliminary Information

PIT5377G Uneven Front Brake Pad Wear

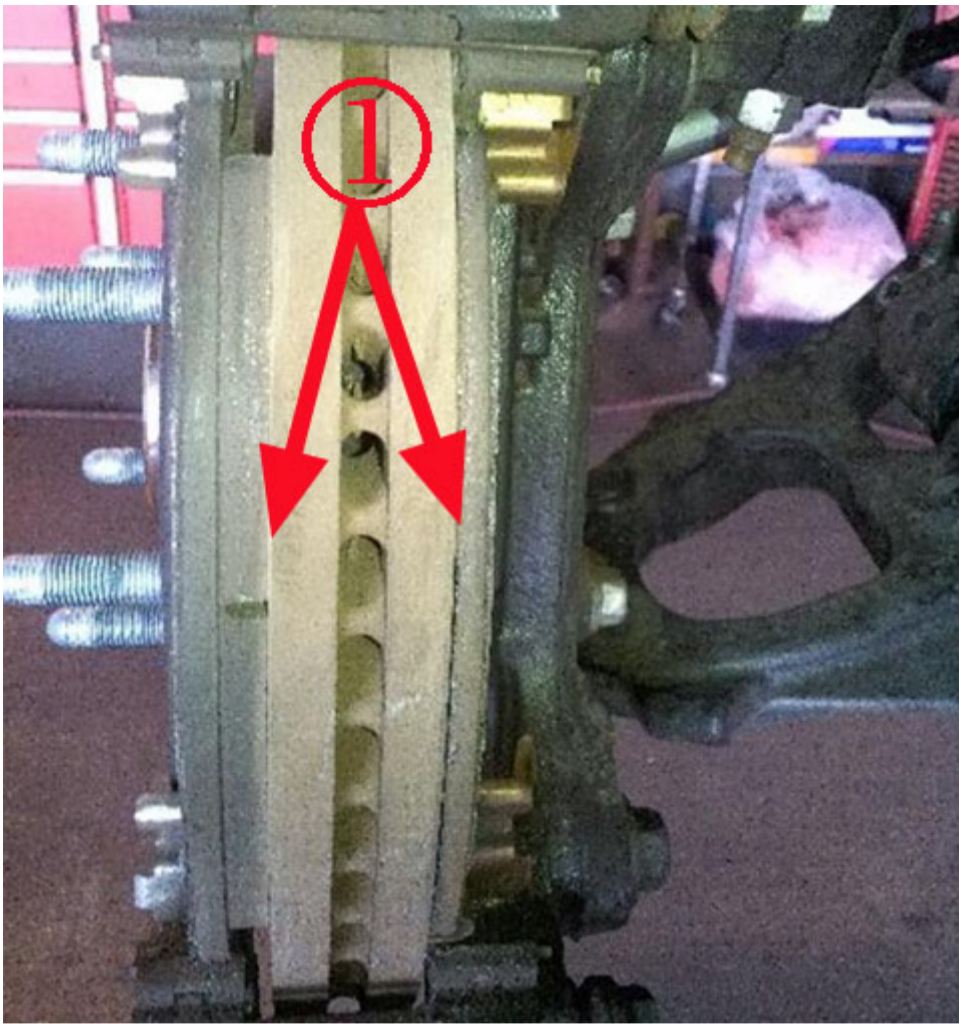
During a brake inspection, some complaints of uneven front brake pad wear have been reported. The vehicle may have low mileage, typically around 10K miles. The inner pad on either the front left or right side may be worn out. It is considered uneven pad wear if one of the following is true:

Shown below is an example from one vehicle with uneven wear. Photo 1 is of the left front brake pads where the inner pad is worn completely out, while the outer pad still has plenty of pad life. Photo 2 is from the same vehicle, but of the right front inner and outer brake pads, which both have plenty of pad material left.

Inspect and measure the brake pads thickness. Determine the type of driving the owner does and compare the measurements to the information listed above (3mm or 6mm).

If the pads are out of specification, perform normal SI diagnostics to determine the cause of the concern (caliper piston binding, binding pads or guide pins in bracket, brake hose restriction, etc).

After completing normal diagnostics, if a root cause for the uneven pad wear is not found, replace the front brake pads with the part number in the table below. Refer to the Brake Rotor Surface and Wear Inspection information in SI to determine if the brake rotor(s) require servicing or replacement. If the brake rotors require service due to excessive heat checking/blueing, it is recommended to replace the rotors rather than attempting to refinish the rotor(s) for this issue. Refer to the parts catalog for the correct O.E.M. rotor part number, which are Ferritic Nitro-Carburizing (FNC) rotors.
