TECHNICAL SERVICE BULLETIN

1.0L EcoBoost - Automatic Transmission - Illuminated MIL With Multiple DTCs

19-2168

Ford 2018-2019 EcoSport

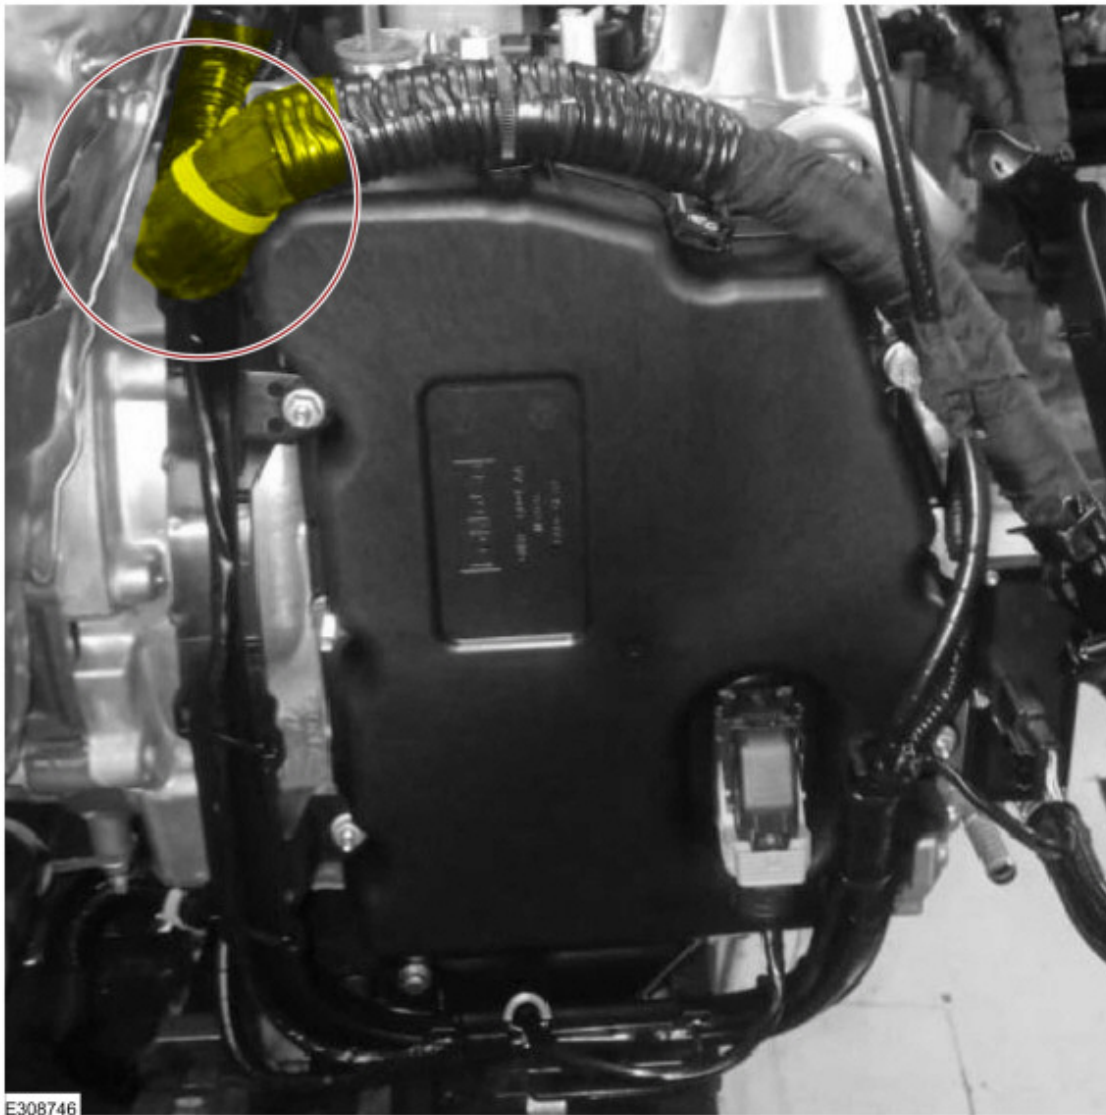
Figure 1

1. Inspect the routing of the engine control harness between the transmission and the exhaust heat shield.
(Figure 1)

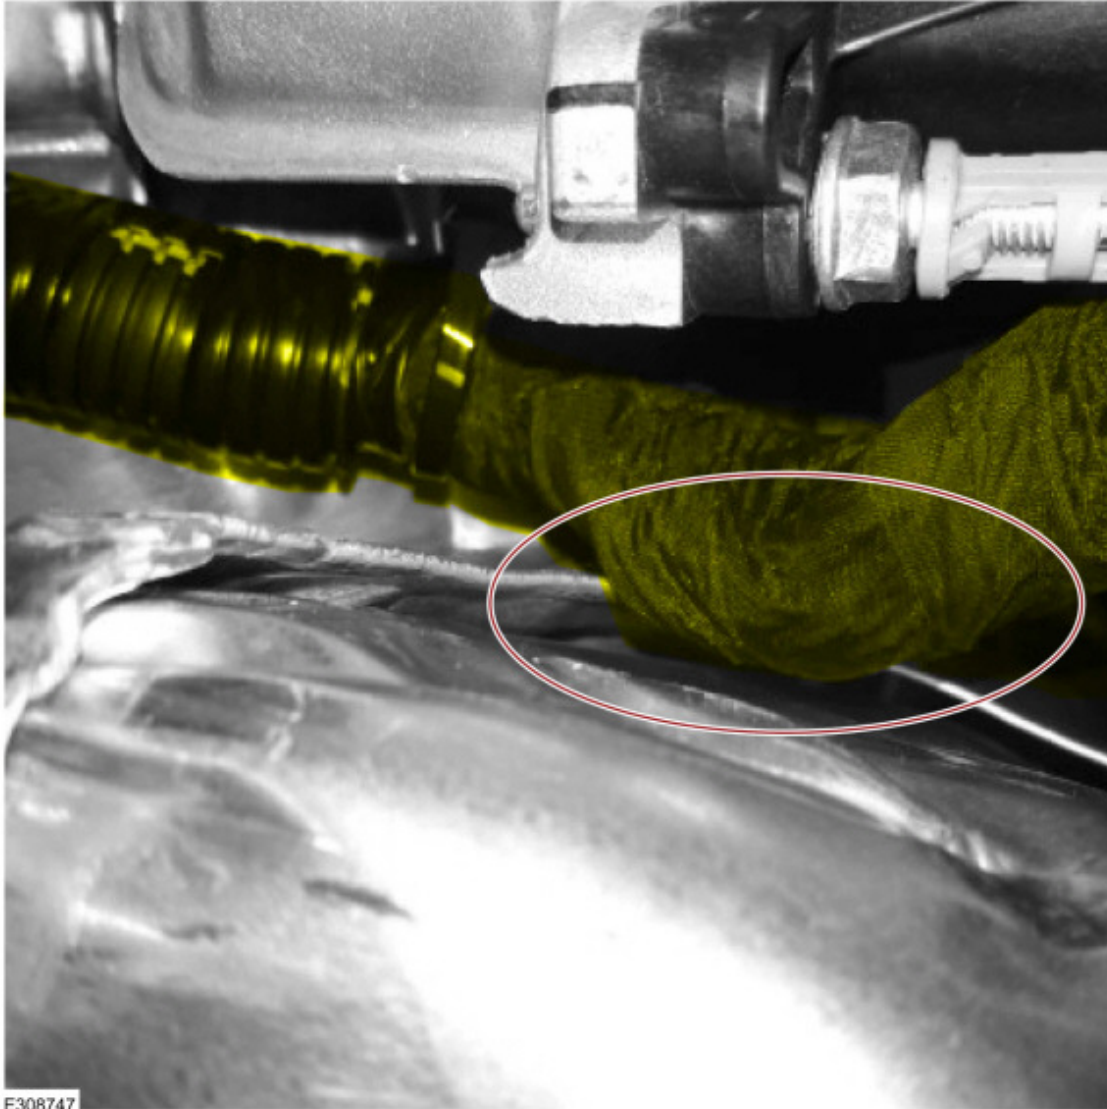
Figure 2

2. Is there evidence of contact between the harnesses and exhaust heat shield? (Figure 2)
 - (1). Yes - proceed to Step 3.
 - (2). No - this article does not apply. Refer to Workshop Manual (WSM) for normal diagnostics.
