## Preliminary Information

### PIT5291E Wind Whistle Noise at Highway Speeds from Left or Right Rear Quarter Glass Area

This PI was superseded to add 2019 Model Year. Please discard PIT5291D.

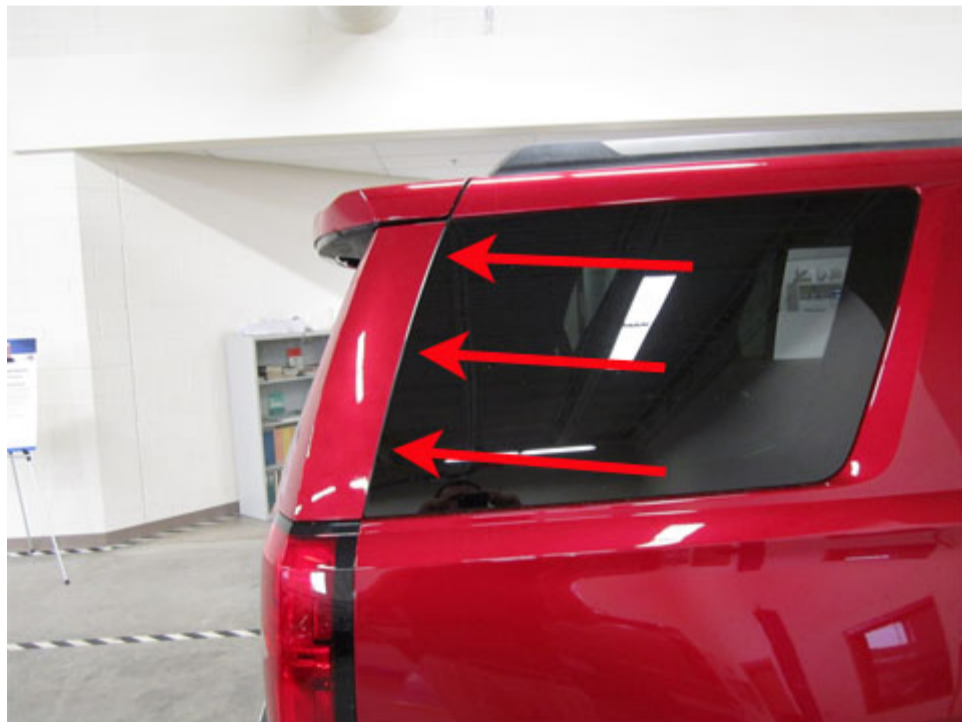
**Some owners may comment when driving at highway speeds (60mph and up) there is a wind whistle noise heard from the right or left rear quarter glass area. This noise may be more noticeable with a cross wind. This concern could be caused by either of the following:**

**1. The fit between the exterior "D" pillar trim and the rear quarter glass in the area shown below.**

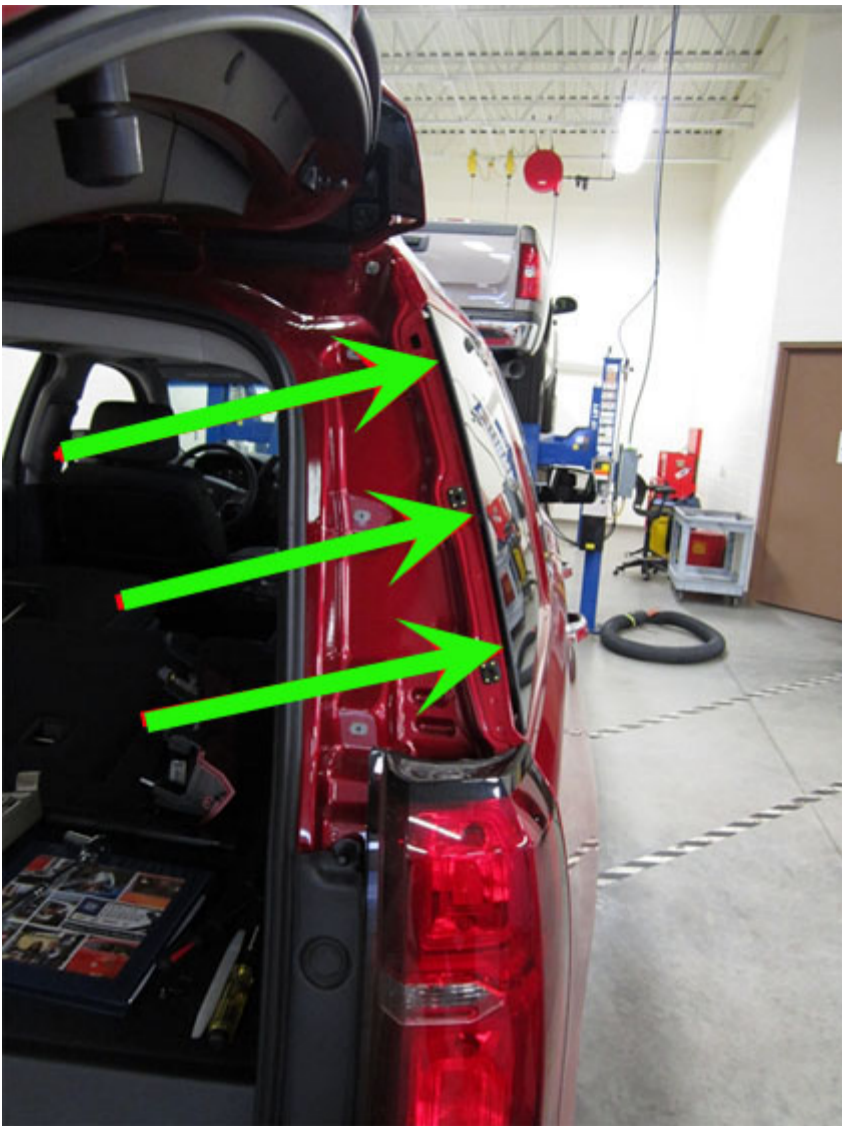
**Excessive urethane from the quarter glass installation may not allow the exterior "D" pillar trim to fit properly against the rear quarter glass, as shown below.**

1. Use a sharp knife and cut off the excessive urethane, as shown below. In most cases the urethane will need to be cut sub-flush to the sheet metal. This will allow the exterior "D" pillar trim to fit correctly against the rear quarter glass.

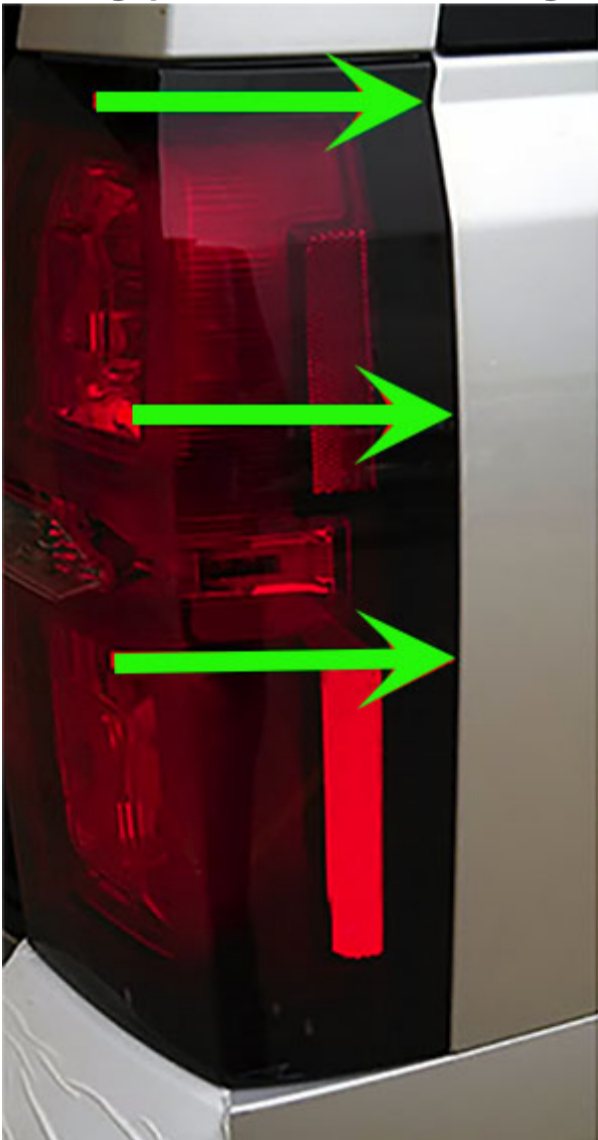
2. The gap between the rear tail light assembly and the quarter panel, as shown below.

**2. Install a 5mm X 5mm (3/16 X 3/16) piece of closed cell foam tape along the entire length of the tail light assembly, as shown below.**
