# Preliminary Information

## PIP5498L SES Lamp P050D P0300 Setting On A Cold Start And/Or a Run Rough Warm with No codes

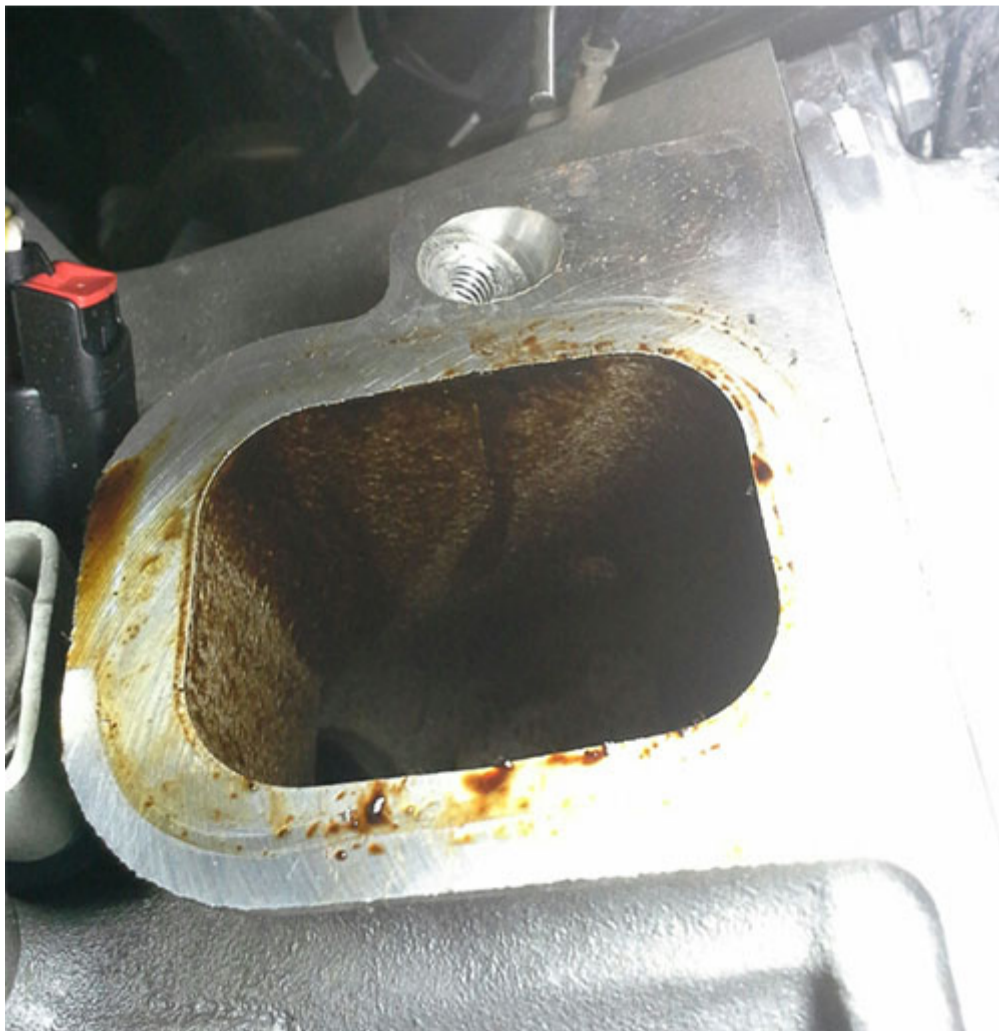
If the head casting line is the concern the intake port will be wet with a coolant oil mix.

This could be the cause of a running rough warm concern with or without codes.

The location of where the coolant is running down in the port will also look washed down.

If this is found the cylinder head will need to be replaced.

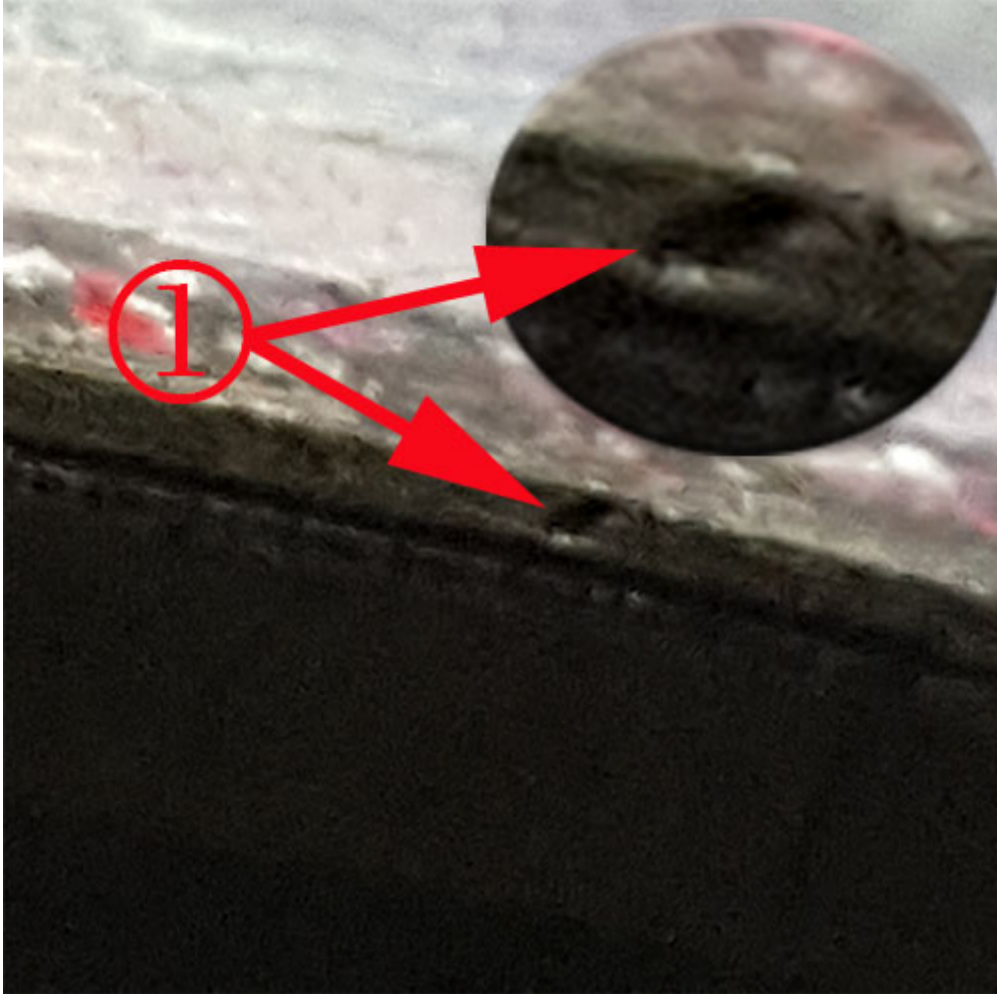
For coolant entry at the liner to deck face casting of the cylinder bore.

It is hard to see the actual source (pin hole) but it usually streams down the liner so that you can see it with a borescope.(Sometimes) The top of the piston will be steam cleaned.

Do not confuse residual fuel on the piston crown / surface as coolant. Some fuel residue may be present and can be mistaken as coolant (reason for the cooling system Dye to be added). Use black light to confirm the liquid is coolant. If this concern is present, do not replace the cylinder head because that will not repair this concern. Call PQC per the latest version of [16-NA-338](#), if required, reference this PI and replace the engine.
