Preliminary Information

PIT5680 Water/Ice In Door Sill Plate Area

Brand:	Model:	Model Years:	VIN:		Engine:	Transmissions:
			from	to		
Chevrolet	Silverado 1500	2018	All	All	All	All
GMC	Sierra 1500	2018	All	All	All	All

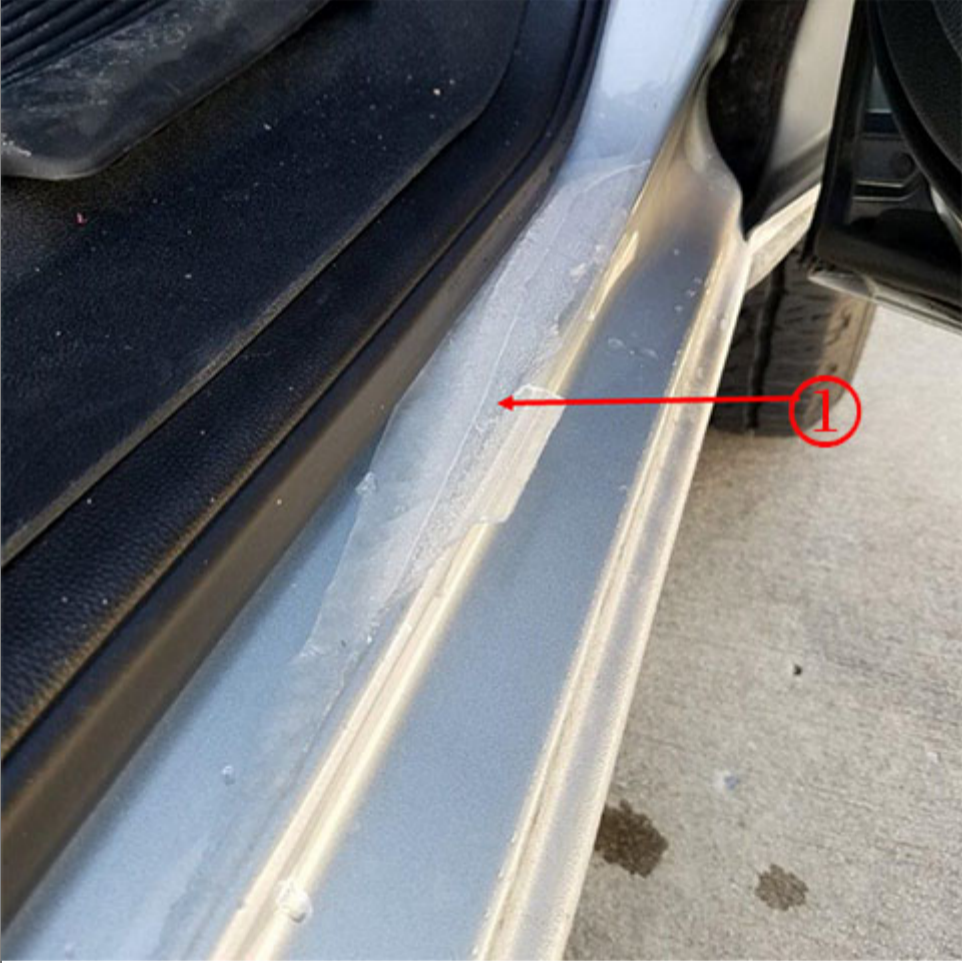
Some customers may notice that when they open a door, water may have become trapped on the sill plate between the body and the door seals. If the outside temperatures are below freezing, the water may freeze on the sill plate, as shown in the picture below (1).

Condition

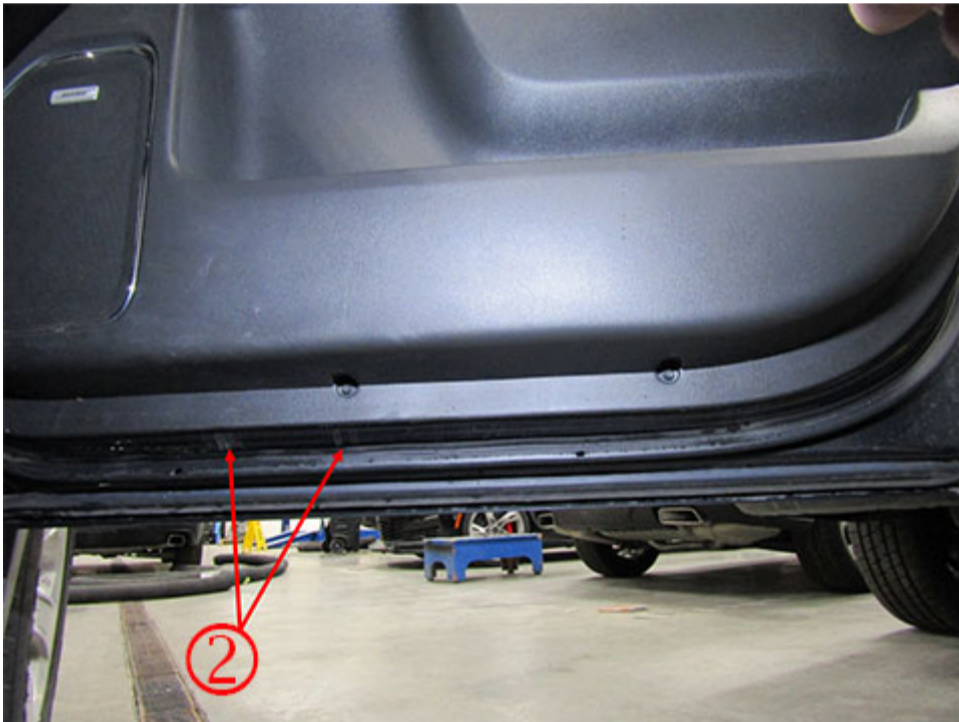
Cause
This concern may be caused by the door water barrier/deflector butyl not being sealed to the door. When inspecting the bottom of the door, water stains may be found coming from below the door trim panel, as shown below (2).

- With the door open and window up, water test the vehicle by pouring water along the outside window belt molding.
- Inspect for water leaking out from below the door trim panel.

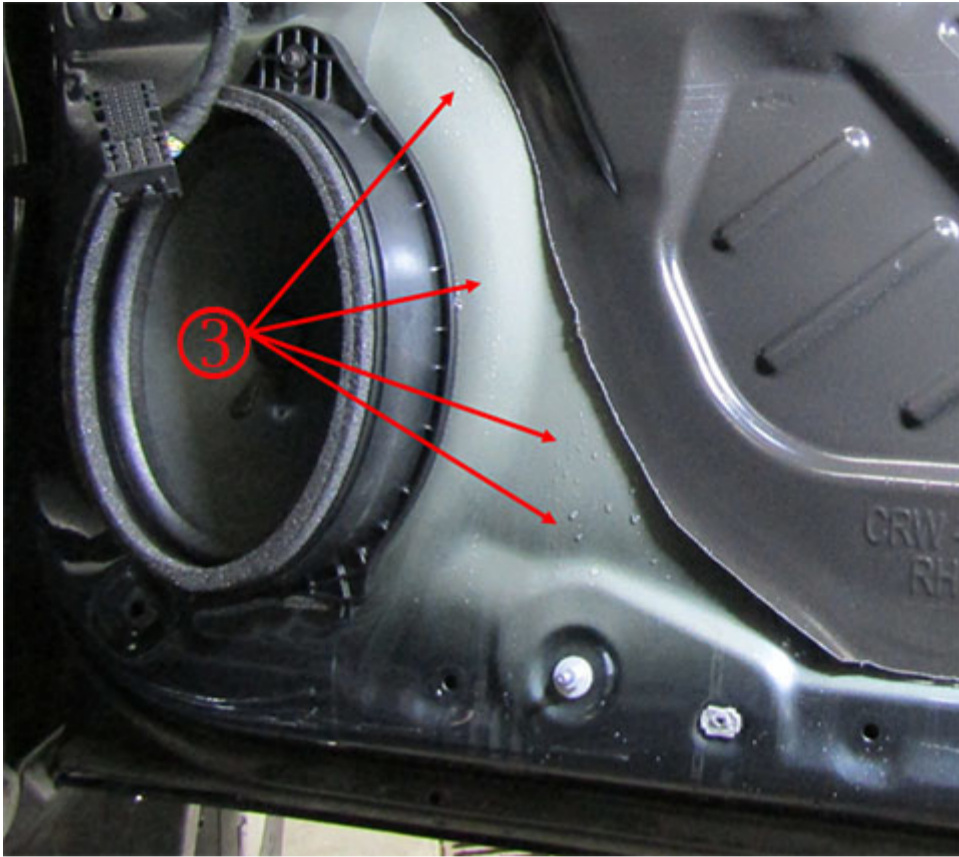
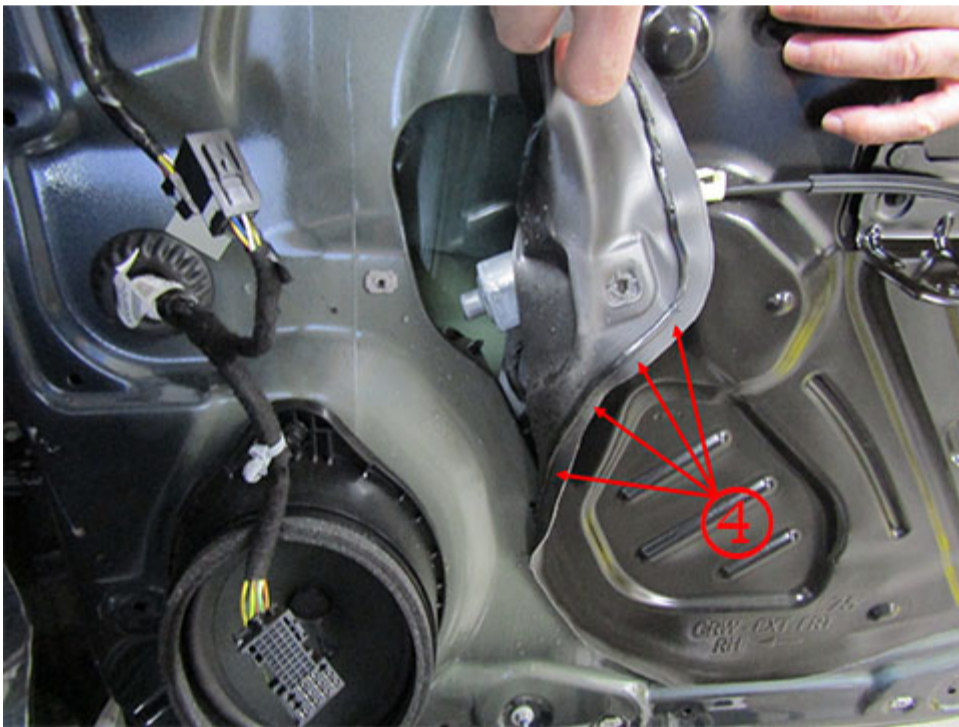
- If water is found leaking out from underneath the panel, remove the door trim panel for further inspection.
- With the door trim panel removed, inspect for water droplets on the door sheet metal, as shown below (3). This will give you an idea/area where the door water barrier/deflector is not sealed properly, as shown below (4). If the door water barrier/deflector is gently pulled away from the door it will come free with little effort, which is an indication it was not sealed to the door properly.

- Dry any water from the door and reinstall the door water barrier/deflector.
- With the door water barrier/deflector in place, use a roller or socket to help seal the water barrier/deflector butyl to the door.

- Reassemble the door trim panel and water test the door again to confirm the vehicle has been repaired.
