## PIC6352A Diagnostic Tip - Service Night Vision - Unable to Perform Night Vision Camera Control Module Learn with a Possible Procedure 31 Request out of Range Message

### Models

Brand:	Model:	Model Years:	VIN:		Engine:	Transmissions:
			from	to		
Cadillac	CT6	2016 - 2020	All	All	All	All
Cadillac	XT5	2020	All	All	All	All
Cadillac	XT6	2020	All	All	All	All

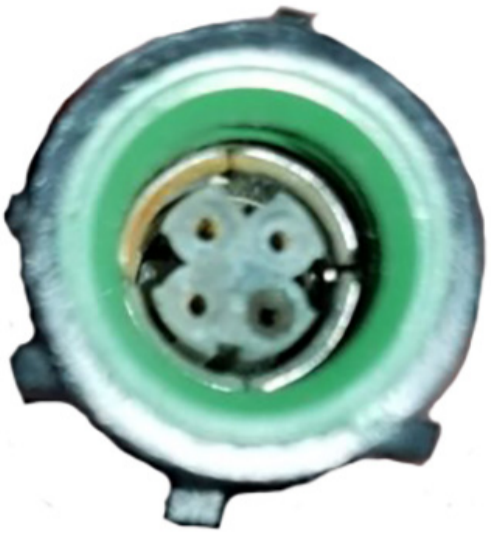
Night Vision Camera Connector:

Examples of corrosion found in LVDS connectors (usually found with damaged camera which allows water intrusion)

Cycle connections on the LVDS cable at X1 of the B276 Night Vision Camera,

Check for any signs of corrosion in the connectors, Make sure CPA's are locked in place. Re-attempt the Night Vision Camera Control Module Learn.
