Preliminary Information

PIP5648 MIL on P0011 and/or P0014

Brand:	Model:	Model Years:	VIN:		Engine:	Transmissions:
			from	to		
Chevrolet	Silverado 1500 (New Model)	2019	All	All	L3B 2.7L	All
GMC	Sierra1500 (New Model)	2019	All	All	L3B 2.7L	All

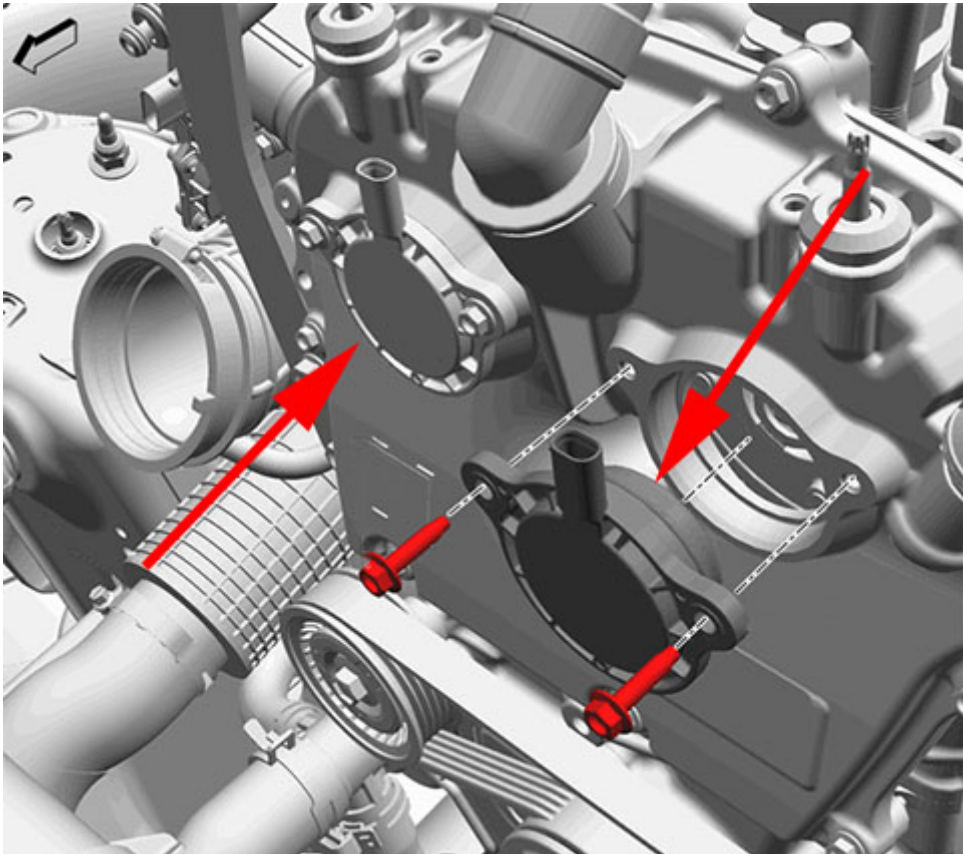
Remove the Intake and Exhaust Camshaft Position Actuator Magnets.

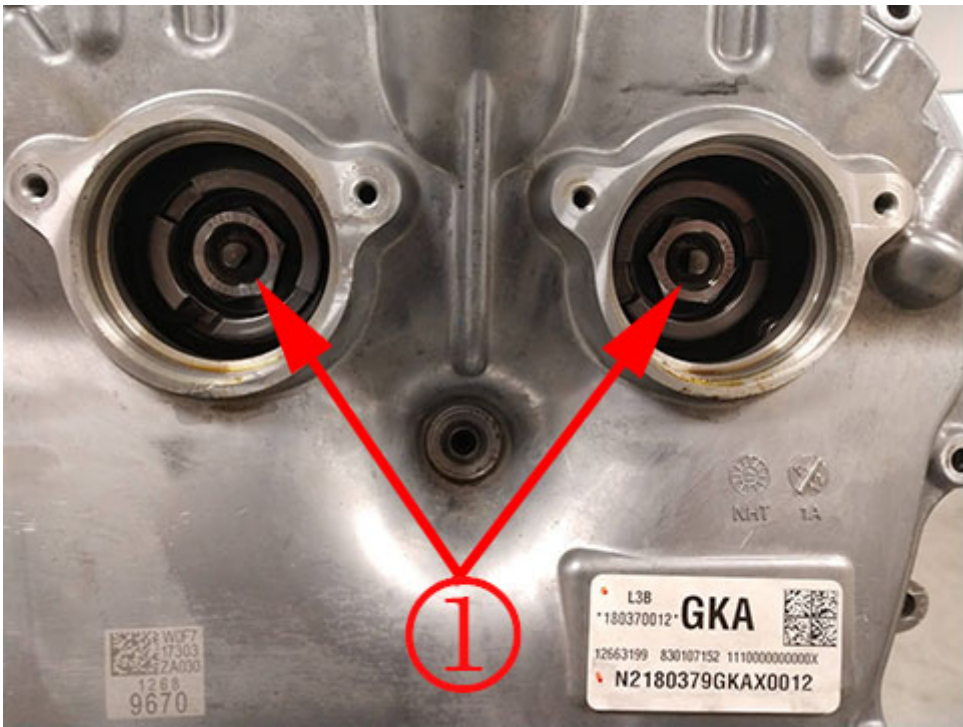
The Intake and Exhaust Camshaft Position Actuator Valve Solenoid bolt plungers (1) are located in the center of the bolt assemblies and protrude slightly from the head of the bolt at rest.

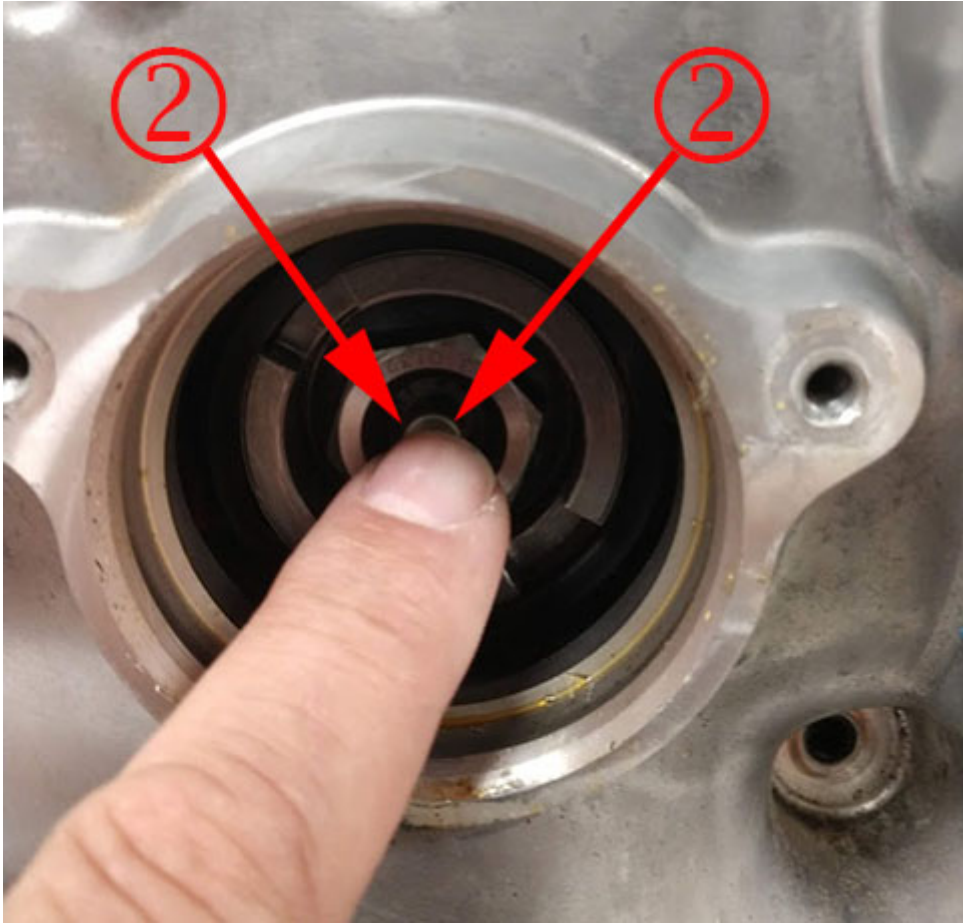
Using your finger, compare the travel and feel of the Camshaft Position Actuator Valve Bolt Plungers (2) to each other.

If the spring is broken, the plunger travel may be decreased, it may not fully return to the proud position, and may have poor spring tension as compared to a new assembly.

If a concern with either plunger is isolated, replace both the intake and exhaust Camshaft Position Actuator Valve Solenoid bolts on vehicles built before March 20, 2019.

On vehicles built after March 20, 2019, replace only the affected Camshaft Position Actuator Valve Solenoid bolt.
