SI M11 01 17  
Engine

May 2019  
Technical Service

## FAULT 118002 - MIXTURE TOO RICH SETS DURING WINTER WITH COLD AMBIENT TEMPERATURES

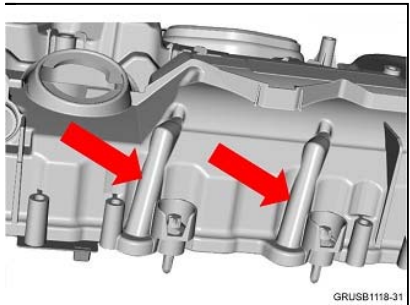
<p style="font-size: 8px; margin-top: 5px;">GRUSB1118-31</p>	<p>The older version is shown to the left.</p>

Replace the cylinder head cover and profile gasket if the older version is equipped.

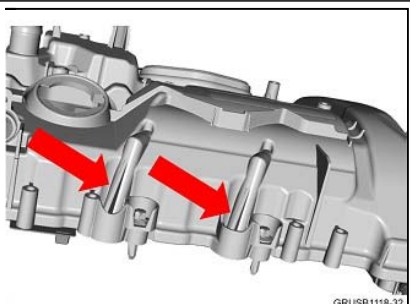
<p style="font-size: 8px; margin-top: 5px;">GRUSB1118-32</p>	<p>The newer version is shown to the left                  Note: This updated version can be identified by the additional supports on crankcase ventilation ports</p>
