ON-ROAD

'18 -'19 GL1800 Navi Update

MSN 17037 (1901)

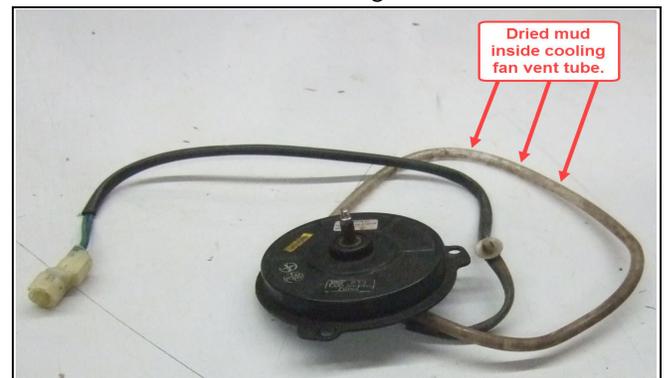
Same engine overheating as above, but a different cause. If a customer complains the cooling fan does not turn on and the engine is overheating, the problem may be due to the cooling fan's clear vent tube end being submerged in water. The temperature differential between the cool water and the hot cooling fan motor draws water into the cooling fan motor through the vent tube, damaging it. To check, follow these the steps below:

1. Check if the cooling fan fuse is blown and for evidence of water or debris in the cooling fan's clear vent tube (see below) - both could be evidence of water ingestion.

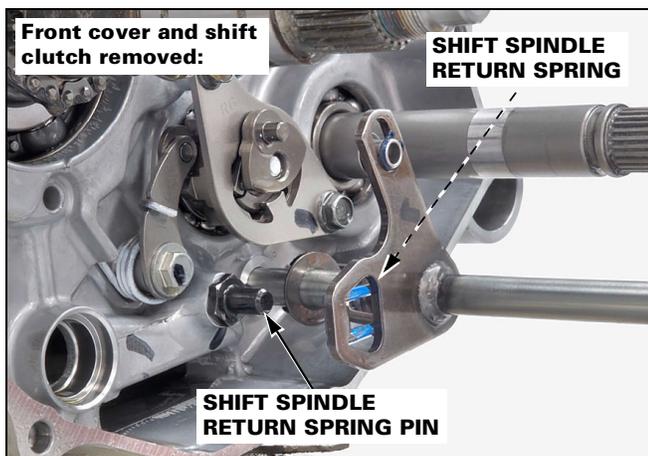
If a customer complains of erratic shifting first verify the shifting problem is repeatable then verify there are no Diagnostic Trouble Codes (DTC). It is possible the gear shift spindle return spring pin may be broken. The pin, along with the shift return spring, returns the shift spindle to its "at rest" position.

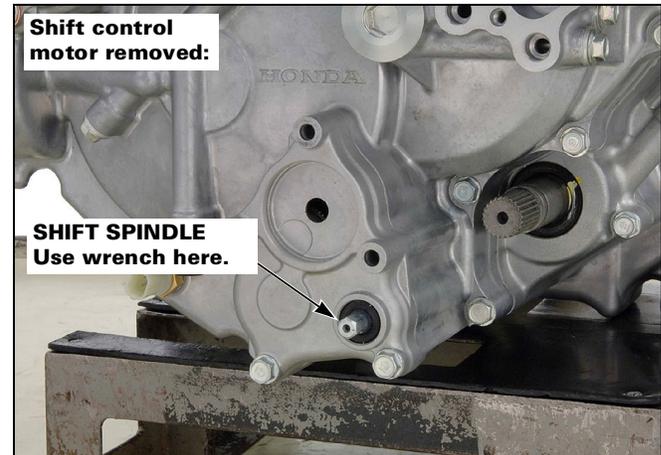
- Remove the shift control motor.
- Then, check for spring tension on the shift spindle by attaching an 8 mm box-end wrench to the end of the spindle and turning the wrench in both directions.

You should be able to feel the spring tension from the shift spindle return spring. If there is no tension, the shift spindle return spring pin is broken and needs to be replaced. There is a new part (P/N 24652-HR3-A70) and the torque spec has changed from 24 N m to 29 N m.
