TECHNICAL SERVICE BULLETIN

Technical Service Bulletin: 40-1044

2019 – BERKSHIRE CLASS A MOTORHOME – L.P. REGULATOR INSPECTION & REMEDY INSTRUCTIONS

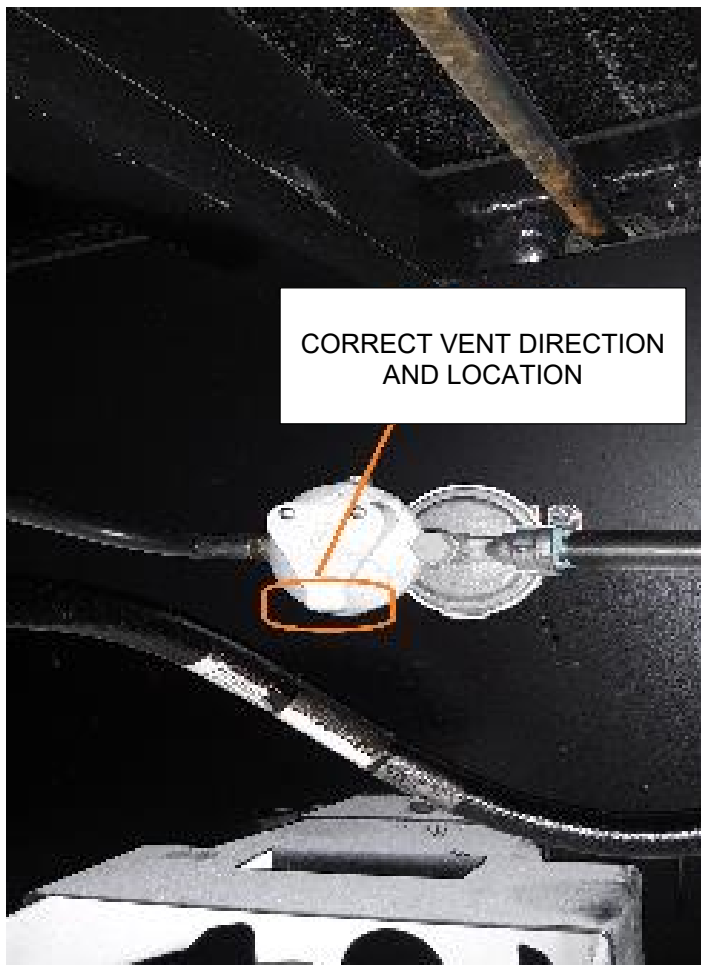
FIGURE 1

STEP 3: IF THE "TRIANGLE DIRECTION POINTS DOWNWARDS (FIGURE 1) **STOP** INSPECTION AND CLAIM REPAIR CODE LISTED ON THE NOTIFICATION FOR INSPECTION ONLY;

STEP 7: ENSURE REGULATOR TRIANGLE POINTS DOWNWARD AND REFASTEN TO COMPARTMENT USING THE RETAINING SCREWS, SEE (FIGURE 1);

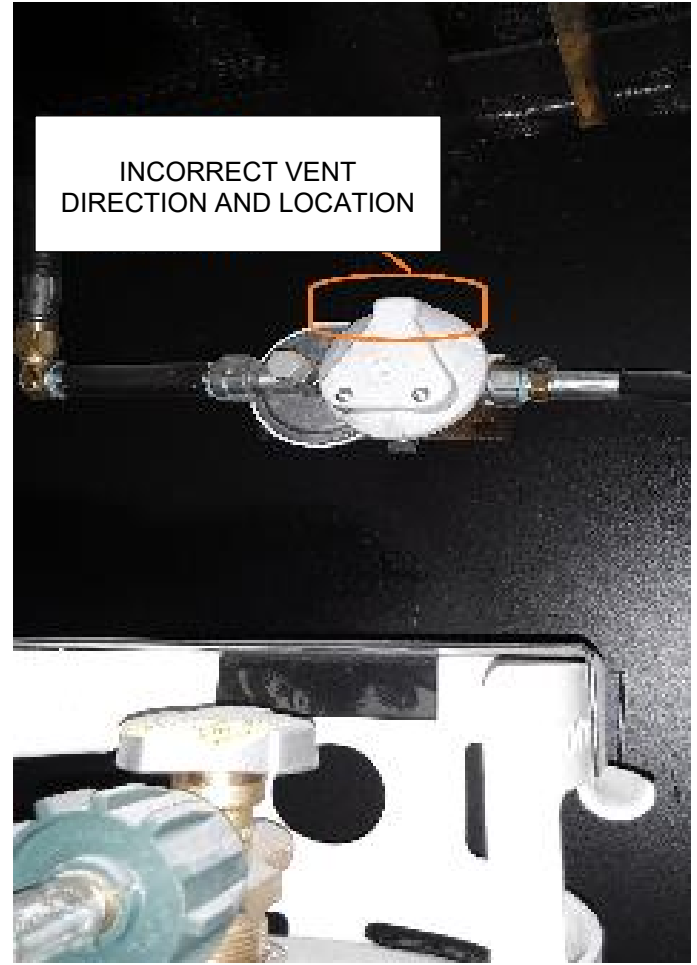
FIGURE 2

The L.P. Regulator was installed upside down in certain vehicles, which places the ventilation screen upward whereas it should be pointed downwards vertically. If the LP regulator vent screen remains vertically up, the vent may accumulate dust, dirt and/or other debris potentially causing poor performance of regulator ventilation affecting L.P. appliances connected to the exterior Quick Disconnect.

STEP 4: IF THE TRIANGLE DIRECTION POINTS UPWARDS (FIGURE 2), BEGIN REMEDY REPAIR;

STEP 5: REMOVE TWO RETAINING SCREWS FROM REGULATOR BASE;

STEP 6: ROTATE REGULATOR 180°, **IMPORTANT: DO NOT KINK ANY HOSE(S)**
