MAINTENANCE Mi14-34D INFORMATION

DATE : MAY 2014	SECTION: 23 - Accessories
SUBJECT : PREVOST AWARE ADAPTIVE CRUISE BRAKING (ACB) • FLR20 & FLR21 RADAR SENSOR ALIGNMENT

THIS MAINTENANCE INFORMATION SUPERSEDES PREVIOUS VERSION.
REVISION D Added: FLR21.

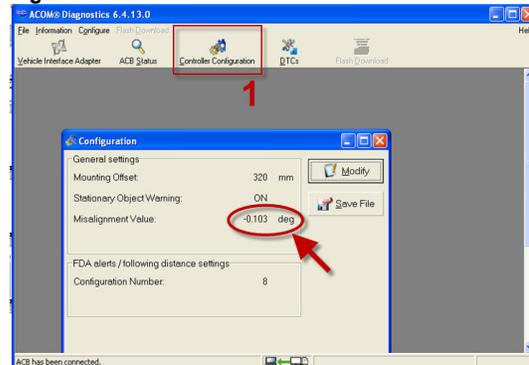
Fig.3

6. To check the Misalignment Value, select *Controller Configuration*.

If the Misalignment Value is within -0.8deg and $+0.8\text{deg}$, no alignment is necessary.

Re-align the radar sensor vertically and horizontally if:

- The system seems to track or warn on vehicles in adjacent lanes.
- The cruise control is not available and the ACB system telltale is illuminating steady in red and the following message shows in the DID: "ACB RADAR MISALIGNMENT".
- The system seems to not "see" as far as it "used to", or warn on many more overhead bridges/signs than previously.

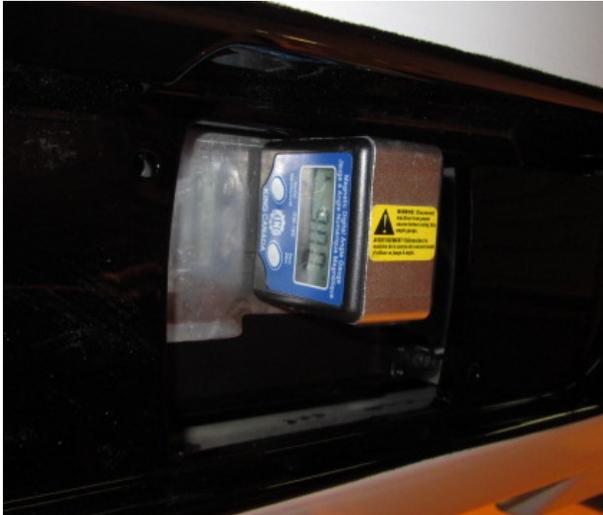
FIG.10

16. Place the digital inclinometer on the steel clip as shown on figure 10.

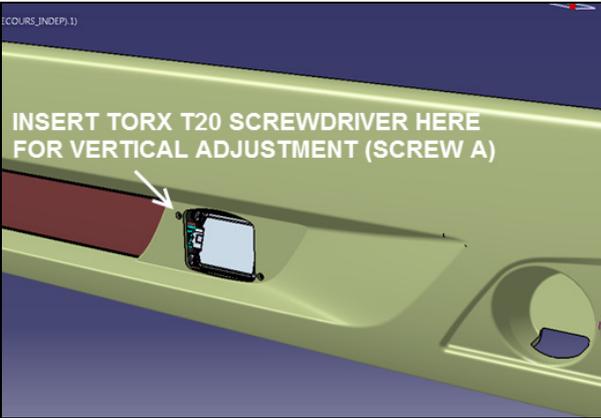
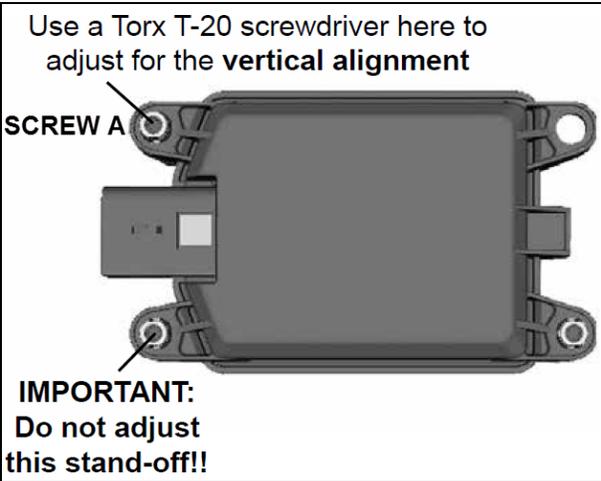
17. Screw **A** serves as vertical adjustment screw. Use a Torx T-20 screwdriver to turn by hand the top-left adjustment screw (screw A). During the adjustment, observe the digital display on the inclinometer and turn the vertical alignment screw **A** clockwise or counterclockwise depending on the vertical direction (up or down) needed, **until the reading is $90.0^{\circ} \pm 0.2^{\circ}$** . (see figures 11 & 12).

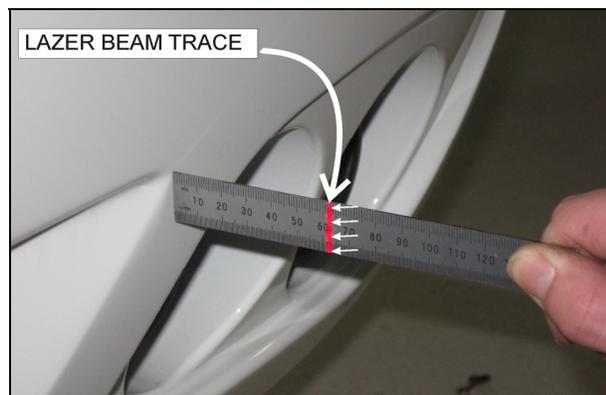
FIG.16

21. Turn on each laser and select the flat beam type.
22. Using a measuring tape, measure distance between the laser beam and the bumper at the reference point. For a perfect alignment, this measure should be equal on both sides.

The radar horizontal adjustment is within tolerances if the difference between both measurements does not exceed 19/32" (15mm)

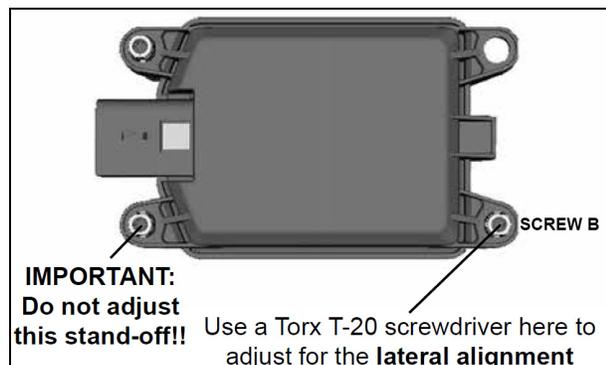
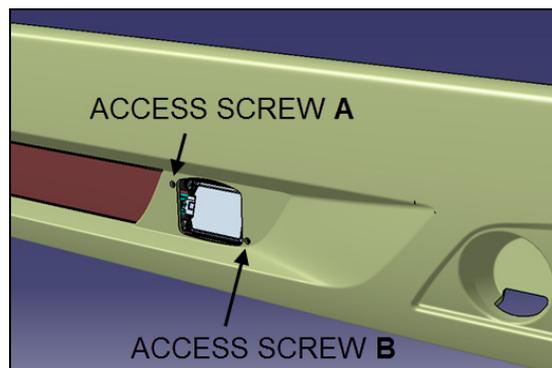
23. Screw **B** serves as horizontal adjustment (lateral) screw (fig.17 & 18). Use a Torx T-20 screwdriver to turn by hand the lower-right adjustment screw (screw B). Turn screw **B** clockwise or counterclockwise depending on direction needed in order to have the same measurement on both sides preferably.
