Title Diagnostic Trouble Code (DTC, Fault Code) MID 140 PSID 210 FMI 12, Faulty Unit or Component Present On DTC Readout; Vehicle Operation Not Affected: No Physical Symptoms Or Warning Lights In Instrument Cluster - **Model Year 2018**

Mack Model AN - Anthem , GR - Granite , PI - Pinnacle

Volvo Model VNL , VNR , VNX , VAH , VHD

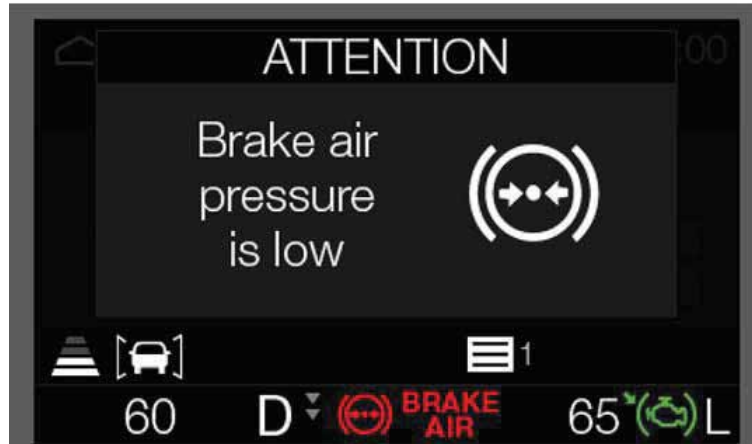
update, the Brake Air Low icon will now appear in the information display when the correct conditions are met. The new icon can be seen below.

- **This function is not related to the symptoms described for this Solution.** Driver or customer reports of this new screen may be received after performing the update, and this note is meant to advise that this is a normal function of the new software.
