Technical Journal

Panoramic roof hard to open/close

REF NO: TJ 34477.1.0	ISSUING DEPARTMENT: Technical Service	CAR MARKET: United States and Canada	
PARTNER: 3 US 7510 Volvo Car USA		ISSUE DATE: 2019-05-15	STATUS DATE: 2019-05-28
FUNC GROUP: 8360	FUNC DESC: Roof hatch	Page 1 of 8

TJ Instruction VCC-516847-1

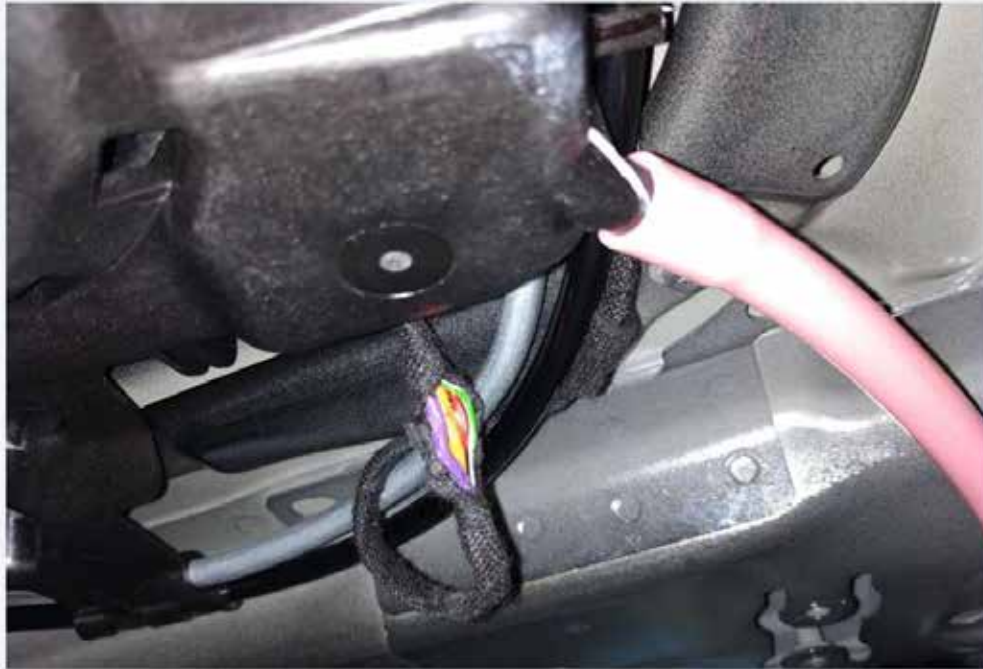
TJ 34477

B) Check the routing of the sunroof harness located in the right front corner [Harness I.PNG](#), if it's routed according to [Harness II.PNG](#), check if the harness is damaged as shown in [Damaged Harness.PNG](#). The damaged harness should be repaired with spare parts according to VIDA (VCC-389589-2). After the wiring repair, reroute the harness correctly [Harness III.PNG](#).

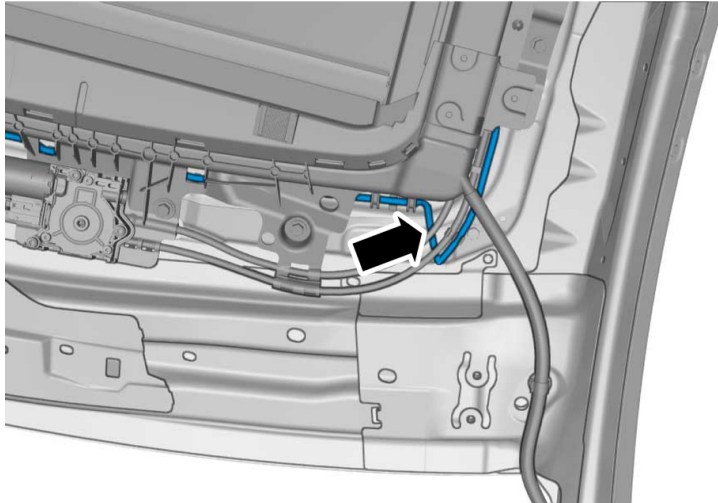
Caution! Make sure that no part of the wiring harness is trapped.

The graphic shows an incorrect design that needs correction.
