Technical Journal

Park Assist System Service Required Message in DIM

REF NO: TJ 31558.8.0	ISSUING DEPARTMENT: Technical Service	CAR MARKET: United States and Canada	
PARTNER: 3 US 7510 Volvo Car USA		ISSUE DATE: 2019-04-24	STATUS DATE: 2019-05-03
FUNC GROUP: 3871	FUNC DESC: Parking assistance	Page 1 of 4

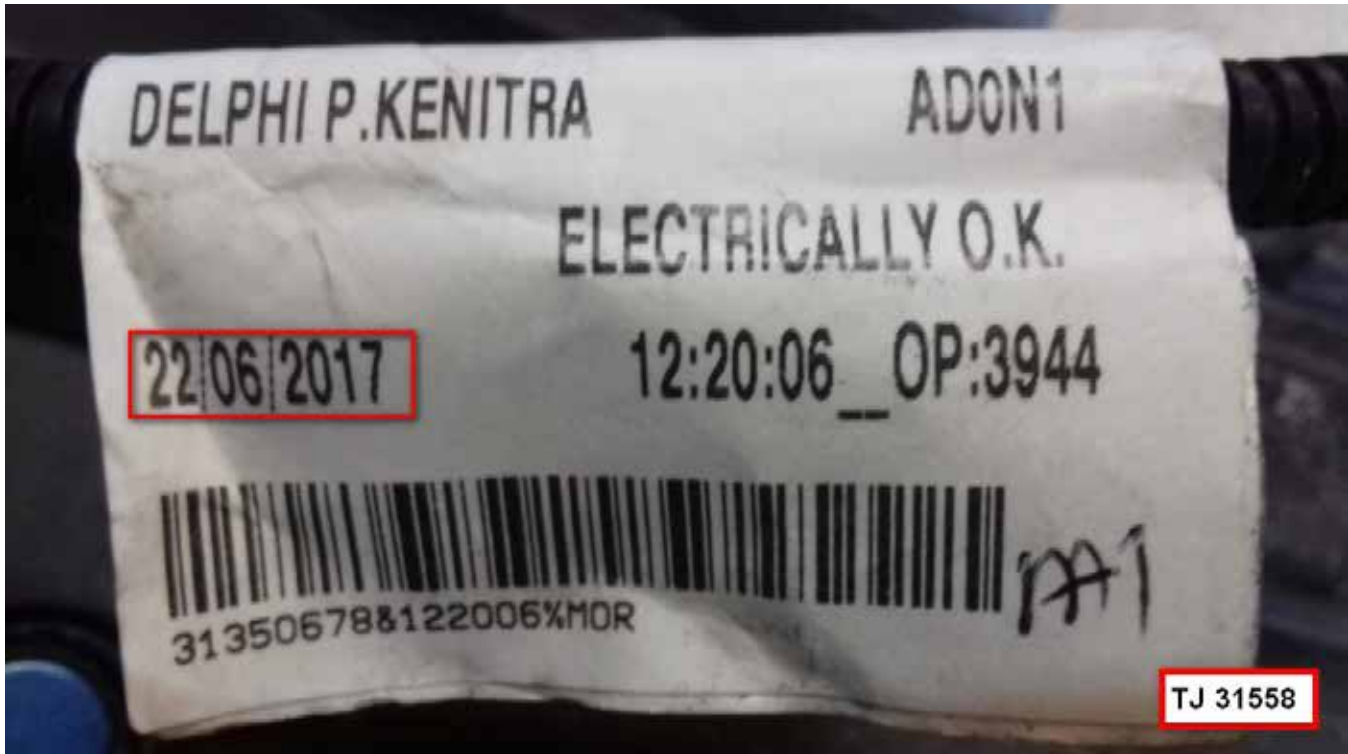
File Name	File Size
Label PAS harness.jpg	0.0960 MB

If the Parking Assistance System (PAS) is not working and there is a message in DIM about “Parking Assistance System service required”, then it is possible that there is water ingress into front/rear park assist sensors and connectors caused by splices in the front/rear cable harness.

A new splice type and process improvement has been introduced in supplier production from 2018-06-06. See attached date marking on cable harness “[Label PAS harness.jpg](#)”. This will be implemented in factory production between 2018w36 and 2018w38 depending on vehicle option variants.

Follow VIDA method for loosening the bumper skin. Disconnect all connectors to the parking sensors and connectors within the engine/luggage compartment to visually check if there is water ingress and/or corrosion.

1. Replace the cable harness.

Note: The cable harness is only in one version, it is important to install plugged connectors P/N 31412936 in all empty positions in the cable harness that are not used.

2. Replace any affected parking sensors and connectors/terminals within the engine/luggage compartment that show signs of water ingress or signs of corrosion.
