SERVICE BULLETIN

APPLICABILITY: 2015-2017MY Legacy and Outback
2015-2017MY WRX

NUMBER: 04-17-17R

SUBJECT: Rattling Sound from EPS Gear Box

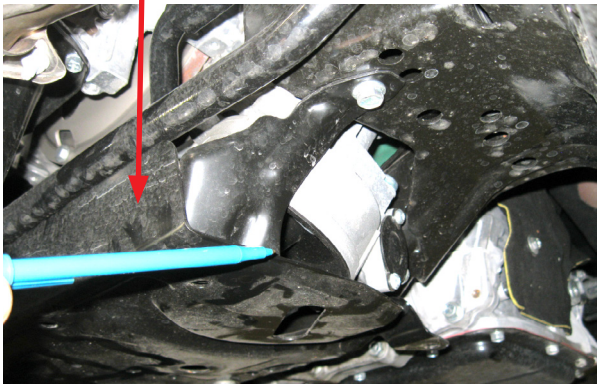
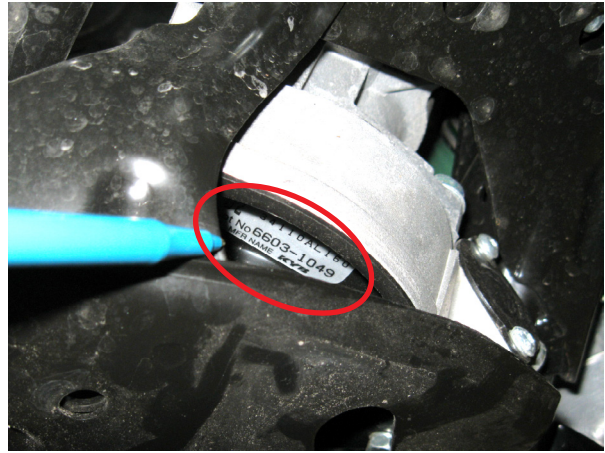
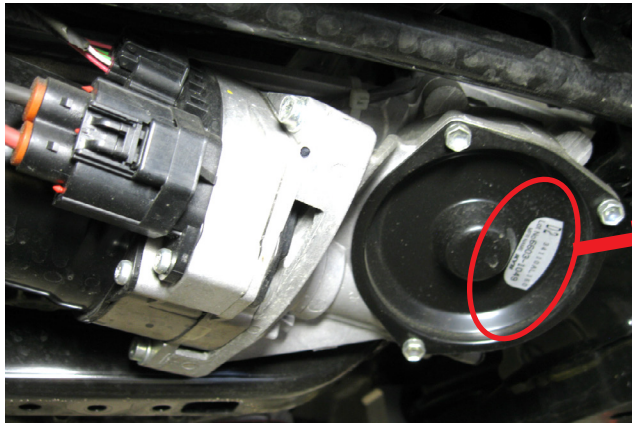
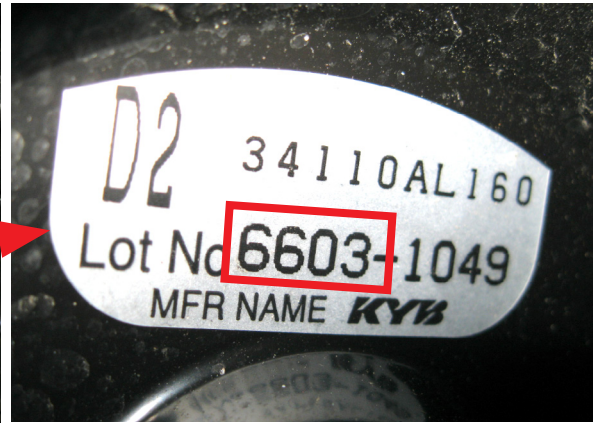
EPS Cover Plate

VERY IMPORTANT: These 4 digits determine the EPS **gear box** Lot Number (date code).

- The first number (a 6 in the picture) is the year (2016).
- The second (also a 6 in the picture) indicates the 6th month (June).
- The third and fourth (03 in the picture) is the 3rd day (June 3, 2016)
- The second set of 4 numbers (1049) is the production number or serial number for that specific date.

If the Lot Number is **equal to or after 7421 (April 21, 2017)**, the EPS **gear box** is post-countermeasure and the condition **will not be repaired** by replacing the tension spring.
