SERVICE INFORMATION BULLETIN

APPLICABILITY: 2015-19MY WRX and WRX STI

NUMBER: 12-264-19

SUBJECT: Child Anchor Retaining Bolt- Design Change

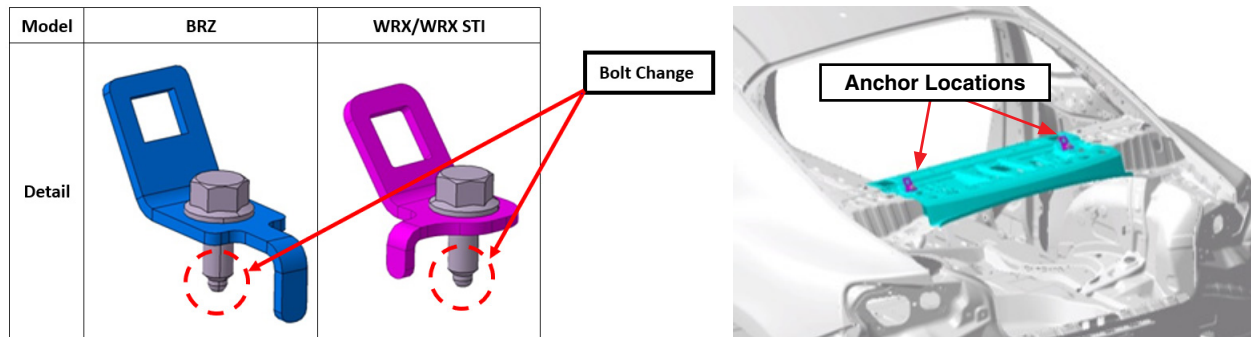
This Service Information bulletin announces a design change made to the retaining bolt used to secure the child anchors to the rear shelf plates on the models listed above. This change was made in support of parts communization with other similar mounting bolts. There is no change between the old and new bolt in terms of function or durability.

The part number for the new FLANGE BOLT is: **901000473**.
