Service Bulletin

Bulletin No.: 19-NA-114

Subject: Information on Malfunction Indicator Lamp (MIL) Illuminated - DTC P0171 Set

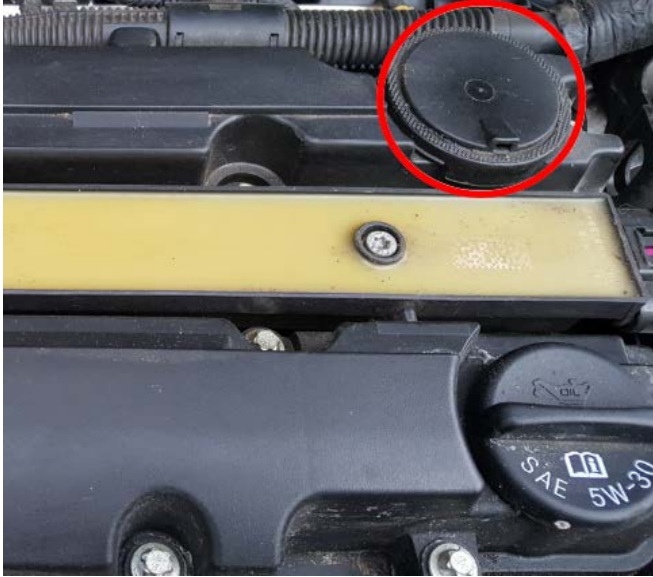
5335015

Involved Region or Country	North America
Condition	Some customers may comment that the MIL is illuminated. Some technicians may find DTC P0171 (Fuel Trim System Lean) or other airflow related codes set in the Engine Control Module (ECM).
Cause	This condition may be caused by a torn positive crankcase ventilation (PCV) Crankcase Pressure Control Diaphragm. ⇒ The PCV crankcase pressure control diaphragm in the PCV valve could be torn, allowing un-metered air to enter the crankcase.
Information	Following the diagnostics in SI for that DTC may lead to the PCV system as a potential source of external airflow. Confirmation of the PCV valve performance must be done before replacing the camshaft cover.

Note: Normal operation of the PCV crankcase pressure control diaphragm could cause a tissue to flutter against the port (smoke would not be continuously drawn into the port). A torn crankcase pressure control diaphragm would cause the tissue to be held against the port (smoke would be continuously drawn in) due to internal engine vacuum leaking through the diaphragm.

5. Check to see if there is vacuum at the PCV vent at the front of the PCV valve by placing a piece of tissue near it.

⇒ The tissue will be sucked against the vent and held if vacuum is present. Smoke can also be used to see if it is drawing into the PCV vent port.

- If the PCV valve is making noise and there is vacuum present at the PCV valve vent, replace the camshaft cover. Refer to *Camshaft Cover Replacement* in SI.
- If the PCV valve does NOT make noise or leak vacuum, the PCV system is not the cause and further diagnostics using SI would be needed.
