Title	Diagnostic / Troubleshooting Procedures For Exhaust Gas Recirculation (EGR) System
	Components; Covers Most EGR System Diagnostic Trouble Codes (DTC), See List In
	Solution - US10, US10+OBD13, US14+OBD*, US17+OBD* With A Variable
	Geometry Turbocharger (VGT)
Mack Models	
Mack Model	LEU, LR, MRU-TerraPro, TE-TerraPro, AN-Anthem, CHU-Pinnacle, Axle
	back , CXU - Pinnacle, Axle front , GR - Granite , GU - Granite , PI - Pinnacle , TD -
	Titan
Volvo Models	
Volvo Model	VNL, VNM, VNR, VNX, VAH, VHD, VT
Emission Standard	
Emission Standard	US10, US10+OBD13, US14+OBD13, US14+OBD15, US14+OBD16, US17+OB
	D16, US17+OBD18, US17+OBD19
Engine family	
Engine family	11L Engine, 13L Engine, MP7, MP8

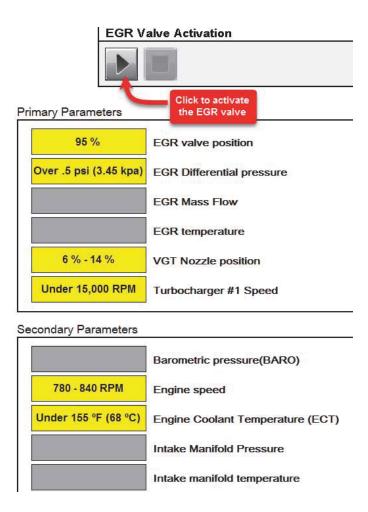
**Screenshot**: Should be taken with Conditions (in YELLOW) achieved and showing EGR valve at 95% just before the valve closes again OR the engine dies.

- Turbocharger speed should drop below 15,000 RPM within 10 seconds of valve activation.
- If turbo speed does not change, the EGR valve should be checked to confirm it is not stuck closed.

- If turbo speed drops but remains above 20,000 RPM, the EGR cooler is likely plugged.
  - A turbo speed reaction to EGR valve activation is a normal indicator of an operational EGR valve.
