Title	Automated Manual Transmission (AMT) Clutch Failures At Service Replacement; New Clutch Found To Be Damaged When Unboxed Or Fails Soon After Replacement
-------	---

Mack Model	AN - Anthem , CHU - Pinnacle, Axle back , CXU - Pinnacle, Axle front , GR - Granite , GU - Granite , PI - Pinnacle
-------------------	--

Volvo Model	VNL , VNM , VNR , VNX , VAH , VHD
--------------------	-----------------------------------

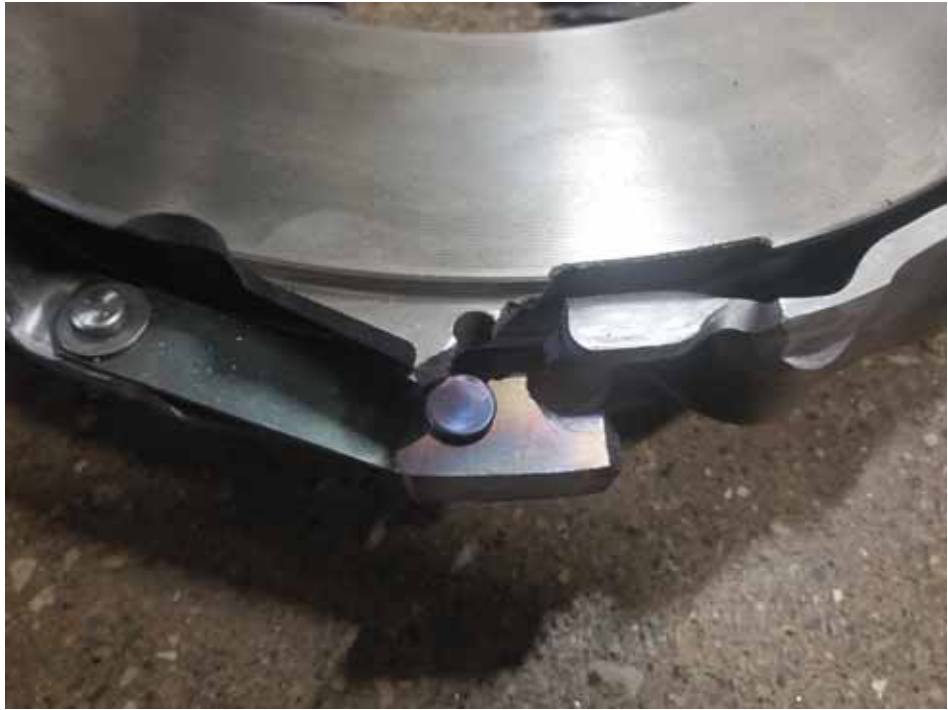
Cause	A new clutch that is replaced in the aftermarket may be found damaged when removed from packaging, or experience failure shortly after installation. This situation is likely to occur before the vehicle leaves the shop or during the first test drive after replacement. It has been determined that this issue arises due to damage that occurs during shipping and handling of the new part. Damage of this nature normally occurs to the tabs shown in the photo below:
-------	---

- The box should be inspected for damage before opening and if damage is found the clutch should be inspected to make sure the tabs shown in the picture above are not cracked or broken from shipping and handling.

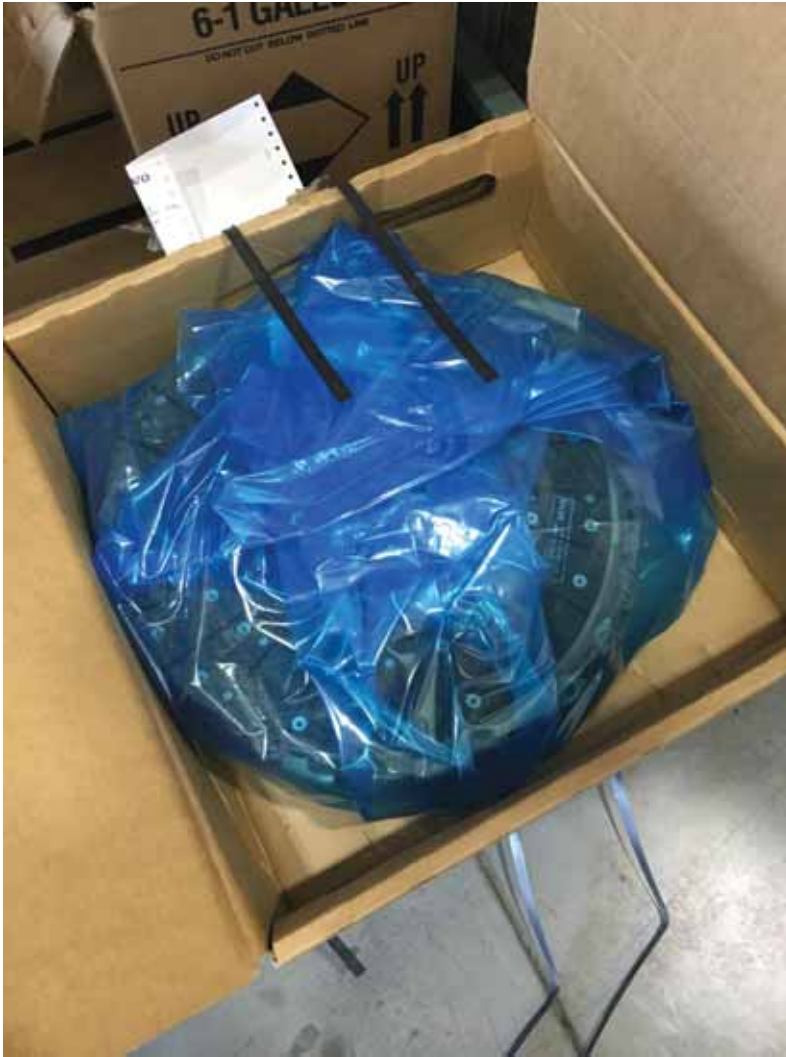
- When inspecting the clutch, if the tabs are aligned in the box along the box sides they are more likely to get damaged in shipping and handling. If they are aligned in the corners of the box as shown below they are less likely to be damaged.

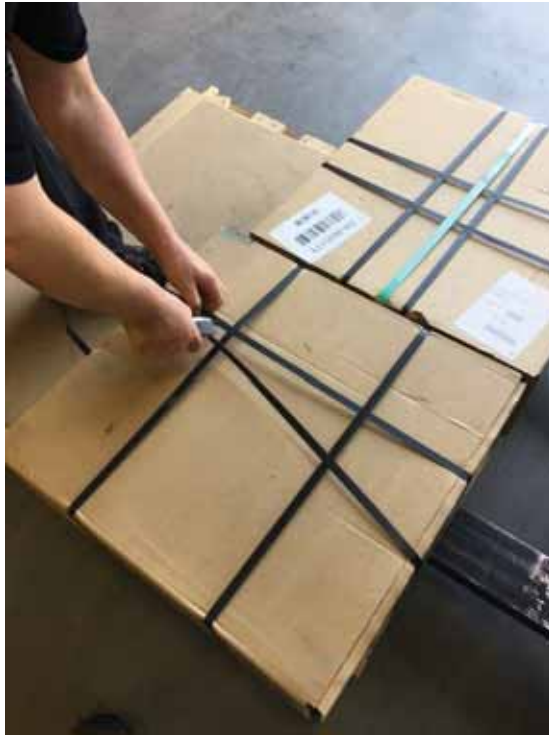
Correct

- **Clutches should always be stored flat on the shipping pallet and never on edge.** Damage to the clutch may result from the on edge storage.
