Title	** Tech Tip ** - TT-019-2016 Automated Manual Transmission (AMT) Bearing And Gear Shaft Inspection
-------	--

Mack Model	AN - Anthem , CHU - Pinnacle, Axle back , CXU - Pinnacle, Axle front , GR - Granite , GU - Granite , PI - Pinnacle , TD - Titan
-------------------	---

Volvo Model	VNL , VNM , VNR , VNX , VAH , VHD , VT
--------------------	--

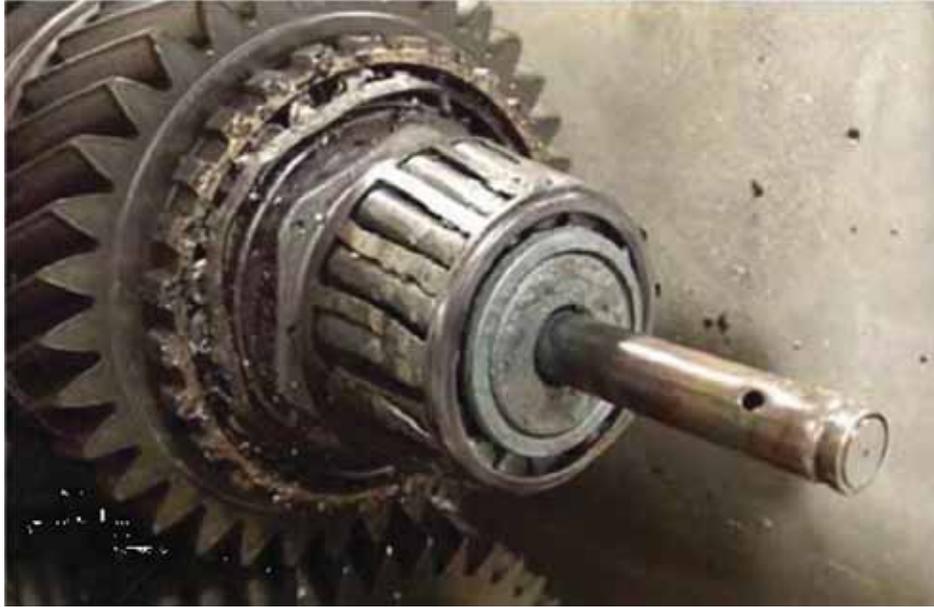
Loss of main shaft pre-load from a spigot bearing failure

Towing Related Failure (Image 1)

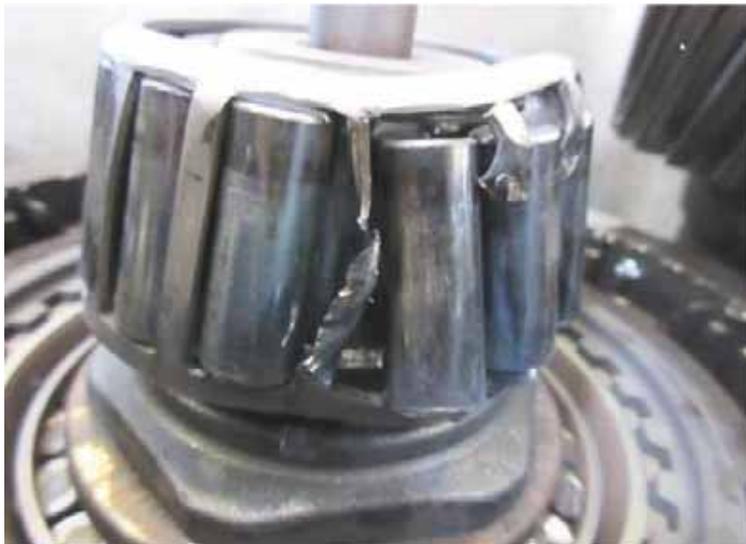
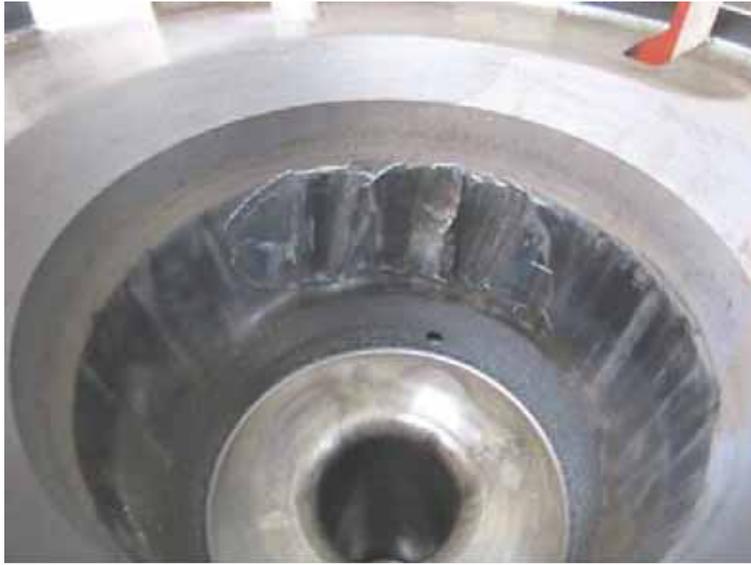
Towing Related Failure (Image 2)

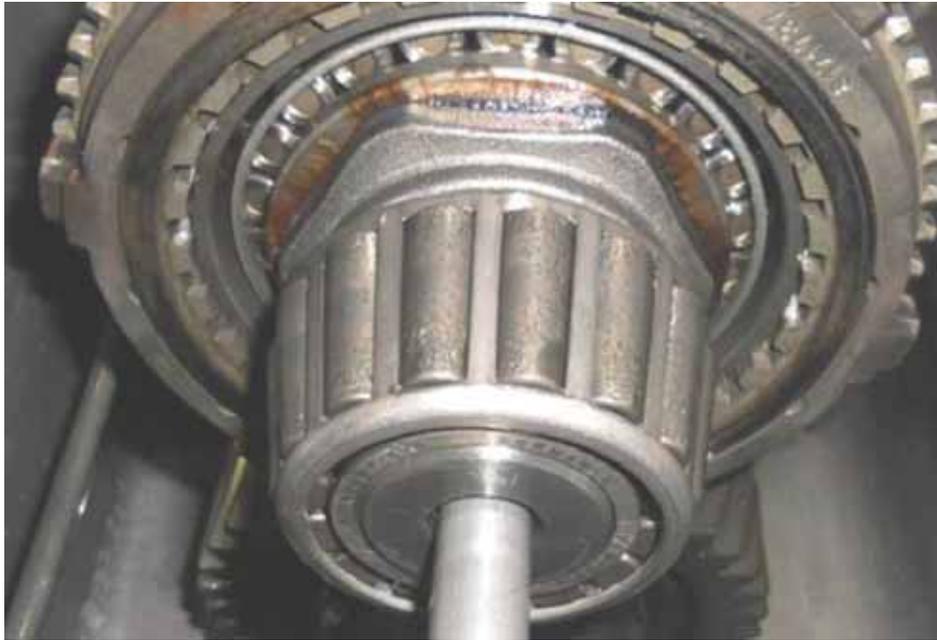
Spalled bearing failure (Image 3)

Reviewing DTC readout can be helpful in determining spalled vs. towing damaged spigot bearing. Main shaft speed codes prior to any towing event can indicate that the loss of main shaft pre-load may have begun before the truck was towed to the shop. This means that the bearing started to spall before the unit was towed improperly.

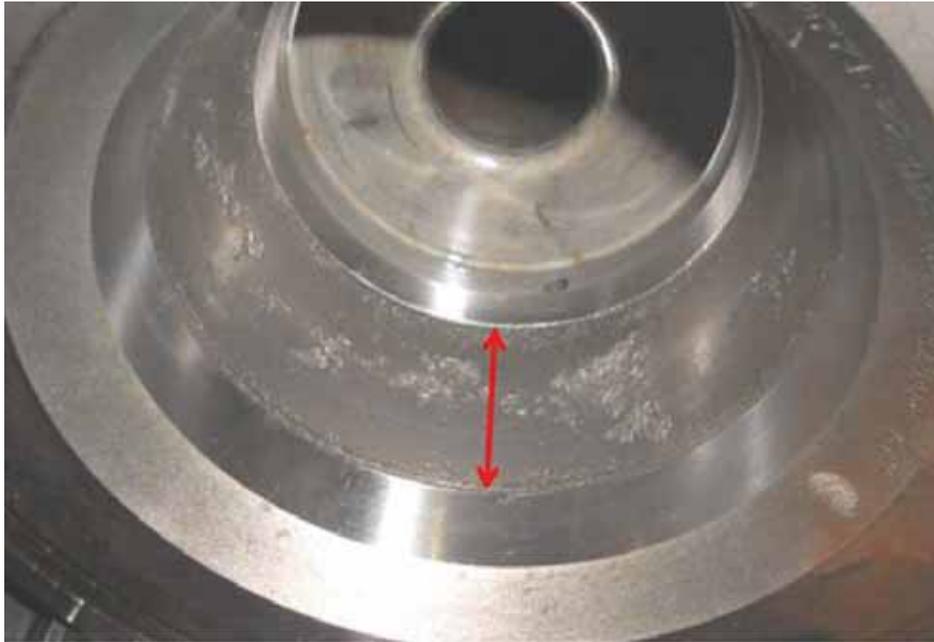
Spalled bearing race (Image 4)

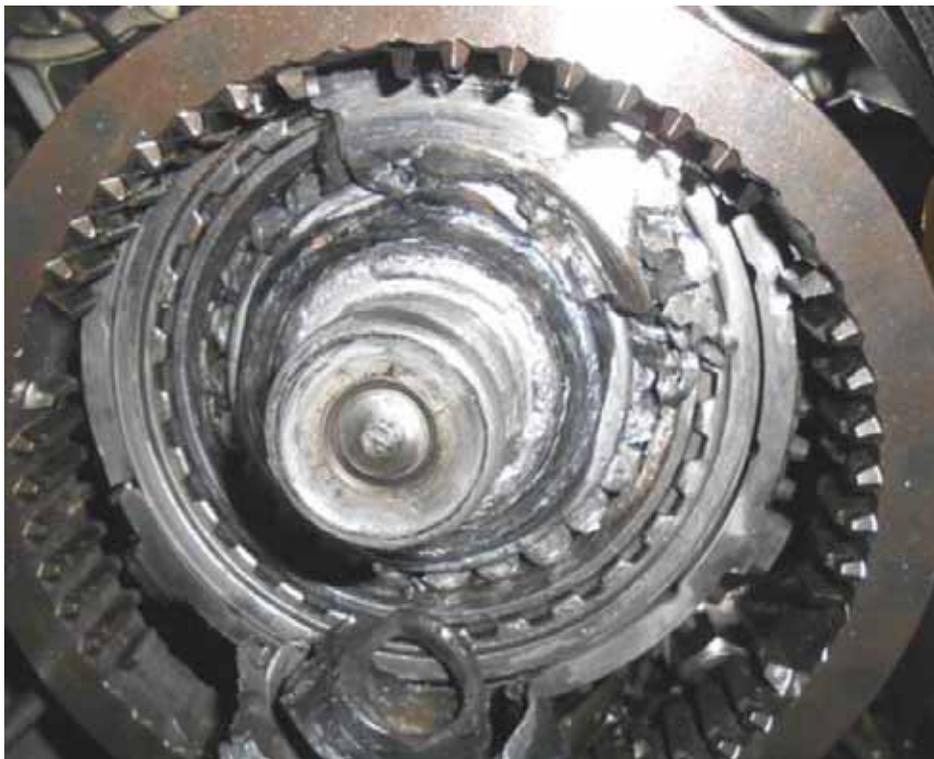
Spalled Bearing Failure (Image 5)

These images (5 & 6) represent a failure that went ignored for some time.

While the main shaft does not have evidence of heat as in the towing example (image 1), there are additional parts that have been affected:

- Contact with the main shaft nut
- Rollers missing and race worn down
- Oil distribution tube twisted off and closed
- P1 bearing damaged
- Split synchro ring broken

- 1.** The ridge in the input shaft. This is similar to what is seen in the spalled spigot bearing failure **image 3**.
- 2.** The DTC readout, as in the example below. The vehicle clock is incorrect however you can assume that the "Last Occurrence" has to be close to the readout day. In this example you can see that there had been main shaft codes for ~2 mo and split shift codes for ~3mo

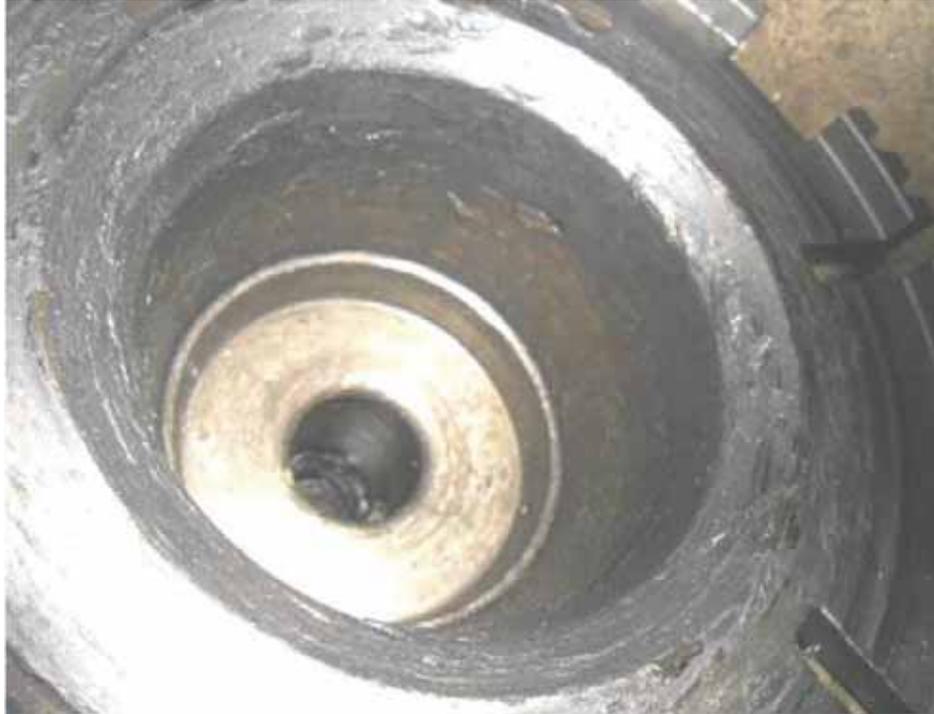
Spalled Bearing Race (Image 6)
