# Service Bulletin

Bulletin No.: 19-NA-110

**Subject:** Visible Cracks in Shock Tower Near Strut Top Mount

Brand:	Model:	Model Year:		VIN:		Engine:	Transmission:
		from	to	from	to		
Chevrolet	Camaro	2016	2019			All	All

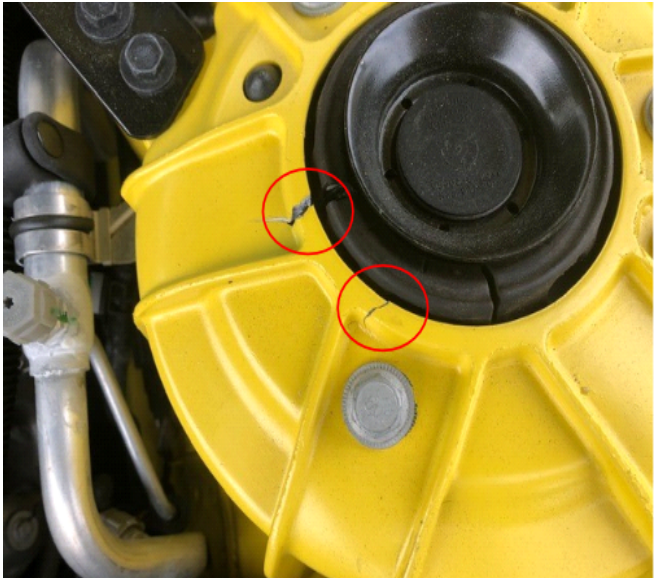
5334406

<p style="text-align: right;">5334411</p> <p>Some customers may comment on seeing cracks on the shock tower, near the strut top mount. Some examples are shown in the graphics above.</p> <p><b>Note:</b> Be sure to inspect additional suspension components and disassemble the tire/wheel assembly to verify no other components are damaged.</p>
<b>Cause</b>	The cause of the condition may be a hard impact (such as curb or pot hole) that drives a lot of energy up through the strut tower casting, ultimately cracking it.
<b>Correction</b>	To repair this condition, the shock tower must be replaced. Refer to <i>Front Wheelhouse Panel Replacement (Partial)</i> or <i>Front Wheelhouse Panel Replacement (Complete)</i> in SI. <b>Note:</b> Vehicles repaired for the conditions outlined in this bulletin should not be considered warranty. Any warranty claims submitted with these conditions may be debited.
