Service Bulletin

Bulletin No.: 19-NA-116

Subject: Pulse, Grinding, Scraping Noise from Brakes, Uneven Front Brake Pad Wear

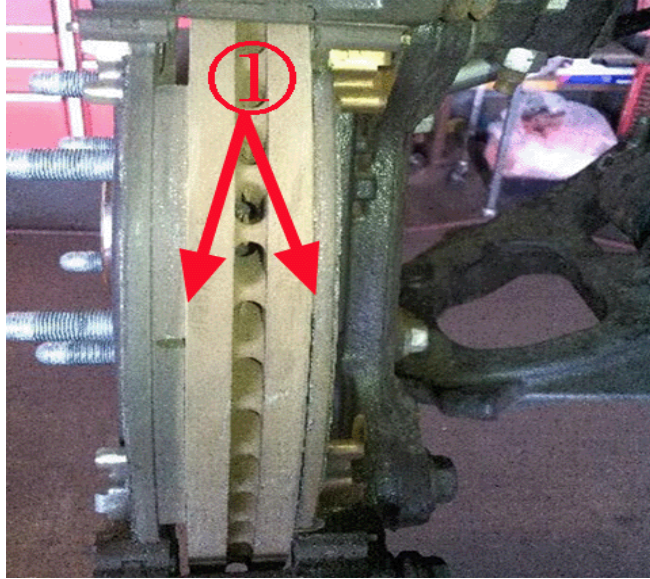
4008926

- Inboard to outboard brake pad wear difference of 3 mm (0.118 in) or greater for 'normal' highway driving (no heavy loads, without trailer towing, without frequent elevation changes).
- Inboard to outboard brake pad wear difference of 6 mm (0.236 in) or greater for the following driving conditions: heavy city driving, frequent elevation changes, frequent trailer towing, heavy loads.
- Left to right inboard to inboard or left to right outboard to outboard brake pad wear difference of 3 mm (0.118 in) or greater for either driving condition.

Shown above is an example from one vehicle with uneven wear. Photo 1 is of the left front brake pads where the inner pad is worn completely out, while the outer pad still has plenty of pad life. Photo 2 is from the same vehicle, but of the right front inner and outer brake pads, which both have plenty of pad material left.

Correction	<p>Note: The disc brake pads should only be replaced if the friction surface is worn to within 2.0 mm (0.079 in) of the mounting plates, per the Brake Pad Inspection procedure in SI.</p> <p>Important: Remember the following when servicing/inspecting the front brake systems:</p> <ul style="list-style-type: none"> – DO NOT use any air tools to remove or install the brake caliper bolts. Use hand tools ONLY. – Install an open end wrench to hold the caliper guide pin in line with the brake caliper while removing or installing the brake caliper bolt. DO NOT allow the open end wrench to come in contact with the brake caliper. – When compressing the caliper pistons, use large C-clamps over the top of the caliper housing and against the back of the outboard pad. Slowly tighten the C-clamps until the pistons are pushed completely into the caliper bores. Using this method will help determine if there is anything binding. <ol style="list-style-type: none"> 1. Inspect and measure the brake pads thickness. Determine the type of driving the owner does and compare the measurements to the information listed above (3mm or 6mm). <ul style="list-style-type: none"> • If the pads are within specification, disregard this bulletin and perform a normal brake repair. • If the pads are out of specification, perform normal SI diagnostics to determine the cause of the concern (caliper piston binding, binding pads or guide pins in bracket, brake hose restriction, etc). 2. After completing normal diagnostics, if a root cause for the uneven pad wear is not found, replace the front brake pads with the part number in the table below. Refer to the <i>Brake Rotor Surface and Wear Inspection</i>, in SI to determine if the brake rotor(s) require servicing or replacement. If the brake rotors require service due to excessive heat checking/blueing, it is recommended to replace the rotors rather than attempting to refinish the rotor(s) for this issue. Refer to the parts catalog for the correct O.E.M. rotor part number, which are Ferritic Nitro-Carburizing (FNC) rotors. <p>Note: The brake pad kit part number listed below is intended to be used together with the O.E.M. brake rotors. If the rotors were previously replaced with part number 22950035 (NON-FNC), per the earlier version of PIT5377G, and the vehicle now requires brake rotors, refer to the parts catalog and replace both rotors with the O.E.M. brake rotors.</p> <ol style="list-style-type: none"> 3. After repairs and pad burnishing have been completed, test drive the vehicle for 32 – 48 km (20 – 30 miles). The test drive needs to be performed on an open road at cruising speeds 88.5 kph+ (55 mph+) where very little braking is actually performed. 4. Immediately after returning from the test drive, lift the truck up on a hoist and spin both front wheels by hand, checking for a wheel that is hard to spin. If a wheel is hard to spin, it may be an indication of a brake drag. 5. While the condition is present, perform normal SI diagnostics to determine the cause of the drag (caliper piston binding, binding pads or pins in the bracket, brake hose restriction, etc). Repair if necessary and re-evaluate the concern.
