# Service Bulletin

Bulletin No.: 19-NA-122

**Subject:** Rough Running Engine, Malfunction Indicator Lamp (MIL) Illuminated - DTC P0300 Set

Brand:	Model:	Model Year:		VIN Breakpoint:		Engine:	Transmission:
		from	to	from	to		
Chevrolet	Malibu	2016	2017	SOP	HF214702	1.5L (LFV)

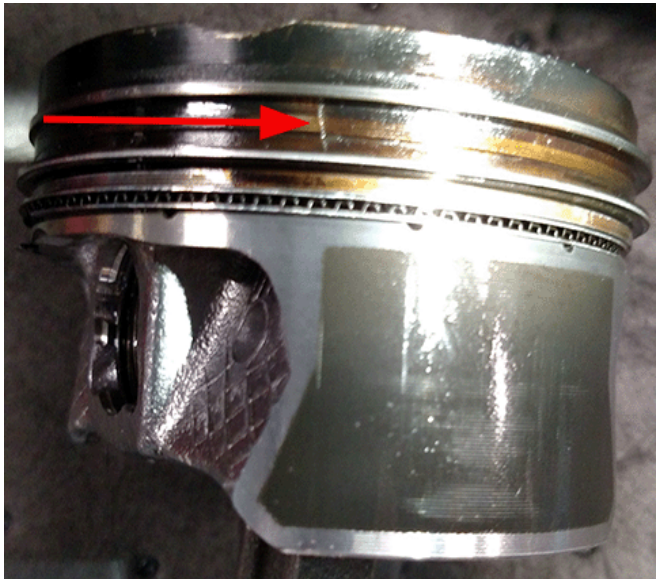
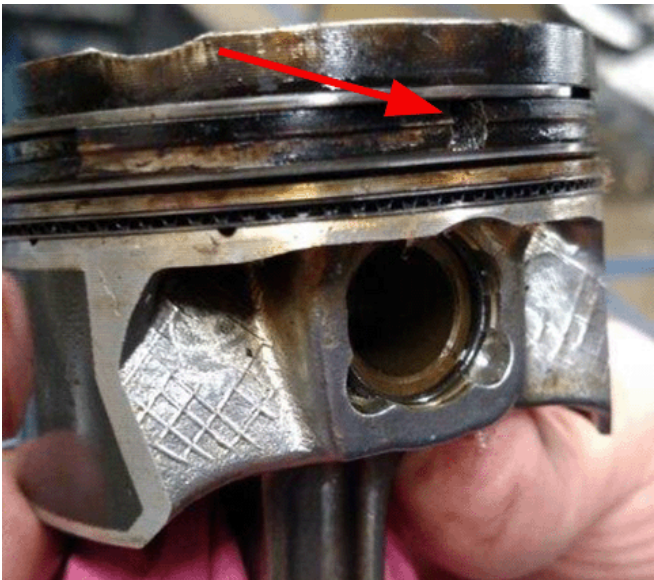
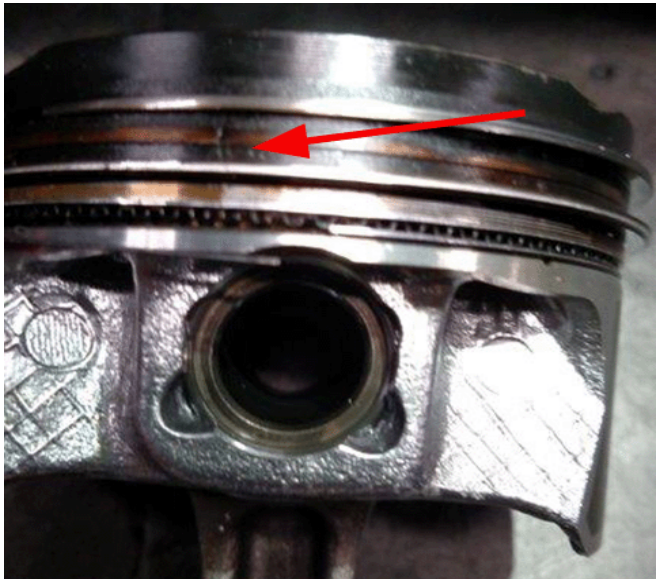
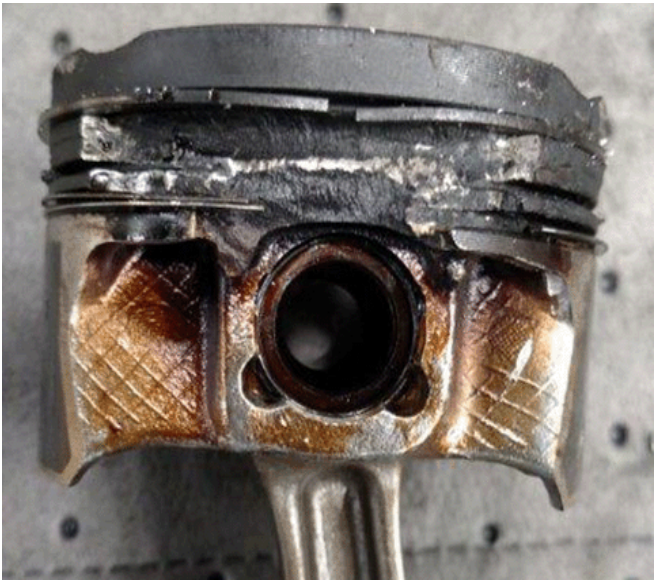
Examples of pistons with varying levels of damage:

1. Perform *Engine Compression Testing* in SI.
2. If low compression is found, perform *Cylinder Leakage Testing* in SI and record the test results to isolate the concern.
  - If excessive leakage to the crankcase is isolated, check piston and cylinder wall condition.
  - If the cylinder wall surface has not been compromised, replace all four piston and rod assemblies.

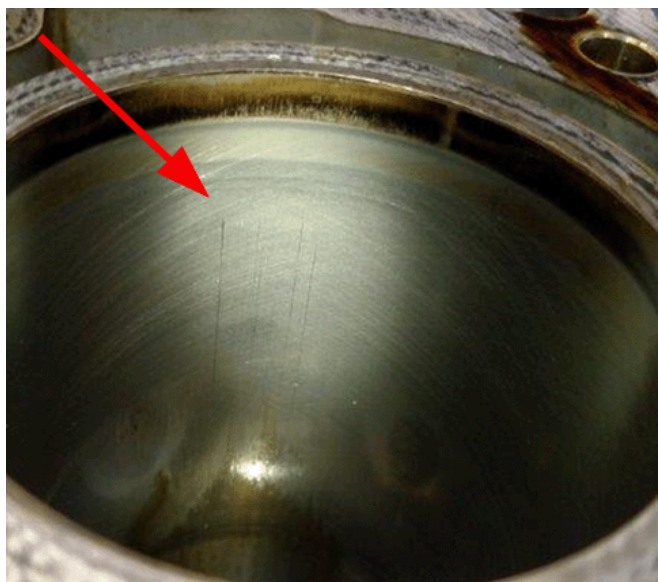
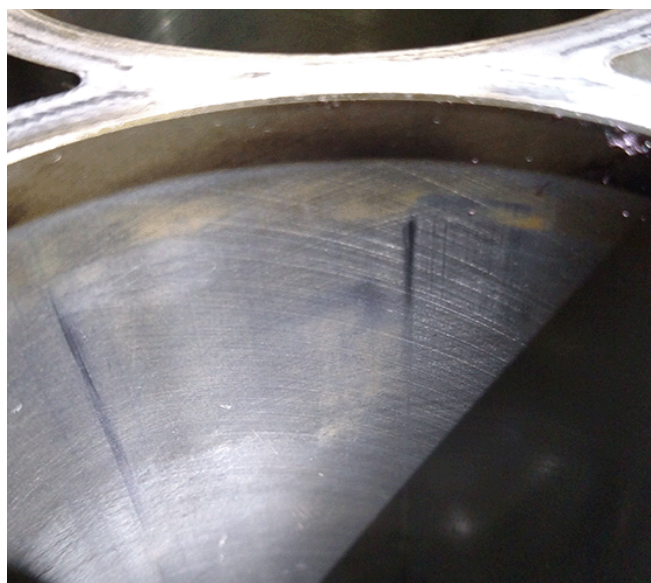
Examples of light vertical marks visible on the cylinder wall:

None of the marks in the cylinder walls could be felt with the fingernail and engine replacement is not recommended.

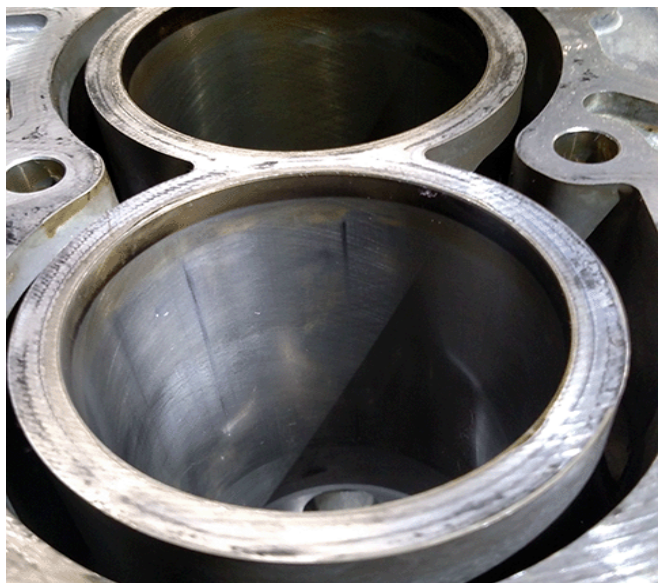
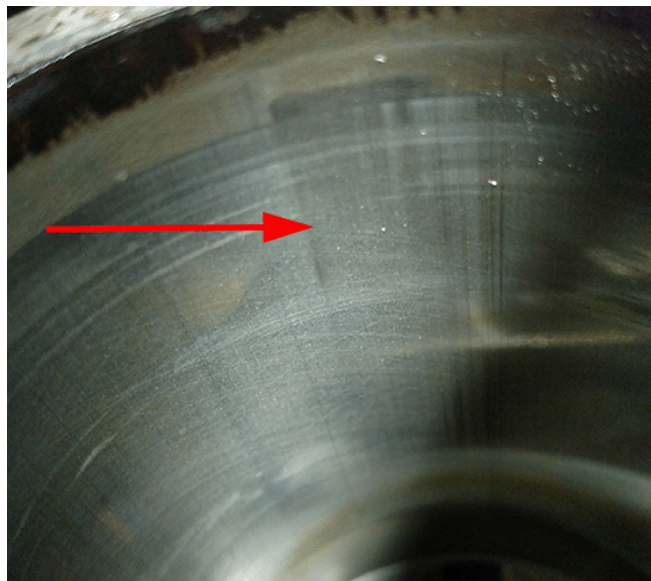
**Example of a damaged cylinder wall:**

In this example, the scuffing is wide and has removed the crosshatch from the cylinder wall in the area above the arrow.

This would result in oil consumption and requires engine replacement.
