Service Bulletin

Bulletin No.: 18-NA-007

Subject: Malfunction Indicator Lamp (MIL) and/or Service AWD Displayed on Driver Information Center (DIC), Loss of Power Steering Assist, Dead Battery, ICS Screen Backlighting Powers Up & Momentarily Flashes and/or Loss of Communication on HSLAN - DTCs C0800, U0136 Set

Brand:	Model:	Model Year:		VIN:		Engine:	Transmission:
		from	to	from	to		
Buick	Encore	2013	2018				
Chevrolet	Trax	2014	2018

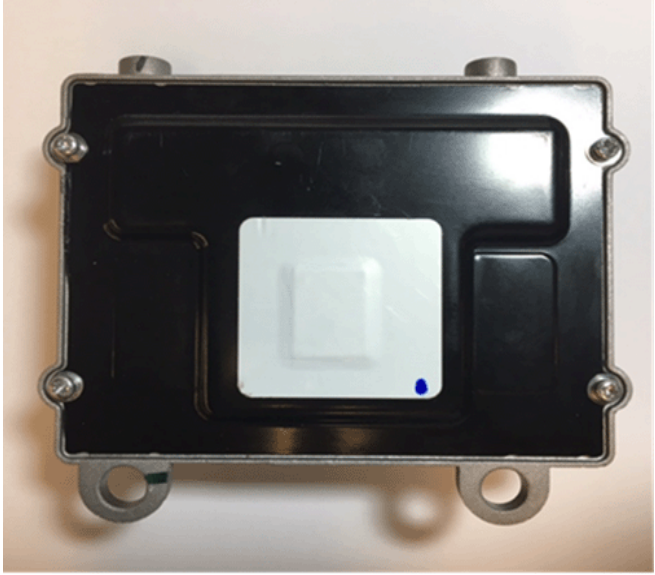
<p style="text-align: right;">4887542</p> <p>This condition may be caused by the rear differential clutch module (RDCM) being corroded at the seam between the base plate (black) and the top housing (grey), including the connector and 4 screws.</p>
<p>Correction</p>	<p>Note: Only 3% of vehicles have been found to have a corroded RDCM connector. DO NOT replace the RDCM wire harness if there is no evidence of corrosion in the connector.</p>

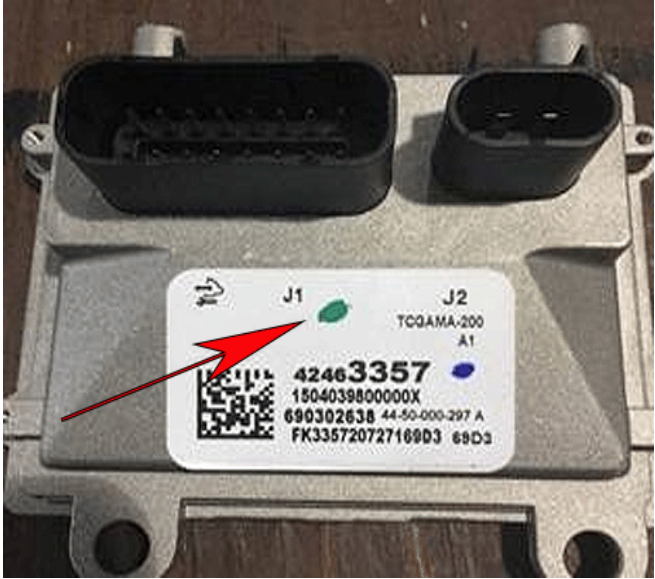
<p style="text-align: right;">4909451</p> <p>Inspect RDCM for signs of corrosion:</p> <ul style="list-style-type: none"> • If corrosion has been found, replacement of the RDCM is required. Verify if the new service part has a green dot. • If replacing the RDCM for issues not related to corrosion, return the part to CCA as a defective part. <p>Replace the RDCM and inspect associated wiring, replacing the connector harness if required. Refer to <i>Rear Wheel Drive Module Differential Clutch Control Module Replacement</i> in SI.</p> <p>If the replacement RDCM is part number 42463357, inspect the replacement RDCM for the presence of a green dot on the tag, as shown above.</p> <ul style="list-style-type: none"> • If the replacement RDCM has a green dot, install per SI procedures. • If the replacement RDCM DOES NOT have a green dot, order a new RDCM. <p>Important: DO NOT install a new RDCM without a green dot.</p> <ul style="list-style-type: none"> • Future part numbers may not have a green dot. In that case verify that part number 42463357 supersedes to the current part number you have received and use it.

Refer to *Rear Wheel Drive Module Differential Clutch Control Module Replacement* in SI.
