Service Bulletin

Bulletin No.: 18-NA-217

Subject: Cruise Control Inoperative, Malfunction Indicator Lamp (MIL) Illuminated - DTCs P0097, P00F4, P0102 and/or P2199 Set

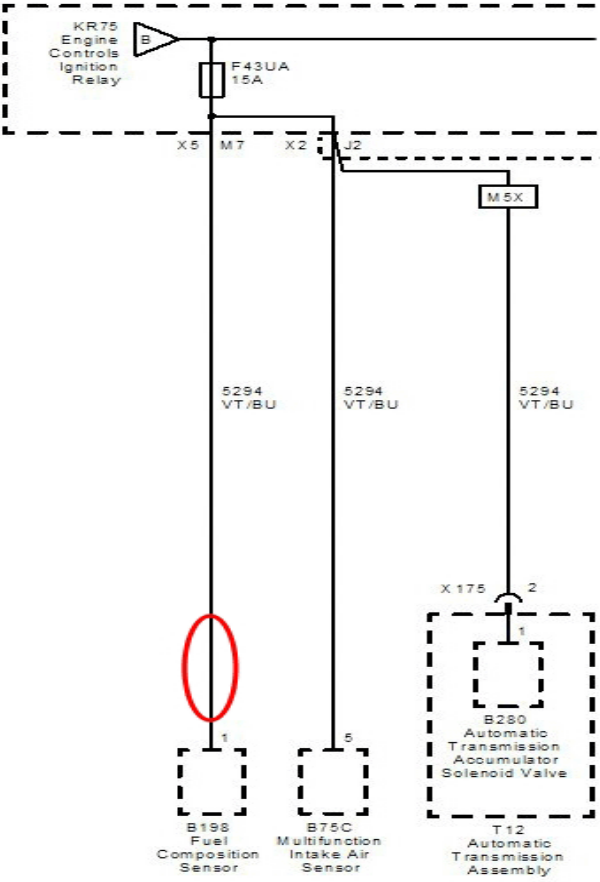
<p style="text-align: right;">5118293</p> <p>This condition may be caused by a short in circuit 5294 near the fuel composition sensor electrical connector. ⇒ Refer to Document ID: 4694347 in SI.</p>
Correction	Validate and inspect the engine wiring harness at the fuel composition sensor (Flexible Fuel Sensor), follow the <i>Wire to Wire Repair</i> in SI to cut the wire and cap it off.

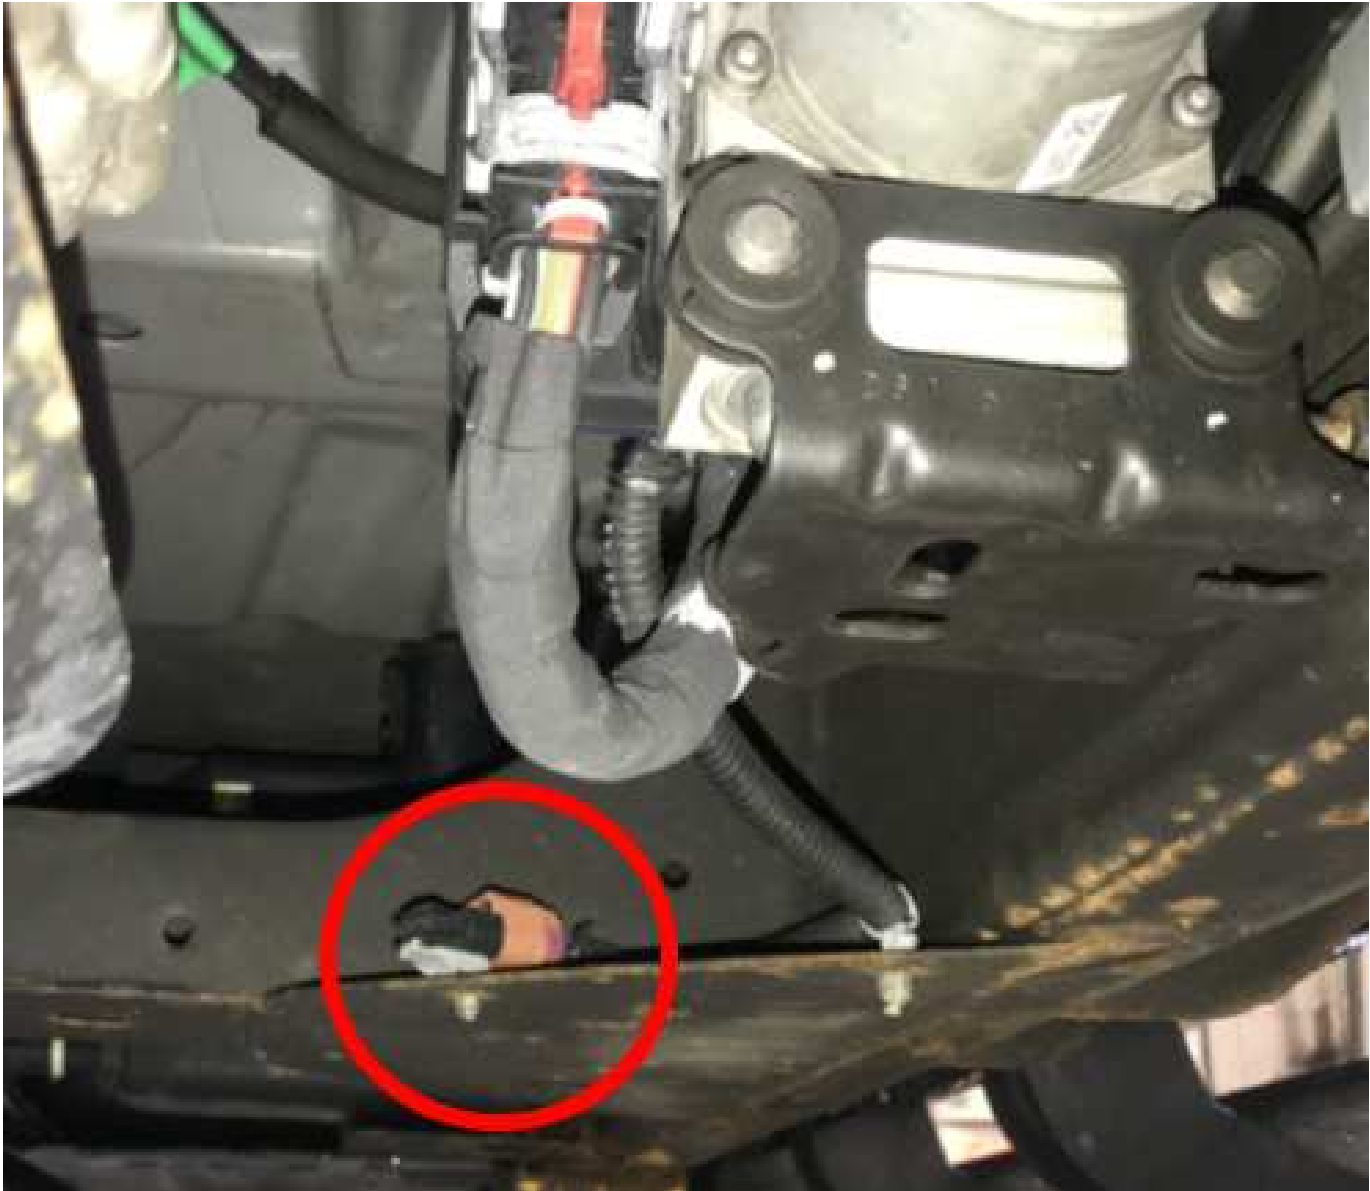
5328976

• Example of wiring harness in normal condition.

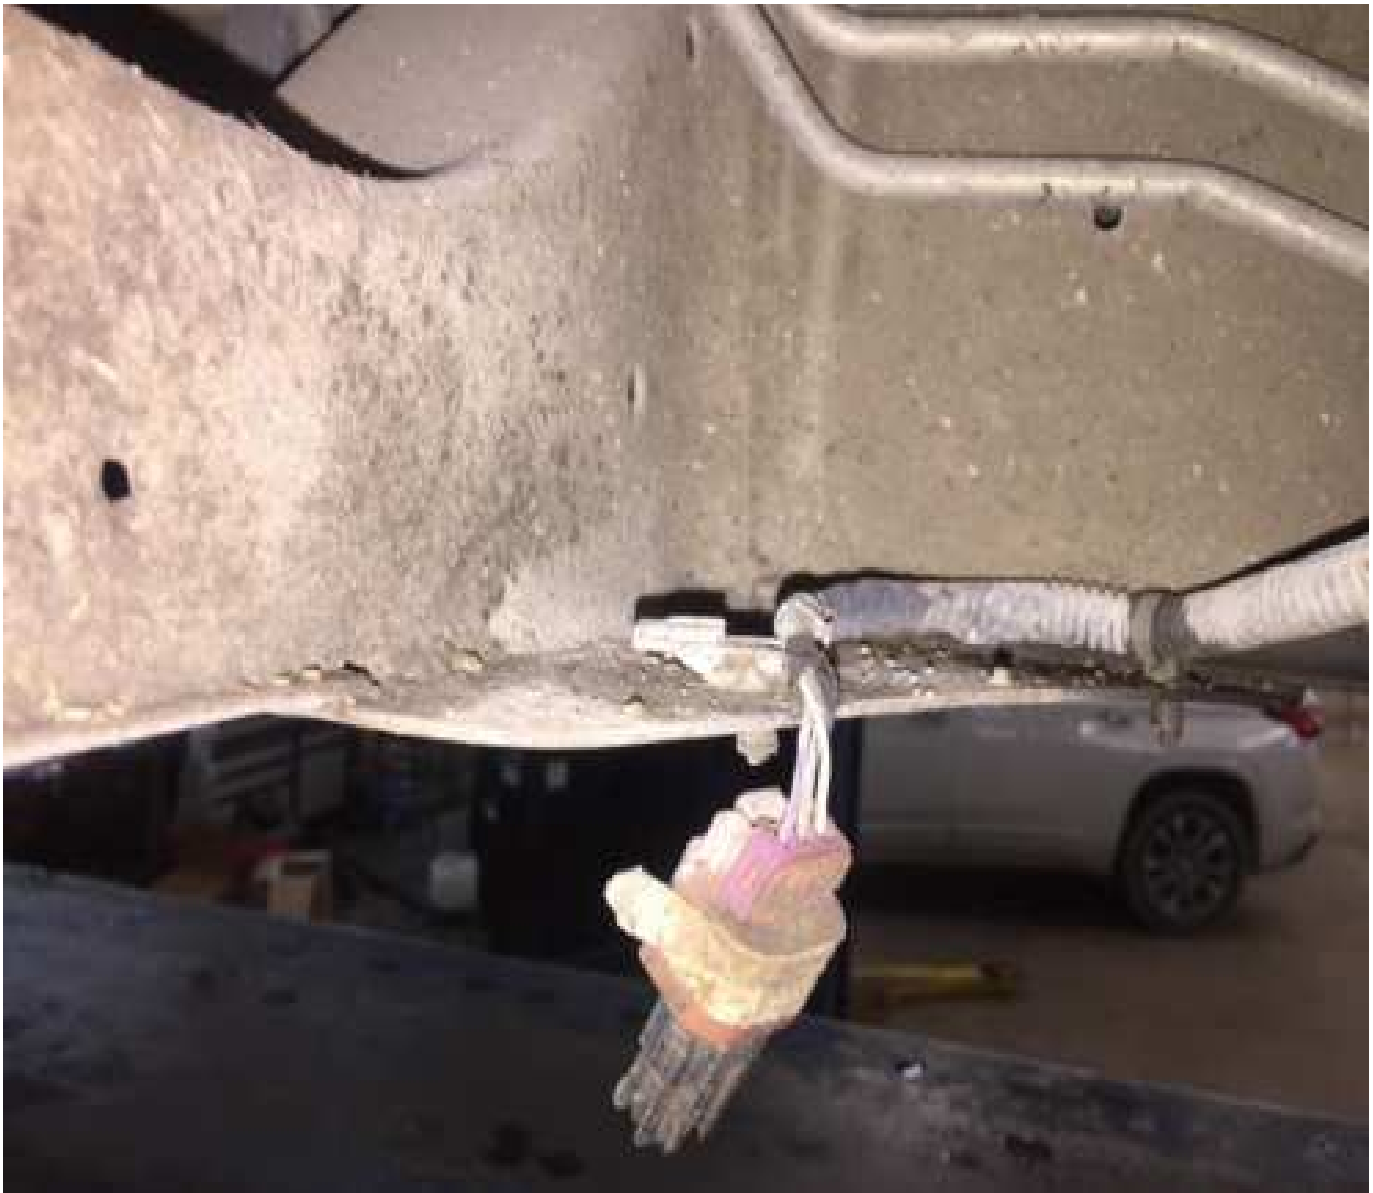
5330264

- Example of wiring harness in a damaged condition
3. Remove the wire connection point from the frame, pull back the casing for the wire.
 4. Cut the wire an inch from the back pin and cap the wire off with a Sealed Splice Crimp Matrix.
– Refer to *Wire to Wire Repair* in SI.
