Service Bulletin

Bulletin No.: 19-NA-103

Subject: Intermittent Click Noise at Front of Vehicle, ABS, Traction Control System (TCS)/ Stabilitrak Lamps May Illuminate Intermittently and/or Deactivate for Ignition Cycle

Brand:	Model:	Model Year:		VIN:		Engine:	Transmission:
		from	to	from	to		
Chevrolet	Volt	2016	2019

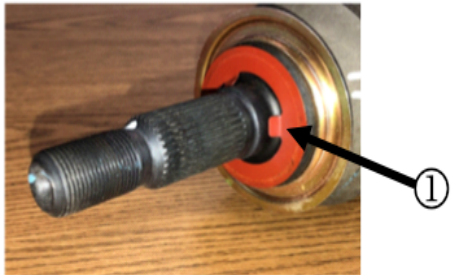
Involved Region or Country	North America and N.A. Export Regions	
Condition	Some customers may comment on hearing an intermittent click noise in the front of vehicle. The ABS, TCS/Stabilitrak system lamps may also illuminate intermittently and those systems may be deactivated/shut off for that ignition cycle.	
Cause	<div style="text-align: center;">

</div> <p style="text-align: right; font-size: small;">5317523</p> <p>The cause of the condition may be a fracturing of the front half shaft anti-click washer (1) and possible collateral damage to the ABS wheel speed sensor (WSS).</p>	
Correction	Upon verifying the condition, remove and discard the anti-click washer on the affected half shaft(s), then inspect the wheel speed sensor on that side(s). Follow the recommended steps in the Service Procedure below.

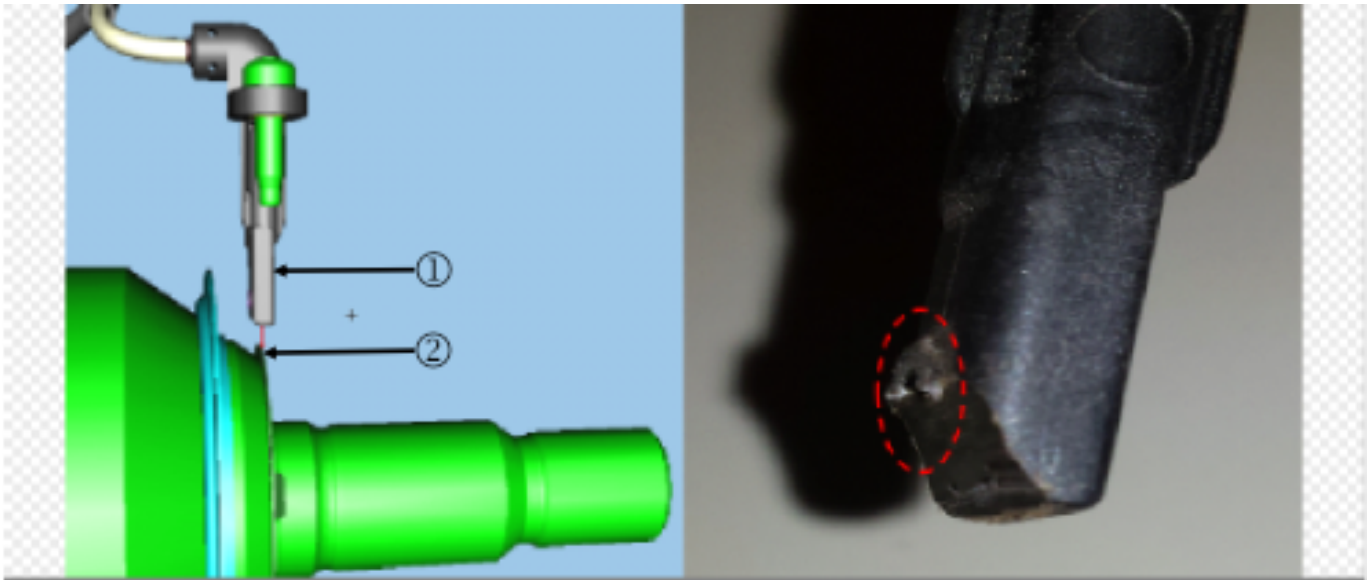
5317529

Note: As shown in the above illustration, the wheel speed sensor (WSS) (1) is directly in-line with the anti-click washer (2) on the outboard joint of the half shaft.

4. **Before reinstalling the bearing/hub**, inspect the WSS on either/both affected side(s) for possible damage. It may be damaged due to contact with the oversized damaged washer.

- If no damage is found, reinstall the front wheel bearing and hub assembly, and no further repairs are necessary. Refer to *Front Wheel Bearing and Hub Replacement* in SI.
- If the WSS is found to be damaged (as shown circled in the graphic above), continue ahead to step # 5 and replace the WSS.
