# Service Bulletin

Bulletin No.: 19-NA-105

**Subject:** Information on Front Seat Back Cover(s) Loose Near Side Air Bag Cover

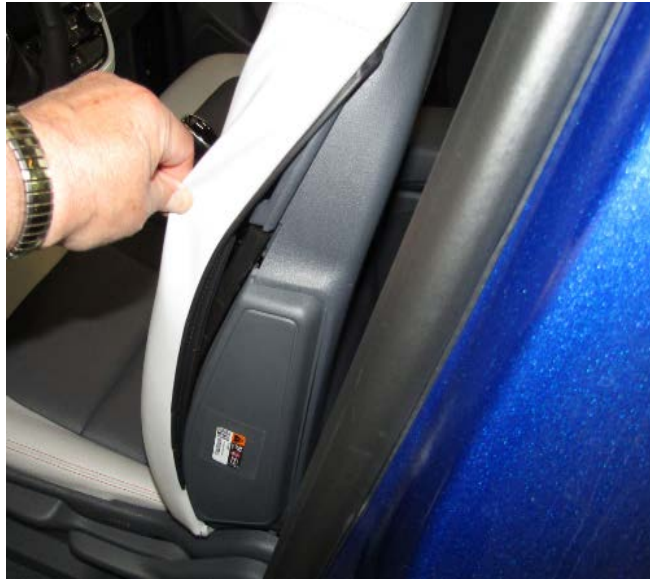
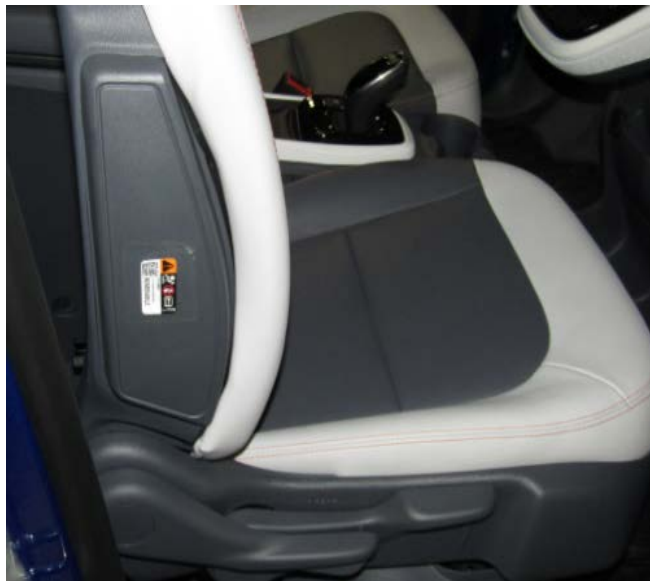
**Note:** Examples of a driver and passenger seat exhibiting the condition are shown in the graphics above.

Some customers may comment on one, or both, of the front seat back cover(s) coming loose around the side air bag cover.

| <p><b>Correction</b></p> | <p>If found to be the original design, replace the seat back cover(s) with the new design cover; and if the cover is new design, reinstall the seat cover and replace the upper support bracket(s) as necessary.</p> <p><b>Note:</b> Refer to SI for the updated front seat back cover replacement procedure. Also, more detail on the procedure can be attained by viewing the Emerging Issue Video of April 2019. In Canada, review the April 2019 edition of TAC Talk.</p> <p>Refer to <i>Front Seat Back Cover and Pad Replacement (2nd Design)</i> in SI.</p> |

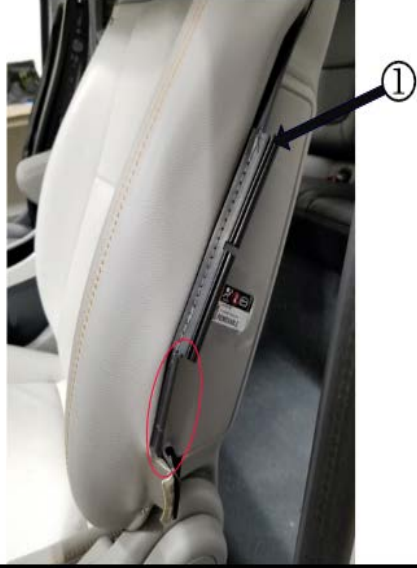
| <p><b>Cause</b></p> | <p><b>Note:</b> A 2nd design seat cover has been released for service, which contains additional side J-channels to help achieve proper retention of the cover to the seat frame.</p> <p>The cause of the condition may be one or more of the following:</p> <p style="text-align: right;">5331854</p> <ul style="list-style-type: none"> <li>• The seat cover may be an early design, which didn't include side J-channels (1). These J-channels were recently added to improve the fit and retention of the cover. The lower area circled is an area of intended non-attachment.</li> <li>• The upper support bracket on the outboard side of the seat, may be damaged or warped out of shape.</li> <li>• The seat contained a 2nd design seat cover, however the J - channels were not installed correctly onto the seat frame.</li> </ul> |
