# Service Bulletin

Bulletin No.: 19-NA-108

**Subject: Cold Start Rough Run, Misfire and/or Malfunction Indicator Lamp (MIL) Illuminated**

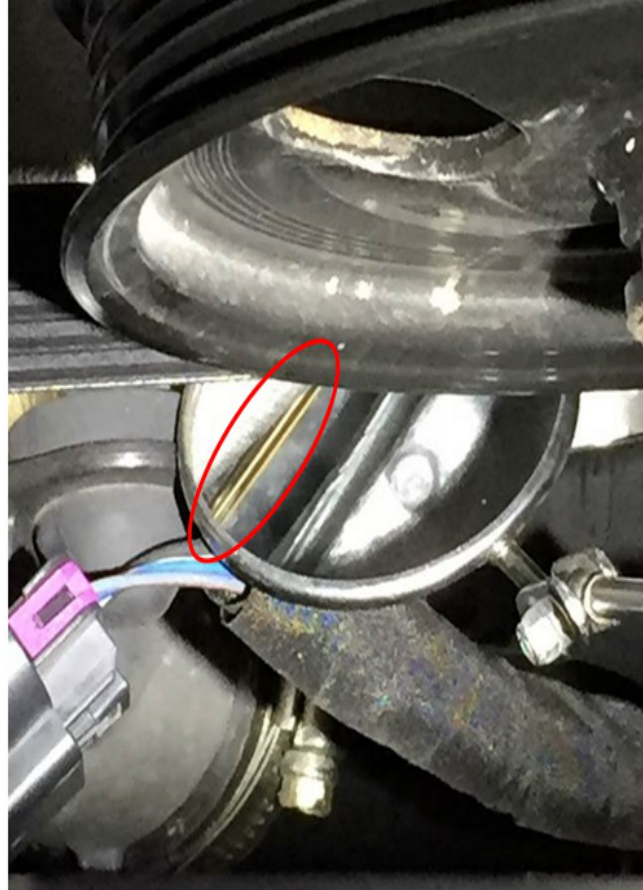
5336396

<b>Involved Region or Country</b>	North America, N.A. Export Markets and Israel
<b>Condition</b>	Some customers may comment on one or more of the following conditions: <ul style="list-style-type: none"><li>• Engine runs rough during cold starts, but smooths out when warmed up</li><li>• Engine misfires</li><li>• MIL illuminated</li></ul> Some technicians may find injector timing related DTCs on ONE bank of the engine.
<b>Cause</b>	This condition may be caused by two head gaskets being installed on one bank of the engine.

Inspect for two head gasket tabs on the driver's side front of the engine (as shown) or on the passenger's side rear of the engine. A bore scope or inspection mirror may be used between the power steering pump bracket and engine. Inspecting the passenger's side head gasket tab(s) can be made easier from underneath with the vehicle on a lift and a bore scope.

⇒ If two head gaskets on one bank of the engine is confirmed, during removal, please try to keep the two gaskets together as an assembly. DO NOT try to separate them. Engineering would like these kept together for analysis. Install a new head gasket with the same grade that was removed.

Replace the affected cylinder head gasket with the same grade that was removed. Refer to *Cylinder Head Replacement - Left Side* or *Cylinder Head Replacement - Right Side* in SI.
