POWER GEAR® POWER UP/POWER DOWN LEVELING JACK INSPECTION

TSB Number:	08-002-19
Product:	Power Gear Jacks
Date:	March 20, 2019

The purpose of this Technical Service Bulletin is to inform REV dealers of the need to inspect Power Gear Power Up/Power Down leveling jacks for common wear versus abnormal leakage.

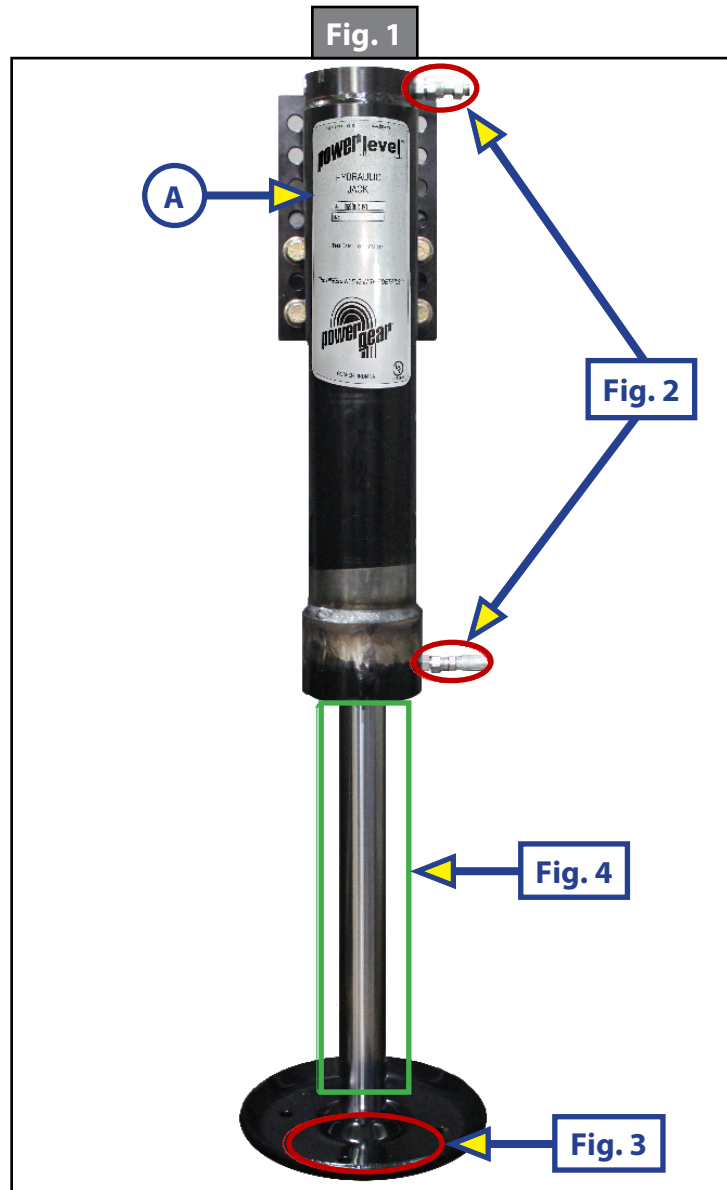
Visually inspect jack for external leakage (Fig. 1). For best results, run the auto-level and auto-retract sequence twice before performing visual inspection. If leaking is observed, verify all fitting connections are tightened to the correct torque and are not damaged. See attached TI-313 for torque specifications. Replace and tighten fittings as needed, clean the jack, and repeat the leveling sequence for additional visual inspection. If leaking persists, see the Action Needed section for information on ordering replacement jacks.

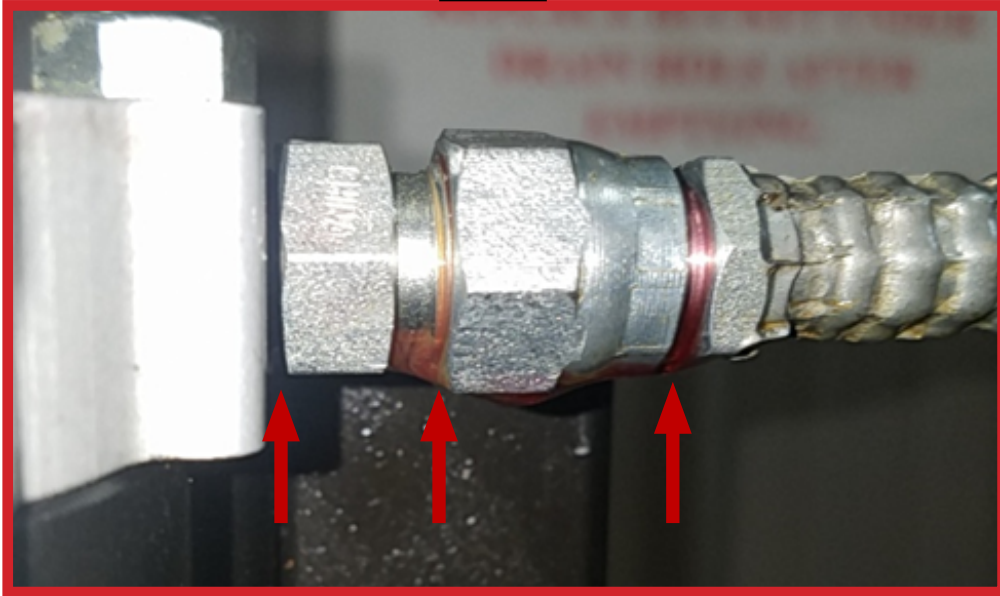
Fig. 2

Leaking fitting. Check fitting torque or replace fitting.

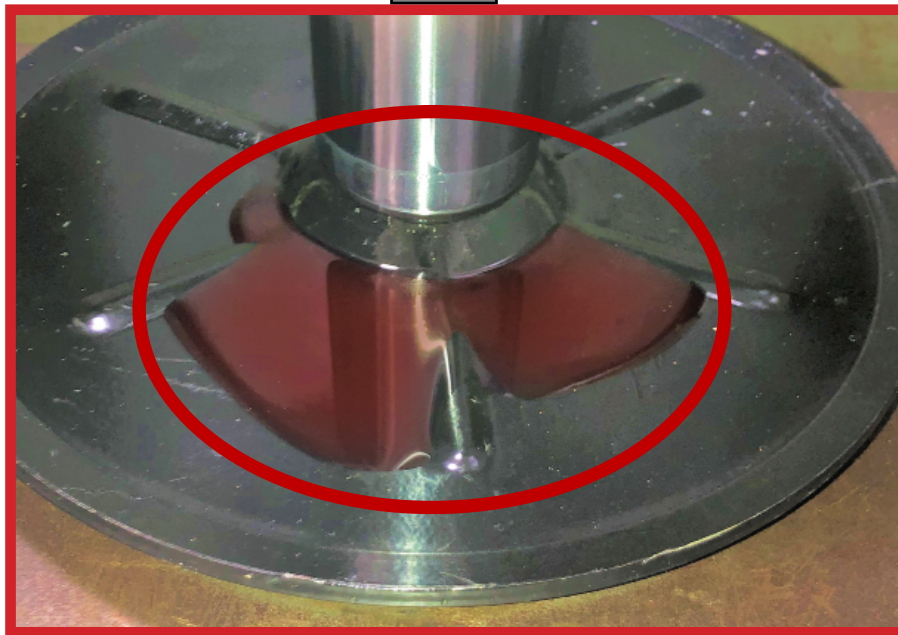
Fig. 3

Pooled fluid on footpad. Confirm fluid did not originate from a leaking fitting. If no leaking fitting is found, replace the jack.

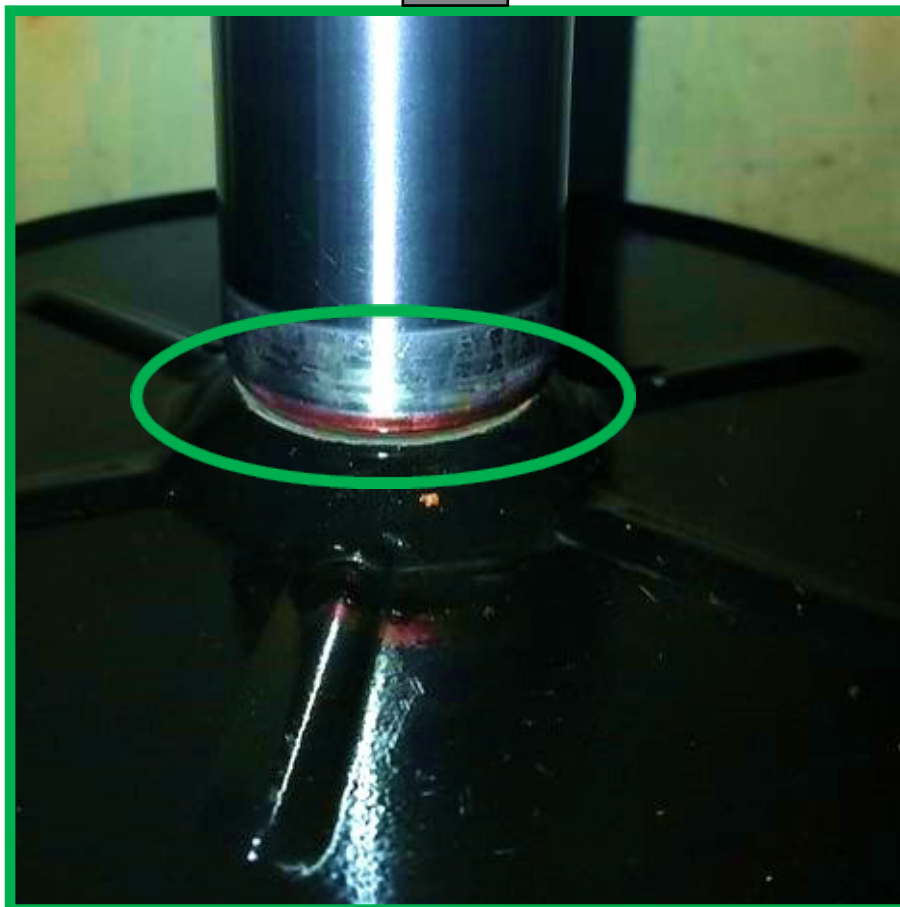
Fig. 4

A light oil ring on the rod at any jack position is normal and not considered to be a leak. No repair necessary.
