# Technical Service Bulletin

<b>Subject:</b> <b>RUBBING/CONTACT MARKS ON CONVERTIBLE TOP (TOP FABRIC WITHOUT INNER CLOTH/HEADLINER)</b>	<b>Bulletin No.:</b> 09-023/19
	<b>Last Issued:</b> 06/06/2019

2016 MX-5 (without inner cloth/headliner) with VINS lower than JM1ND\*\*\*\*\*117607 (produced before May 16, 2016)

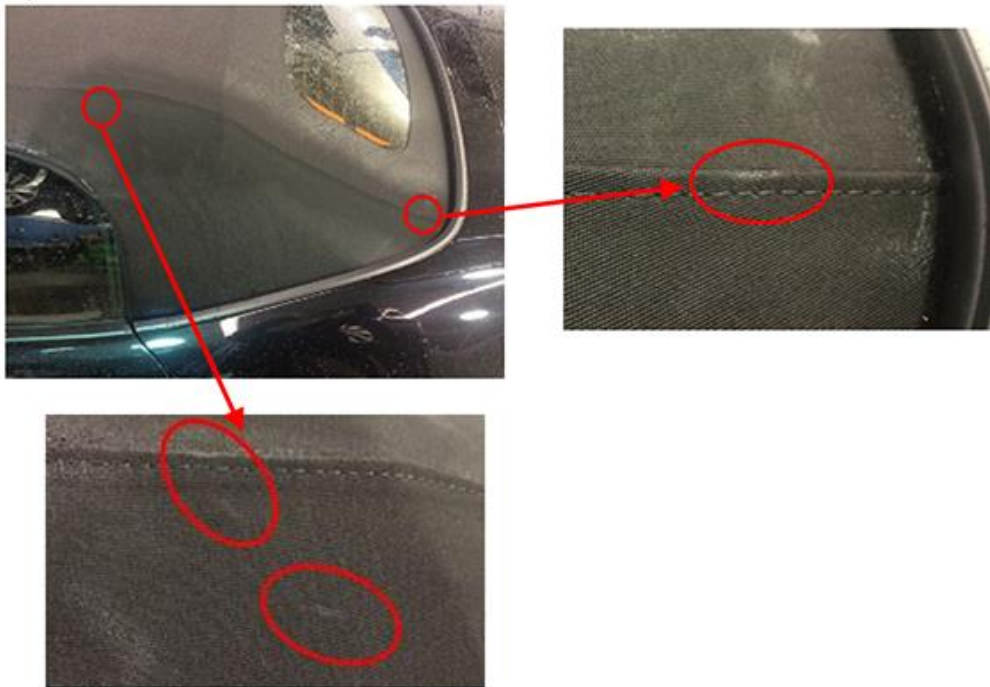
Some vehicles (without inner cloth/headliner) may exhibit rubbing/contact marks on the top fabric of the convertible top around the area as shown. The marks may occur on the right and/or left side(s).

**NOTE:** Left side is shown.

This is caused by the top fabric receiving vibration and the stitching line (hard) touching the top fabric while the vehicle is running with the convertible top opened (top fabric folded and piled up). To correct this

concern, the link stopper of the convertible top has been changed to adjust the opening angle of the convertible top, thereby decreasing the contact pressure applied to the top fabric when folded and piled up.

1. Verify the customer concern.
2. Check warranty history for a previous repair. If a top assembly was previously replaced under warranty, do not replace it again.
3. Replace the convertible top assembly with a modified one according to the procedure on MGSS (CONVERTIBLE TOP REMOVAL/INSTALLATION).
