Service Alert

2019 MAZDA3 SERVICE CAUTIONS FOR NEW AND REVISED FEATURES

Service Alert No.: SA-010/19

Last Issued: 06/13/2019

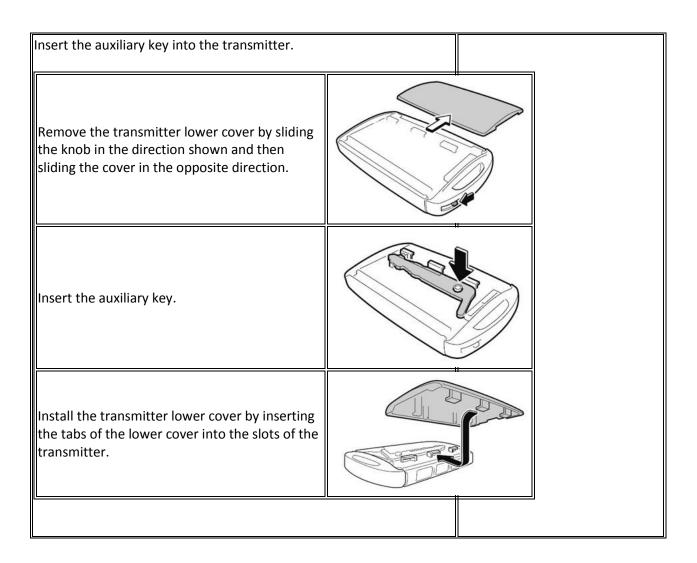
Auxiliary Key The auxiliary keys need to be inserted into the transmitters during Auxiliary Key Transmitter **NOTE:** The auxiliary keys are small and could be overlooked during PDI. Vehicles arrive at the dealer with Auxiliary Keys Vehicles arrive at the dealer with Transmitters located in the glove compartment* located in the front cup holder* /lanual -> Before s-> Auxiliary ke * Vehicles that arrive at the dealer after business hours, transmitters/duxiliary keys are located in the dealer's early bird key drop box. 1. If one auxiliary key is lost, some key machines can trace cut a new replacement key. 2. If both auxiliary keys are lost, key cutting machines do not recognize vehicle key code and will not cut new replacement keys. 1. Mazda is aware of this issue and is working on a resolution. **Transmitter Note:** 1. If one transmitter is lost, inform the customer to take cautions not to lose the 2nd transmitter. 2. If both transmitters are lost, the vehicle will be disabled. 1. MDARS is not able to program transmitters at this time. 2. Mazda is aware of this issue and is working on a resolution.
