Subject: 1980, ISX15 CM2350 Fuel Pump Tappet -EDS Guided -ATC-Multiple Customer

Number: Atc1980

Date: 03-May-2019

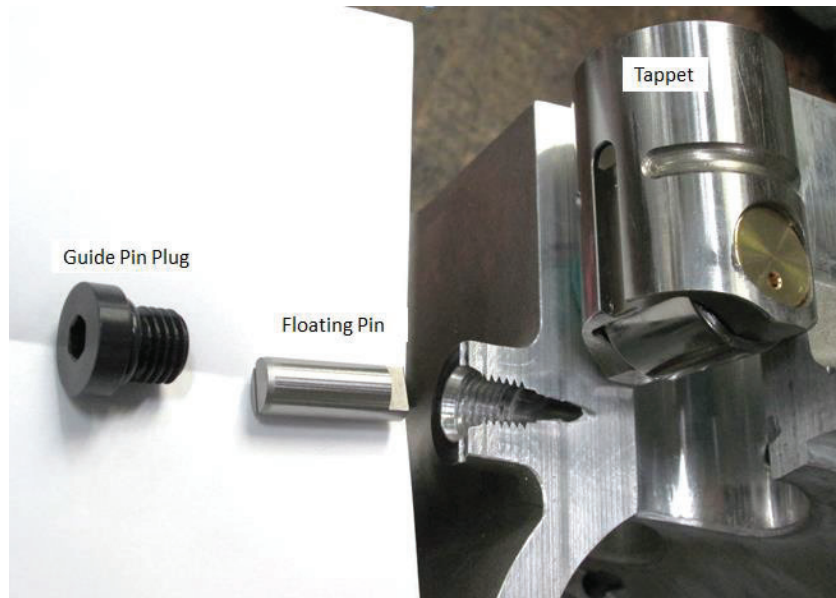
The tappet guide pin is a floating pin and plug design, as shown in Figure 1 below. The floating pin has a rectangular end that engages the groove on the tappet. Refer to Figures 2 and 3. The pin can be rotated by hand. Be certain the pin engages the tappet properly before installing the fuel pump head.

Figure 1: Tappet guide plug, floating pin, and the tappet roller with guide slot.

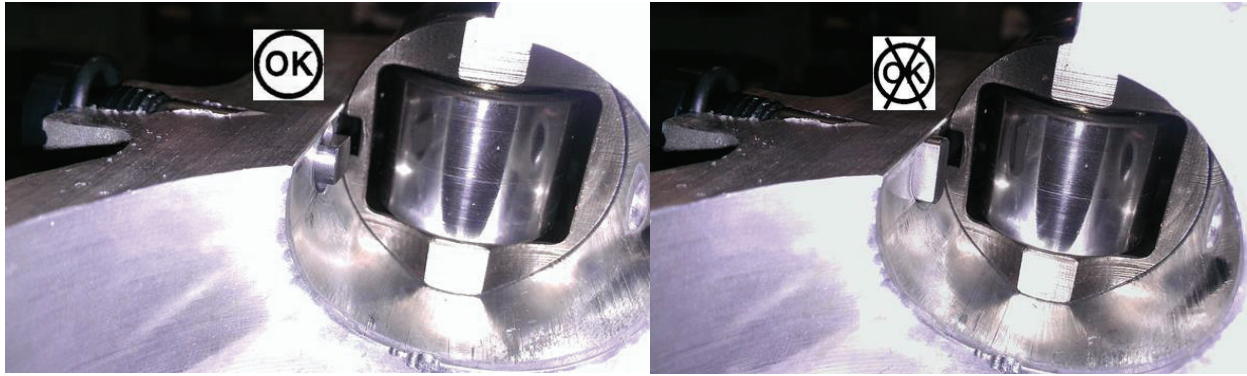
Figure 2: Bottom view using cut-away cam housing. (a) Tappet guide pin correctly oriented within the bore. (b) Tappet guide pin incorrectly oriented within the bore.

NOTE: Warning! The tappet guide pins may rotate during the removal of the tappet. The tappet cannot be correctly installed if the tappet guide pin is out of position. Please refer to Attachment B for the proper orientation of the tappet guide pin.

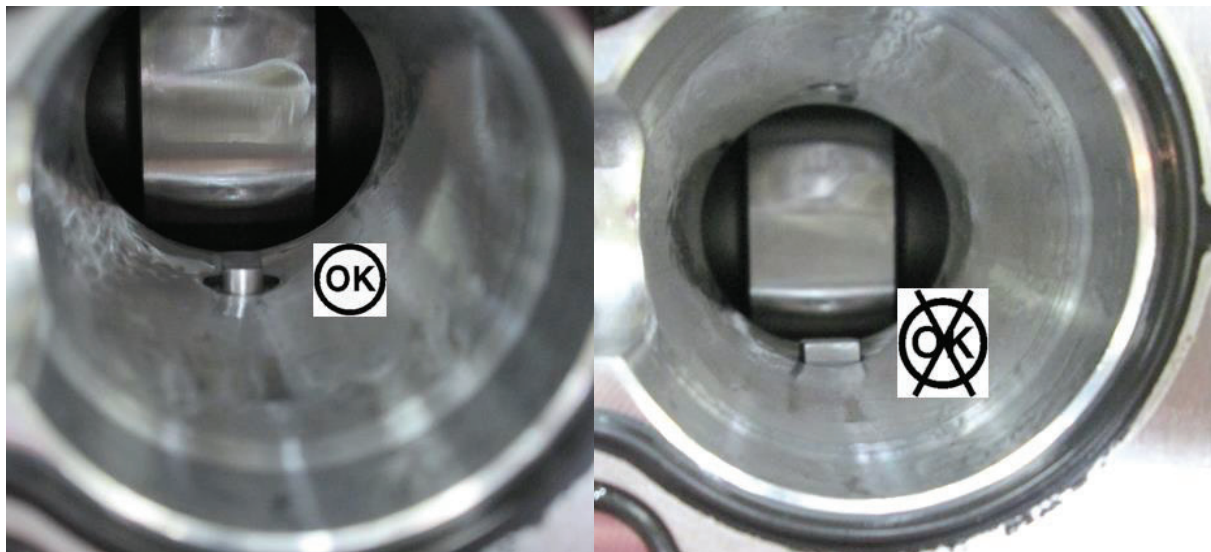
Figure 3: Top view looking down into bore. (a) Tappet guide pin correctly oriented within the bore. (b) Tappet guide pin incorrectly oriented within the bore.
