Preliminary Information

PIT5659C Driver Side Power Seat Inoperative

Product Investigation Review Required

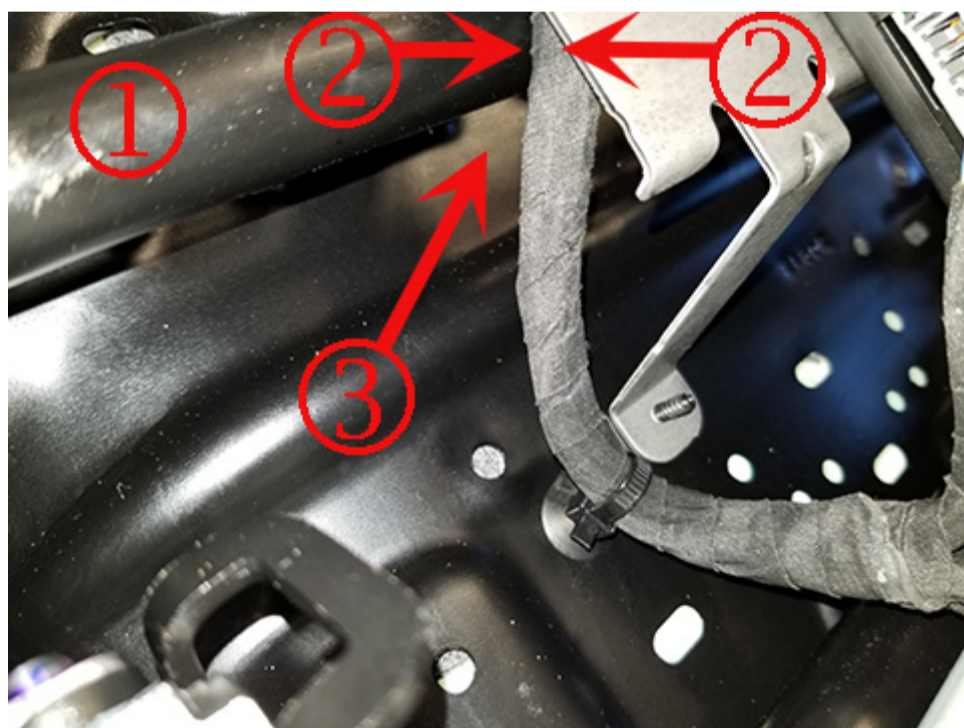
Involved Region or Country	North America
Additional Options (RPO)	AAB
Condition	A vehicle may arrive at the dealer with a complaint that the driver's side power seat will not move at times. Upon checking for codes a B3920 may be found.
Cause	The wire harness may be incorrectly routed below the seat frame tube and pinched between the memory seat module bracket and the seat cushion frame tube.

1. Seat Frame Tube

2. Harness routed below seat frame tube allowing contact with MSM bracket

3. Proper routing of harness above seat frame tube.

Inspect the seat harness for being routed below the seat frame tube instead of above it.

The harness can be seen by looking in from the front of the seat with the seat in a raised position.

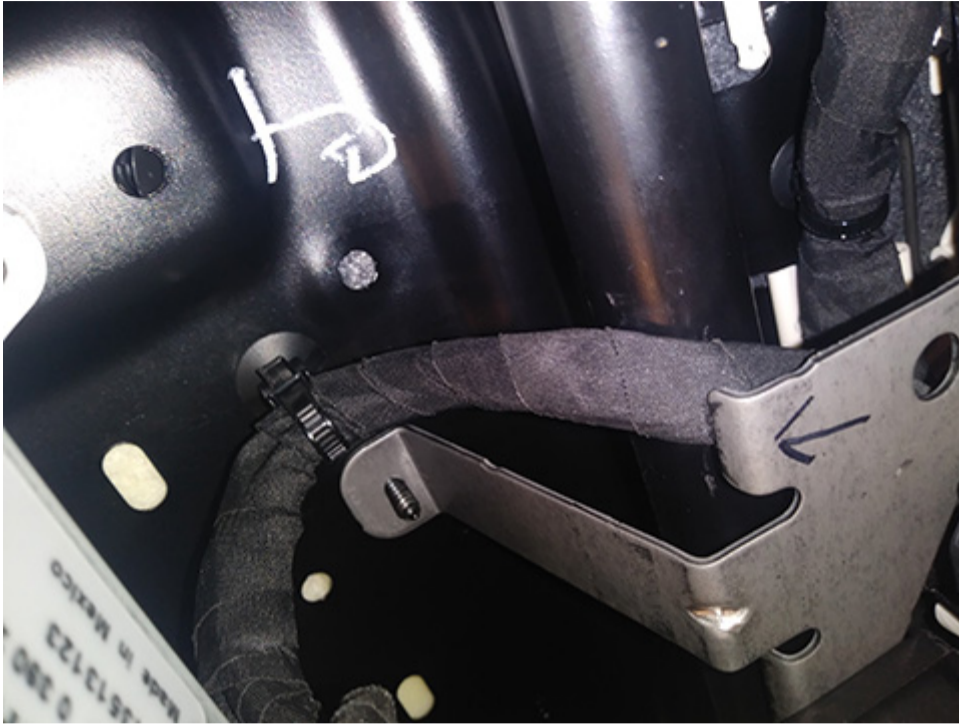
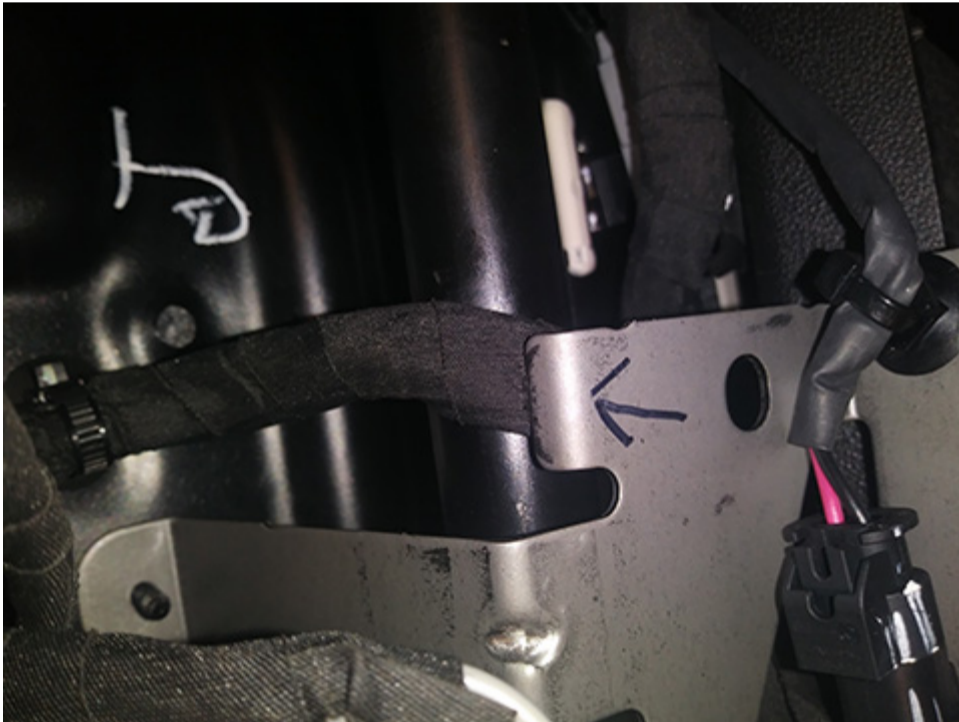
If the harness is found to be routed below the seat frame tube inspect it for being pinched between the memory seat module bracket and the seat frame tube as shown below.

Unbolt the seat and flip it up to gain access.

Repair or replace the seat harness as needed.

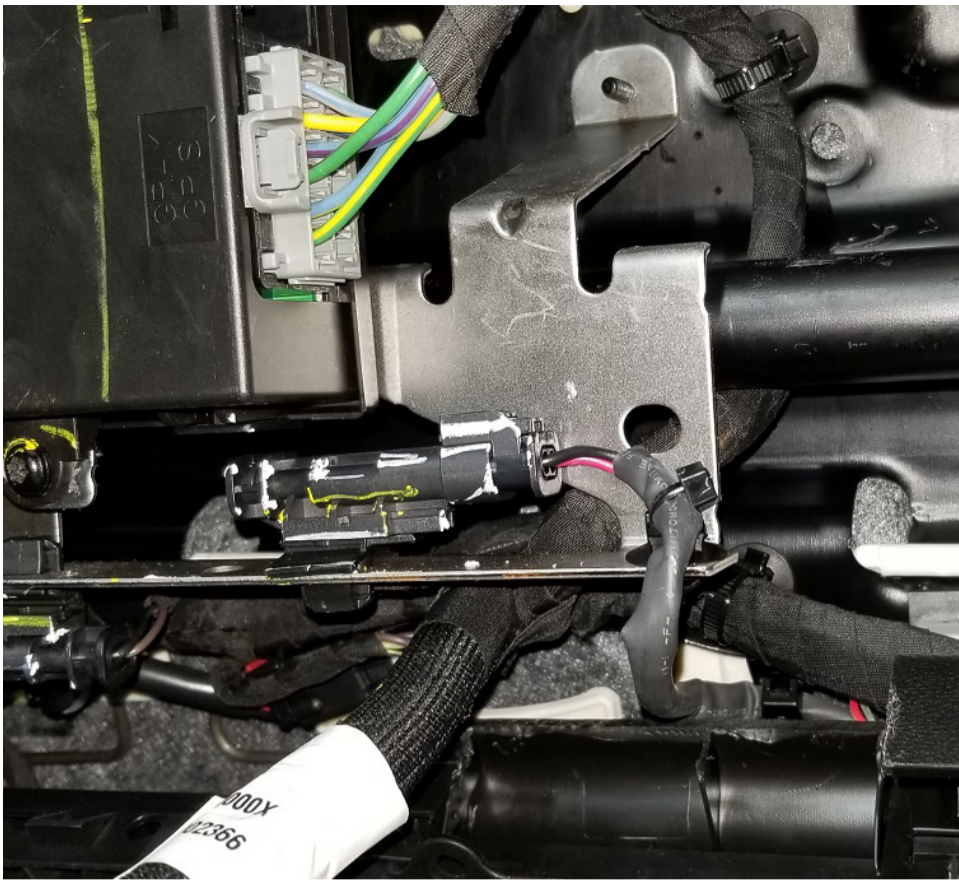
See photo below showing harness properly routed above the seat frame tube.

Re-route the harness above the seat frame tube so that it will not become pinched or damaged.
