Preliminary Information

PIT5457D Service ABS / TCS / Power Steering and/or Suspension Message DTC U0077 U0121 U0126 U0131 U0139 U0151 U0401 U0415 U0428 (Circuit 5986)

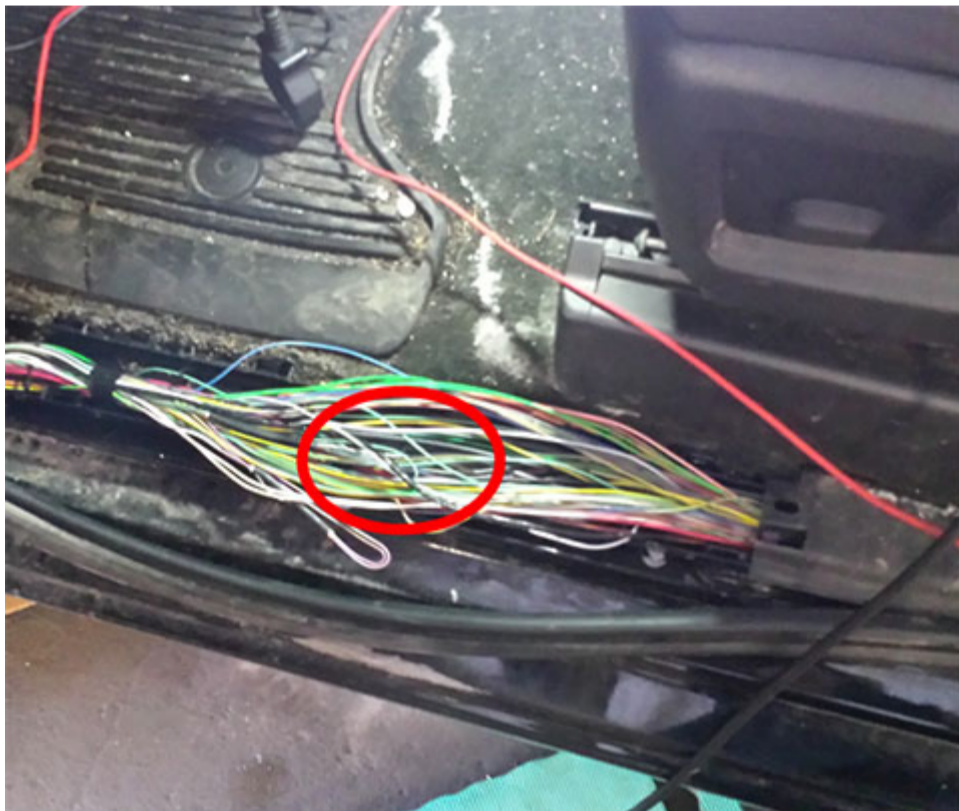
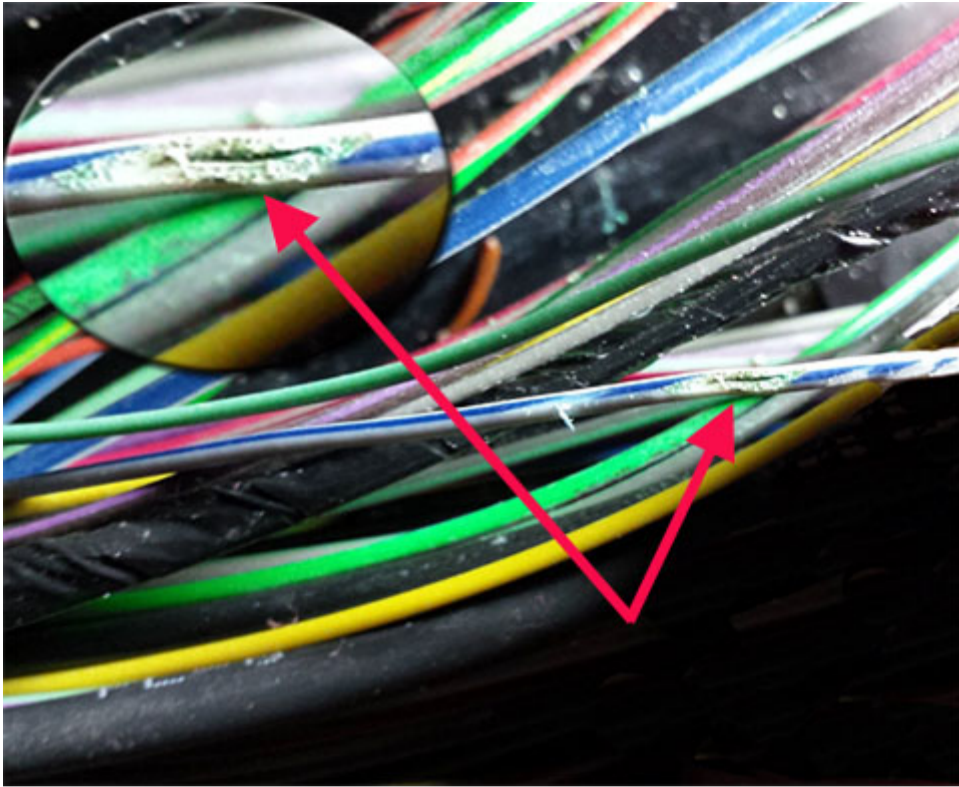
- 1. On short wheel base utilities (Escalade, Tahoe and Yukon), the chassis harness cut/pinched/shorted between the body and spare tire crossmember, see latest version of [PIT5556](#) for more details.**
- 2. Under the driver's sill plate, shown below.**

Monitor the voltage on the communication enable circuit 5986 at any of the modules affected, example EBCM, SDGM, PSCM, SWPS, SDM, HMI, PTO, and/or SCM. If low voltage or no voltage is present when the concern occurs, inspect for open/high resistance/shorts on circuit 5986. Repair any opens/high resistance/shorts in the circuit.

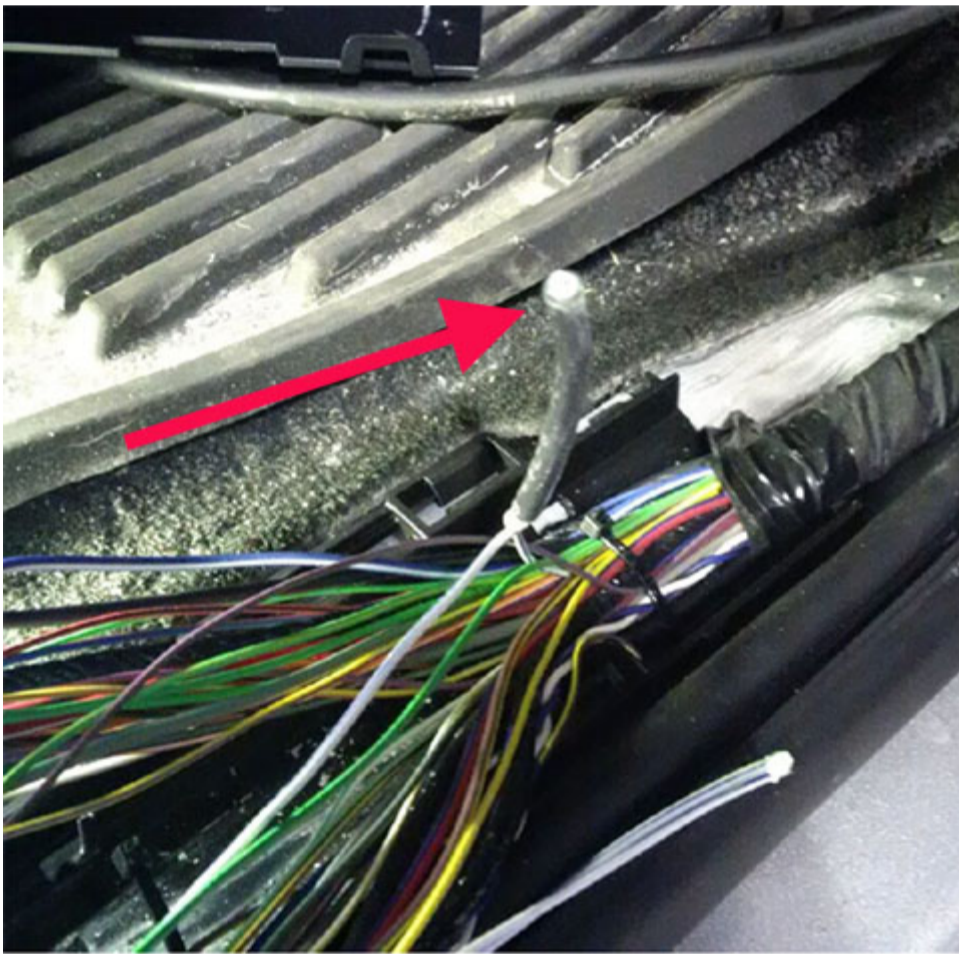
3. Splice J365 located under the passenger front sill plate, shown below.
