Bulletin No.: PIT5693  
Published date: 06/24/2019

### PIT5693 Service Air Bag, Park Brake, Stabilitrack or Park Brake Light

Brand:	Model:	Model Years:	VIN:		Engine:	Transmissions:
			from	to		
Chevrolet	Blazer	2019	All	All	All	All

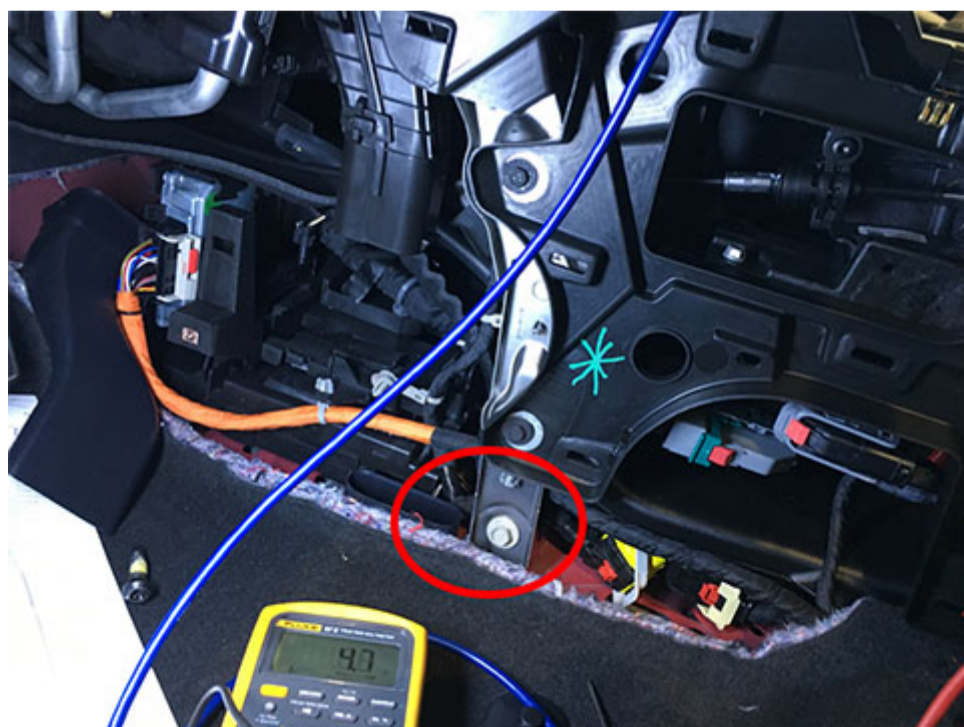
<b>Involved Region or Country</b>	<b>North America</b>
<b>Condition</b>	<b>Some customers may complain of any of the following conditions: Air bag Light Service Stabilitrack, Service Park Brake and/or Steering Assist Message displayed. You may also find any of the following DTC's set: B101E, U0077, U0131, U0151, U0232, U0415, U0422, U1510, U2415 or other communication codes.</b>
<b>Cause</b>	<b>The cause of this condition may be due to the IP harness being pinched behind center console metal side brace on the left side of the console, causing a wire short.</b>

**Remove the left side Front Floor Console Extension Panel and inspect for the harness being pinched behind the vertical metal side brace in the area shown below.**

**If a pinch condition is found repair the wiring following the proper procedure in SI and ensure that the harness is not contacting the brace upon reassembly .**
