**When working on any of the systems listed below that receive power from the rear body fuse block (1), inspect for loose fuse connections inside the fuse block itself. In some cases, the fuse has poor terminal tension and may cause intermittent or completely inoperative conditions for these systems:**

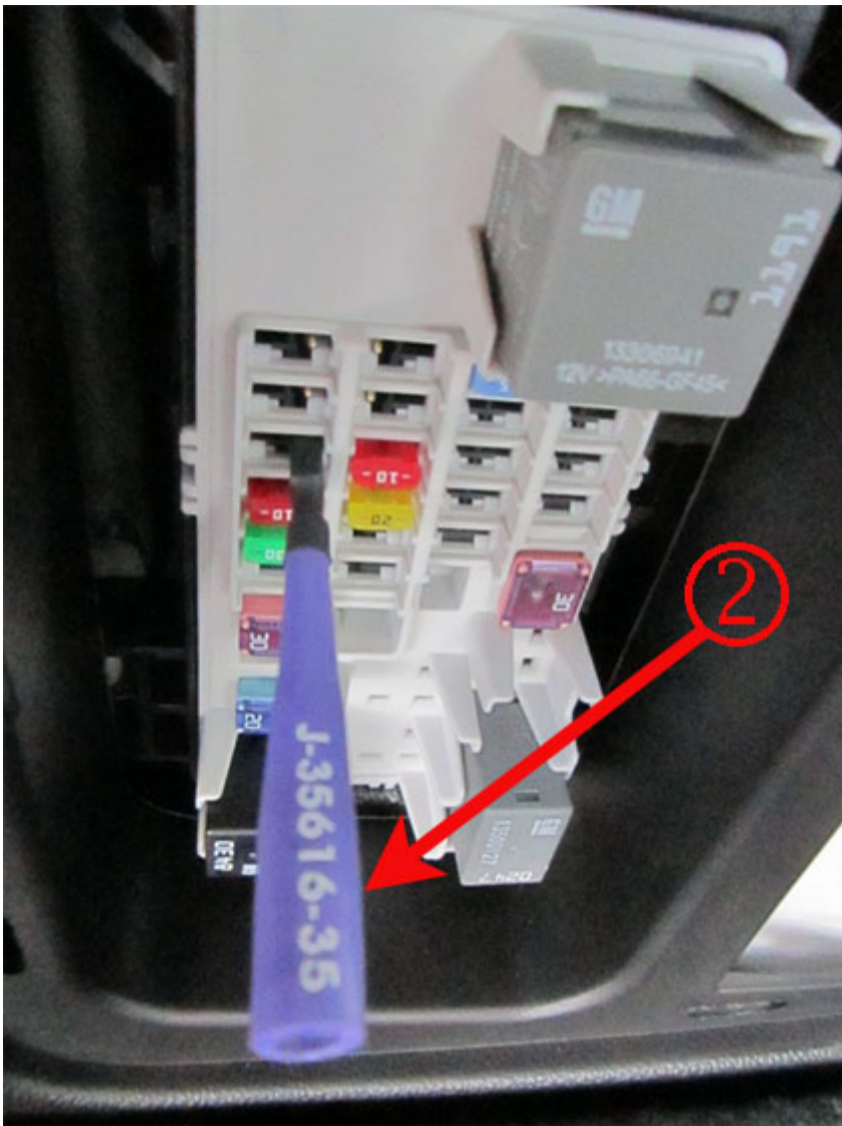
**Using the "purple" J-35616-35 test probe, check for proper terminal tension at the suspect fuse (2).**

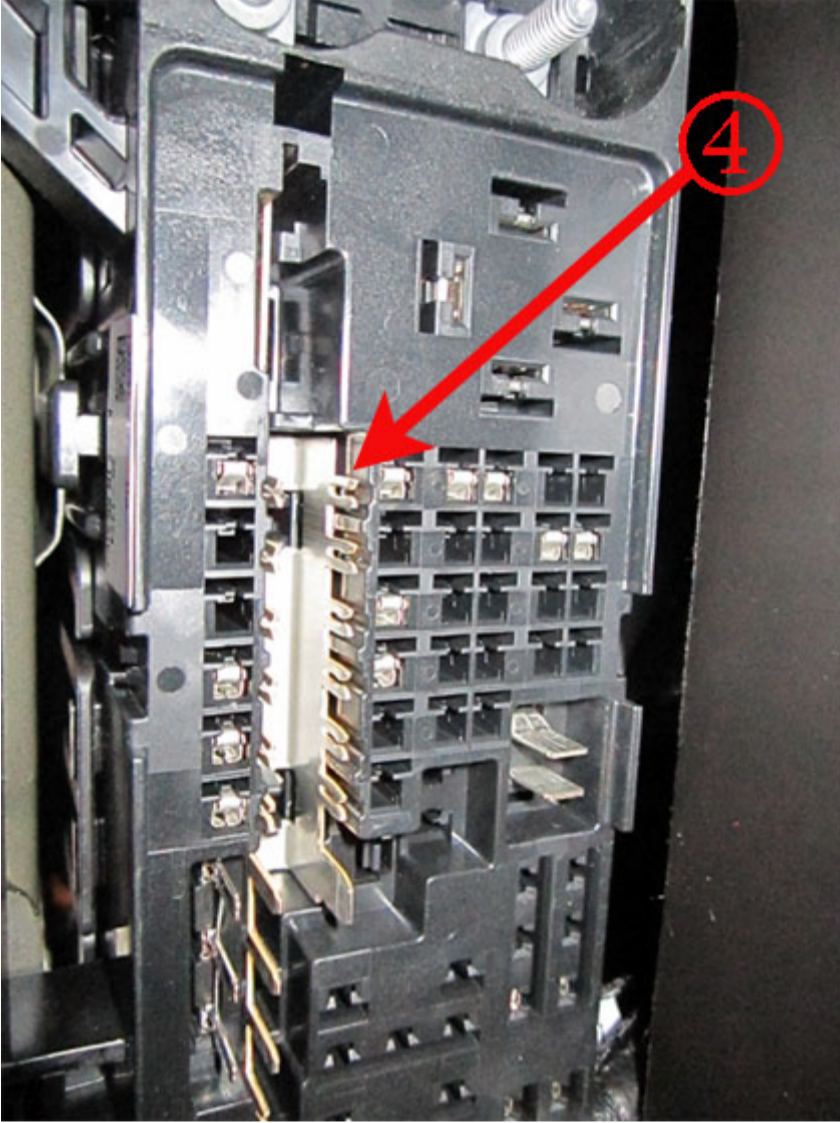
In many cases, the loose connection is on the main power buss bar (4), inside the rear body

**fuse block.**

**If the loose connection is found to be with the main power buss bar (4) or the plastic fuse block body is deformed, replace the complete Rear Fuse Block with GM Part number 13586872. The new Rear Body Fuse Block will include the main power buss bar and the black plastic body, shown below. All fuses/relays/terminals will need to be transfer over from the old fuse block.**
