SERVICE BULLETIN

APPLICABILITY: 2013-2019MY BRZ

NUMBER: 12-267-19

SUBJECT: Front Bumper Cover Gap / Loose Fit

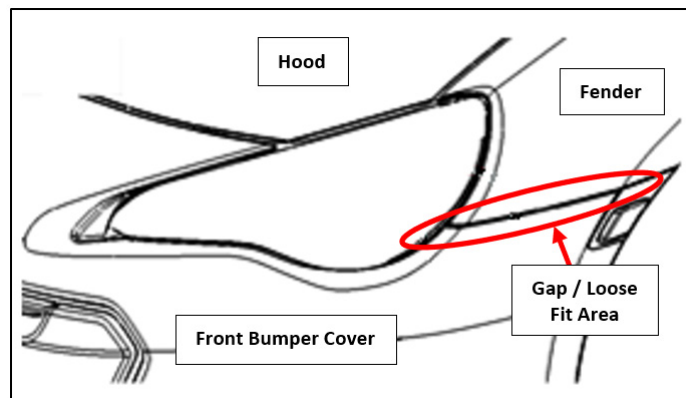
This bulletin announces availability of a new retaining plate and installation method to address gapping conditions which may develop between the front bumper cover and fender as shown in the example illustration below.

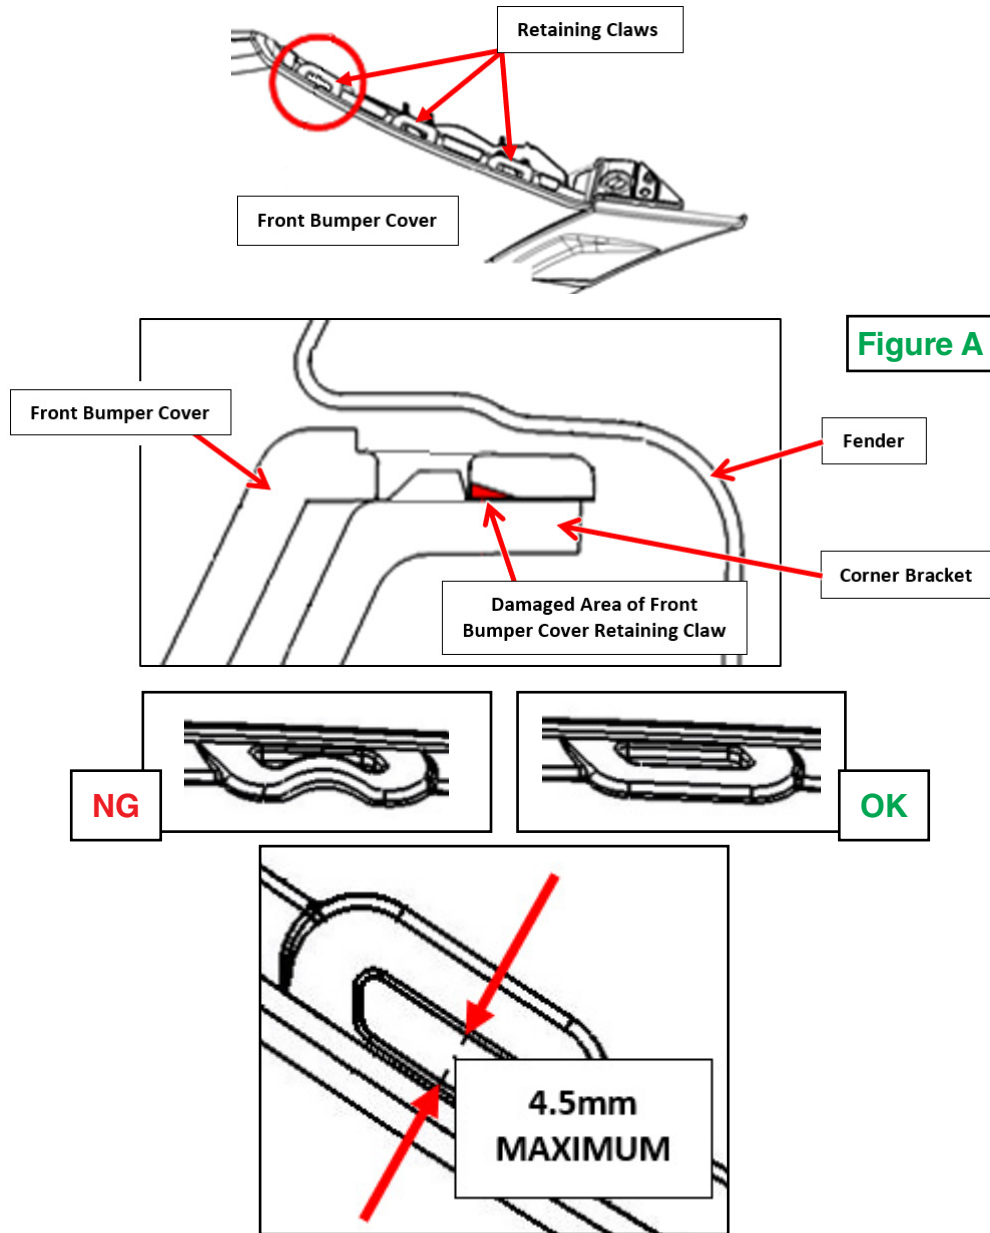
- 1) After confirming a loose fit / excess gap condition exists, CAREFULLY remove the front bumper cover assembly following the procedure in the applicable Service Manual. Follow all precautions to protect the finish of both the cover, fender and surrounding painted surfaces.
- 2) On each side of the bumper cover, there are 3 claws to secure it to the corner bracket as shown in the illustrations below. These claws can become damaged reducing their ability to secure the cover to the corner bracket properly. This causes the gap / loose fit condition to occur.

- 3) Inspect the removed bumper cover and determine if it is reusable by the following criteria:
 - If any of the claws are broken, deformed as shown in the **NG** illustration above or, have a center opening exceeding 4.5mm, the cover must be replaced following the procedure in the applicable Service Manual.
 - If the claws are in-tact as in the **OK** illustration and / or only have minor wear as shown in **Figure A**, proceed to **Step 4** below.
