SERVICE INFORMATION BULLETIN

APPLICABILITY: 2019MY Ascent

NUMBER: 16-122-19

SUBJECT: DTC P0842- Revised Diagnostics Procedure

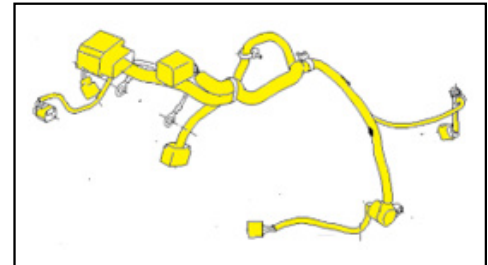
This Service Information bulletin provides an updated procedure to follow when diagnosing / repairing a DTC P0842: “TRANSMISSION FLUID PRESSURE SENSOR/SWITCH “A” CIRCUIT LOW”.

Steps 4 and 5 of the Working Procedure for Diagnosis and Repair of DTC P0842 have been updated as shown below. When the resistance determined to be out of specification is found during diagnosis and electrical testing, the transmission harness must be REPLACED (NOT repaired as previously stated in the Service Manual).
