# Service Bulletin

Bulletin No.: 17-NA-308

**Subject:** Carpet Damage, Seat Mounting Stud Wear Through, Hole in Second Row (Intermediate) Carpet

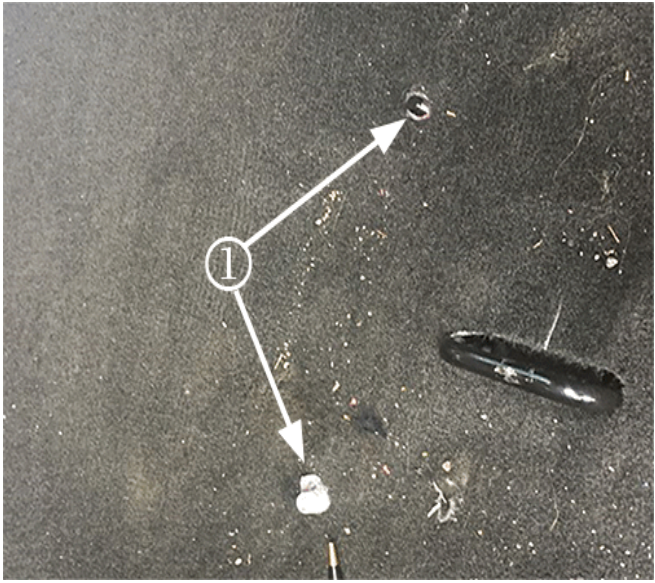
<p style="text-align: right;">4867790</p> <p>Some customers may comment that studs are wearing through (1) the second row (intermediate) carpet, around the base of the second row seats. This may be most noticeable on vehicles with second row bucket seats.</p>
<b>Cause</b>	This condition may be due to the interface design of the intermediate carpet to the seat studs, which may allow the studs to wear holes in the carpet.
<b>Correction</b>	Replace the intermediate carpet and add protective hose to the seat studs, following the steps in the Service Procedure below.

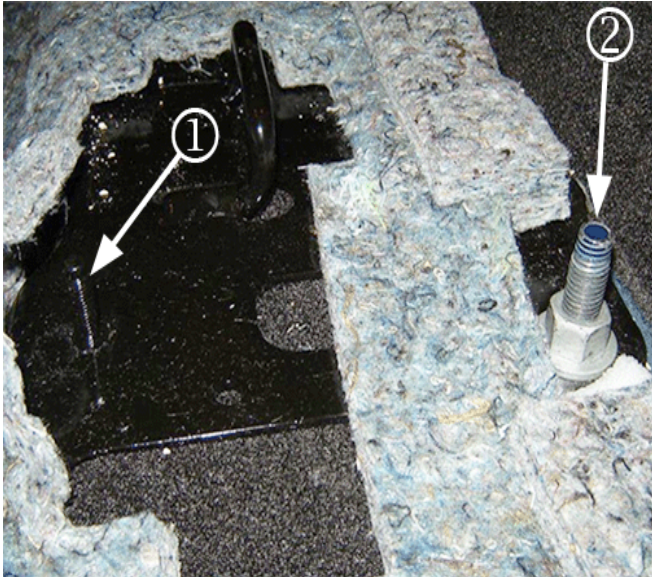
4867792

**Note:** There are two different size seat studs; 8 mm (1) used for long side bench to short side bench seat attachment (present on right side bucket seat), and 12 mm (2) used for seat to floor attachment.

1. Inspect the intermediate carpet for wear through from seat studs and mark the affected stud locations.
