# Service Bulletin

Bulletin No.: 17-NA-374

**Subject: Information On Diesel Exhaust System Configuration and DPF Soot Accumulation, Malfunction Indicator Lamp (MIL) Illuminated - DTC P2463 Set**

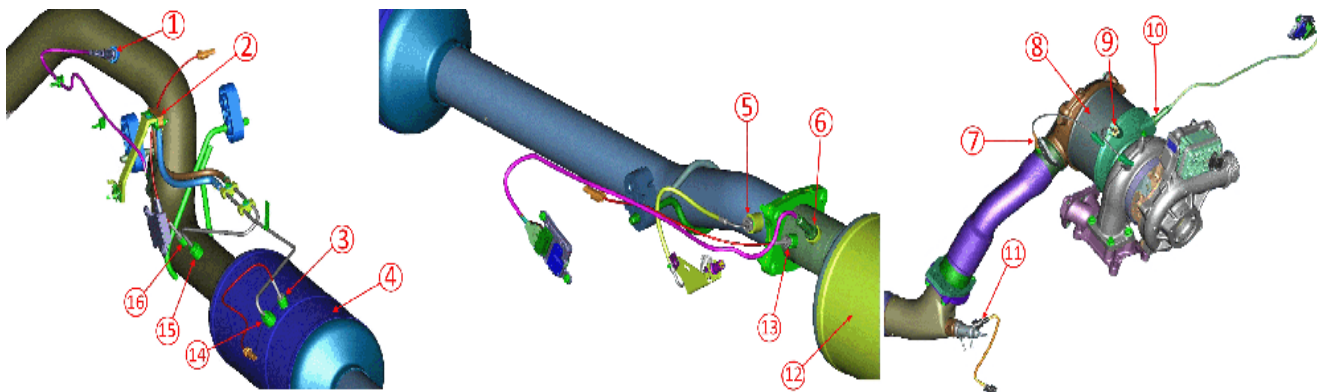
4898858

Below is an illustration of the location of the exhaust components, Sensors, and Injectors on the exhaust aftertreatment system for the above vehicles:
