Service Bulletin

Bulletin No.: 18-NA-056

Subject: Drivers Side Object Sensing Alert Module Not Working Correctly and/or Incorrect Side Mirror Notification

Brand:	Model:	Model Year:		VIN:		Engine:	Transmission:
		from	to	from	to		
Buick	Encore	2017	2019

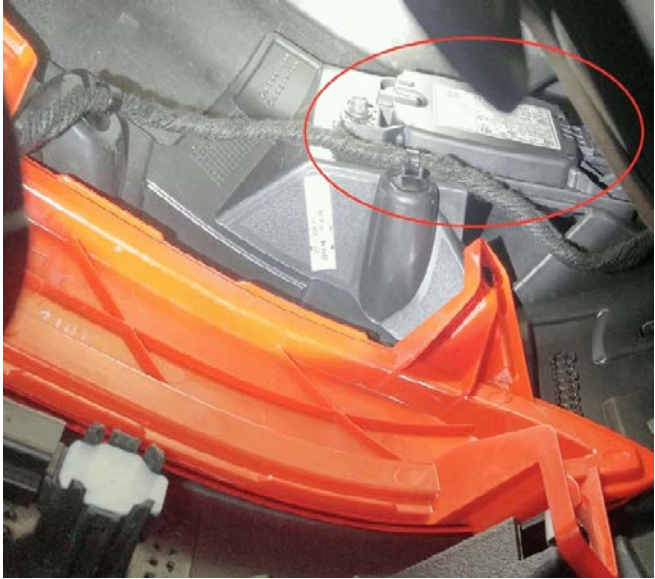
Involved Region or Country	North America
Additional Options (RPOs)	Equipped with SIDE ACTIVE SAFETY-OBSTACLE DETECTION (RPO UFT)
Condition	Some customers may comment when driving, the side mirror indicates there is a vehicle present when there is not.
Cause

<p style="text-align: right;">4974639</p> <p>Note: Most radar reflections may be found worse on the driver side than the passenger side. This condition may be caused by unwanted radar reflection being detected and triggering the false alerts.</p>
Correction	If the side blind zone has been found not working properly, apply a piece of aluminum butyl tape to the bottom of the drivers side object sensing alert module.
