Service Bulletin

Bulletin No.: 18-NA-268

Subject: Rattle Noise Heard from Front of Vehicle When Engine is Running at Slower Speeds

Brand:	Model:	Model Year:		VIN:		Engine:	Transmission:
		from	to	from	to		
Chevrolet	Corvette	2014	2019			6.2L (LT1, LT4)	6L80, 8L90 Automatic (MYC, M5U)

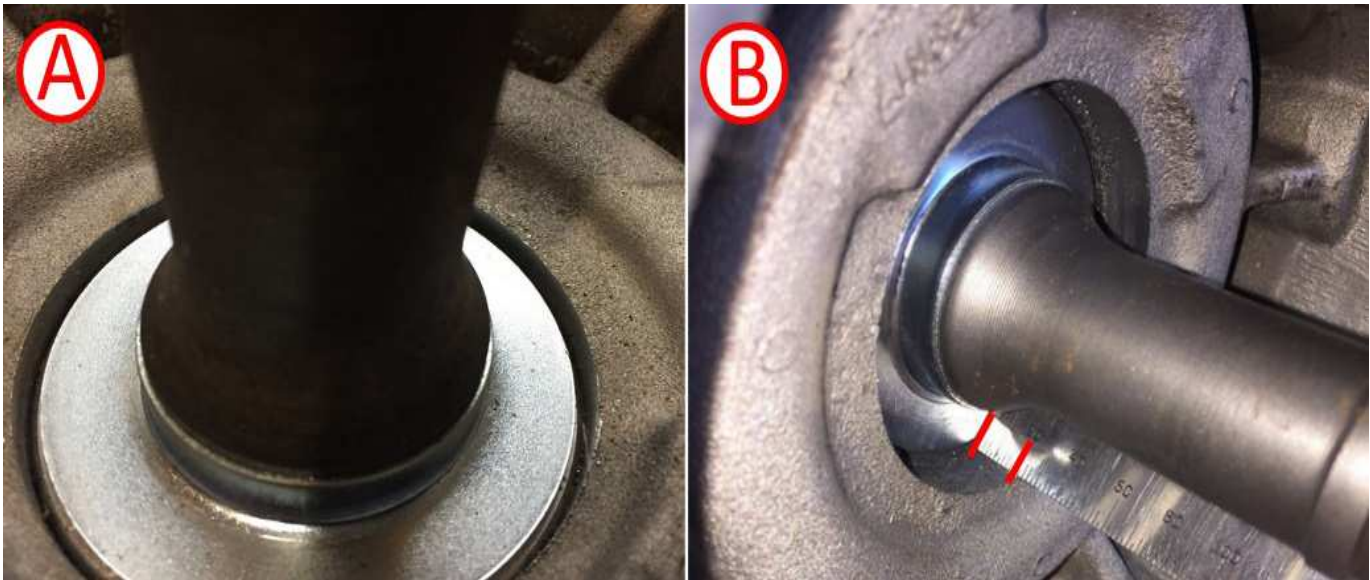
5315085

3. Inspect that the front bearing/slinger is flush (A) with the housing:
 - ⇒ If the bearing/slinger has been validated to be the cause of the noise and/or found to be pushed rearward more than ¼ inch (6 mm) (B), continue with *Propshaft Replacement* procedure in SI.

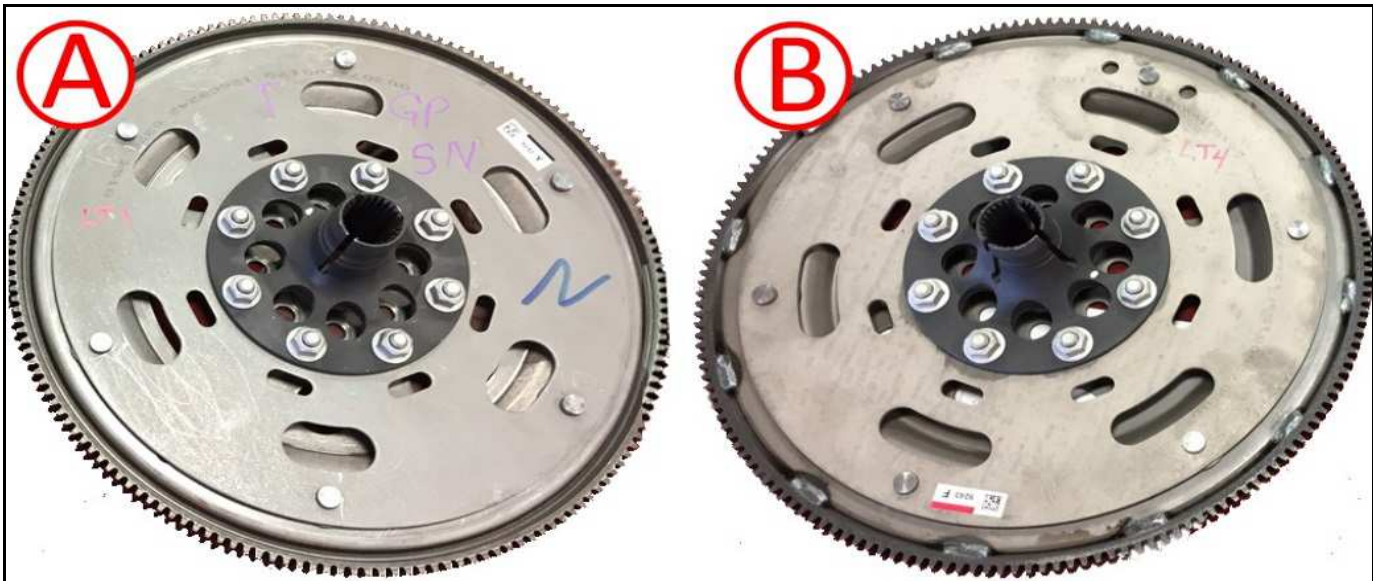
5300907

4. Verify that the propshaft hub clamp bolt is properly torqued.
5. Inspect the flex plate:
 - If an LT1 flex plate is installed (A), it is crucial that the LT4 flex plate (B) be installed.
 - ⇒ If the bearing/slinger is found to be pushed rearward more than ¼ inch (6 mm), continue with *Propshaft Replacement* procedure in SI.
 - If the LT4 flex plate is installed, but the bearing/slinger is pushed rearward, continue to the next step.

Note: Add medium strength thread locker to the DSA flex plate clamp pinch bolt.
