Service Bulletin

Bulletin No.: 19-NA-108

Subject: Cold Start Rough Run, Misfire and/or Malfunction Indicator Lamp (MIL) Illuminated

Brand:	Model:	Model Year:		VIN:		Engine:	Transmission:
		from	to	from	to		
Chevrolet	Silverado	2017	2018			L5P	
	Silverado 2500/3500	2019	2019				
GMC	Sierra	2017	2018				
	Sierra 2500/3500	2019	2019

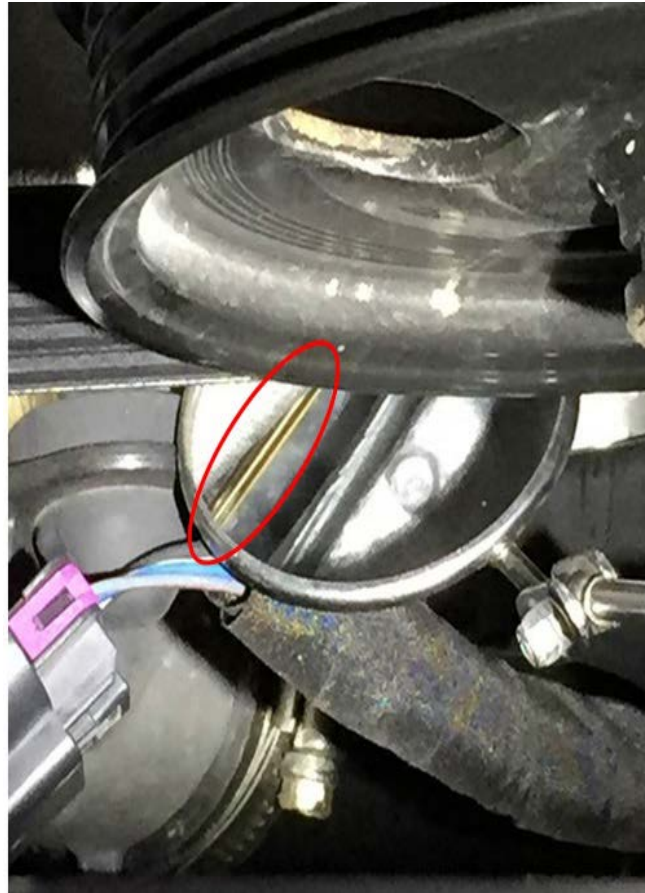
5336396

Involved Region or Country	North America, N.A. Export Markets and Israel
Condition	Some customers may comment on one or more of the following conditions: <ul style="list-style-type: none">• Engine runs rough during cold starts, but smooths out when warmed up• Engine misfires• MIL illuminated Some technicians may find injector timing related DTCs on ONE bank of the engine.
Cause	This condition may be caused by two head gaskets being installed on one bank of the engine.
Correction	Important: The vehicle must have more than 2000 miles (3219 km) since new or the latest fuel injector replacement.

Inspect for two head gasket tabs on the driver's side front of the engine (as shown) or on the passenger's side rear of the engine. A bore scope or inspection mirror may be used between the power steering pump bracket and engine. Inspecting the passenger's side head gasket tab(s) can be made easier from underneath with the vehicle on a lift and a bore scope.

⇒ If two head gaskets on one bank of the engine is confirmed, during removal, please try to keep the two gaskets together as an assembly. DO NOT try to separate them. Engineering would like these kept together for analysis. Install a new head gasket with the same grade that was removed.

Replace the affected cylinder head gasket with the same grade that was removed. Refer to *Cylinder Head Replacement - Left Side* or *Cylinder Head Replacement - Right Side* in SI.
