Service Bulletin

Bulletin No.: 19-NA-123

Subject: Rear Closure Hands Free Lamp Logo Projection Distorted

Brand:	Model:	Model Year:		VIN:		Engine:	Transmission:
		from	to	from	to		
Chevrolet	Blazer	2019	2019			All	All

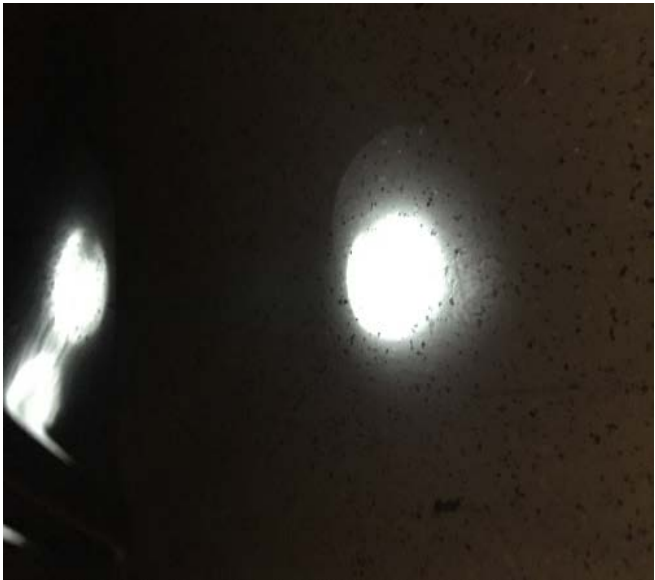
</div> <div data-bbox="1419 1421 1484 1438"><p>5343106</p></div> <p data-bbox="540 1451 1455 1528">Some customers may comment that the on-ground image of the rear closure hands free lamp logo projection is distorted, and does not resemble the Chevrolet Bow Tie. Some further comment that the logo lamp resembles a 'C' or a circle.</p>
<p>Cause</p>	<p data-bbox="540 1539 1438 1591">The cause of the condition may be water entering between the rear closure hands free lamp and lamp bracket, and gathering onto the lens of the lamp.</p>

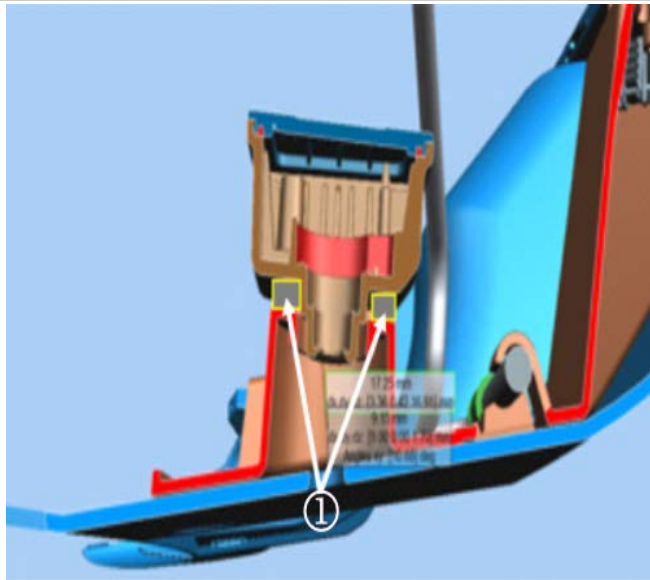
5343112

Note: The illustration above shows a cross-section of the seal installed (1), which results in blocking the main water path.

Following the steps in the Service Procedure below, add the service part foam seal referenced in the Part Table.
